ASSESSMENT OF DAM SAFETY OF COAL COMBUSTION SURFACE IMPOUNDMENTS FINAL REPORT

**CPS Energy
J.T. Deely Power Plant
San Antonio, Texas**

Prepared for
*U.S. Environmental
Protection Agency
Washington, D.C.*

February 2014
Revised May 2014
Revised June 2014

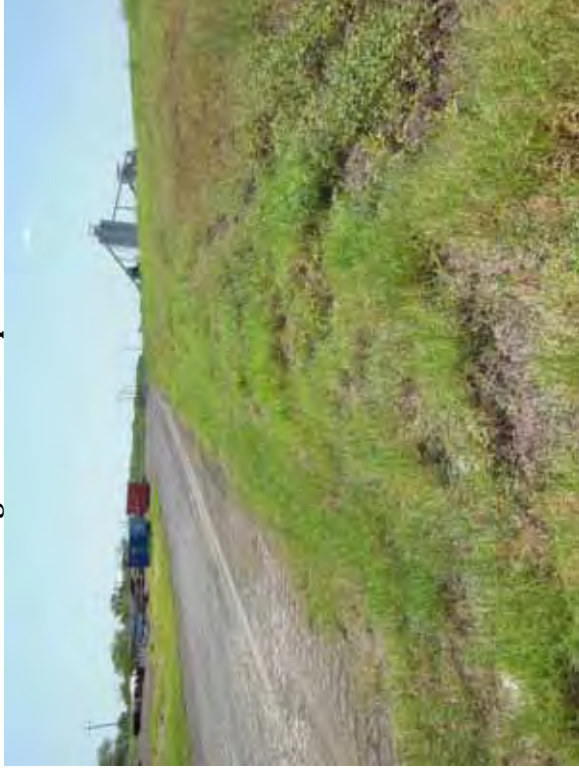
Photo 14: NP - Loose ash material at east embankment interior slope.

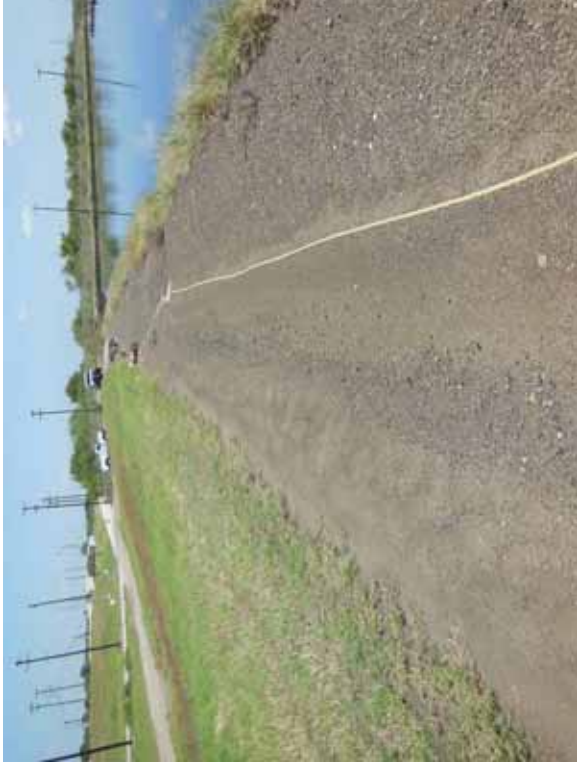
Photo 41: NP - West embankment exterior slope, looking north. Note area of loose soil/ash material.

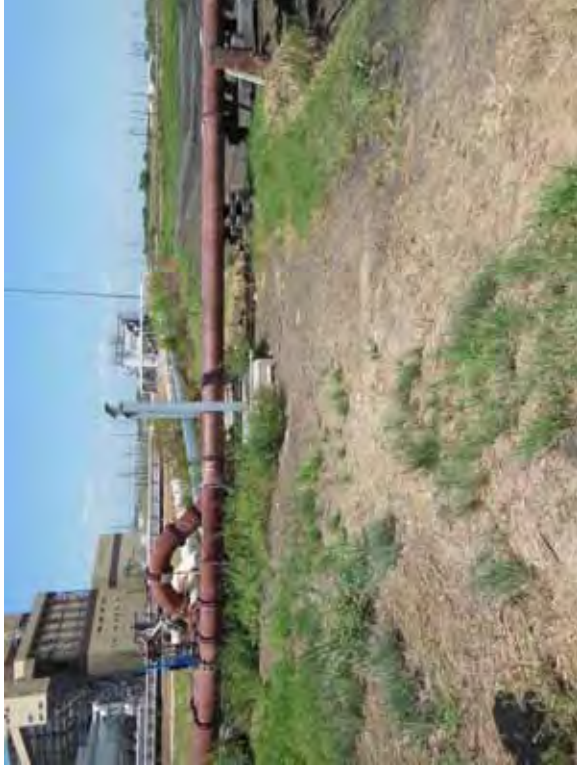
Photo 68: SP - South embankment exterior slope, looking west. Note equipment working in pond to replace inlet piping.
