ASSESSMENT OF DAM SAFETY OF COAL COMBUSTION SURFACE IMPOUNDMENTS FINAL REPORT

**CPS Energy
J.K. Spruce Power Plant
San Antonio, Texas**

Prepared for
*U.S. Environmental
Protection Agency
Washington, D.C.*

February 2014
Revised May 2014
Revised June 2014

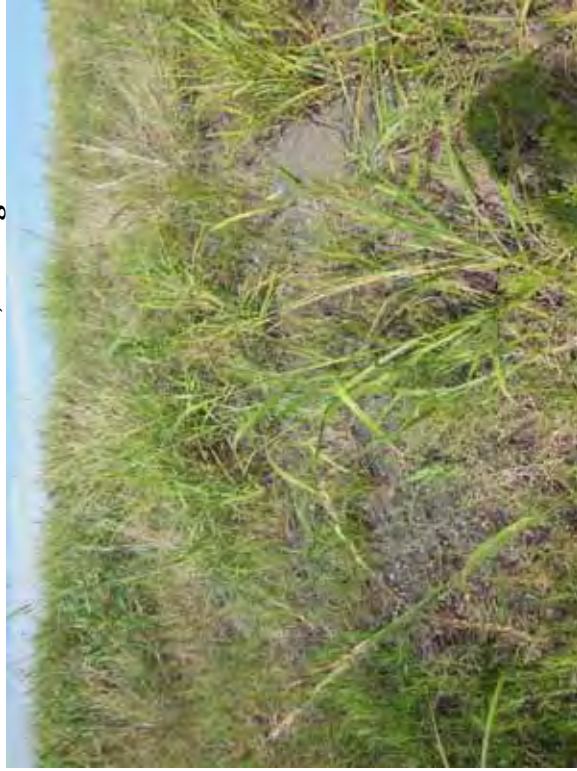
The exterior slopes of the Evaporation Pond are covered in grassy vegetation approximately 2 feet high and a few small trees and bushes with diameters less than 6 inches. Areas of loose soil were observed at the east embankment exterior slope of the Evaporation Pond and an animal burrow was observed at the west embankment exterior slope. Trees up to 12 inches in diameter were located at the toe of all embankments of the Evaporation Pond. Visible portions of interior slopes of the Evaporation Pond and SRH Pond did not include riprap or other armoring.

Photo 60: Loose soils on east embankment exterior slope.

CDM Smith recommends that vegetation on the SRH Pond and Evaporation Pond embankments be cut on a regular basis to help ensure that adequate visual observations can be made by CPS' personnel during routine inspections. CDM Smith also recommends trees (including the root ball) located at and within 15 feet of the toe of all embankments of the Evaporation Pond be removed and the excavations filled with compacted fill under the supervision of a qualified dam engineer. Animal control measures should be implemented to reduce embankment disturbance. All affected areas should be backfilled with compacted fill, graded to match the surrounding topography, and seeded with appropriate non-invasive grassy vegetation. It is also recommended that riprap be placed on interior embankment slopes in areas with little or no armoring.

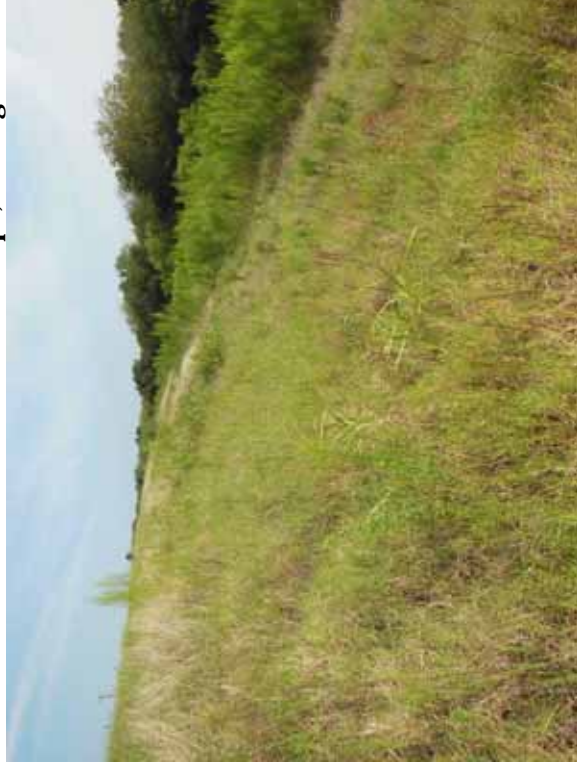
Photo 61: East embankment exterior slope, looking north.

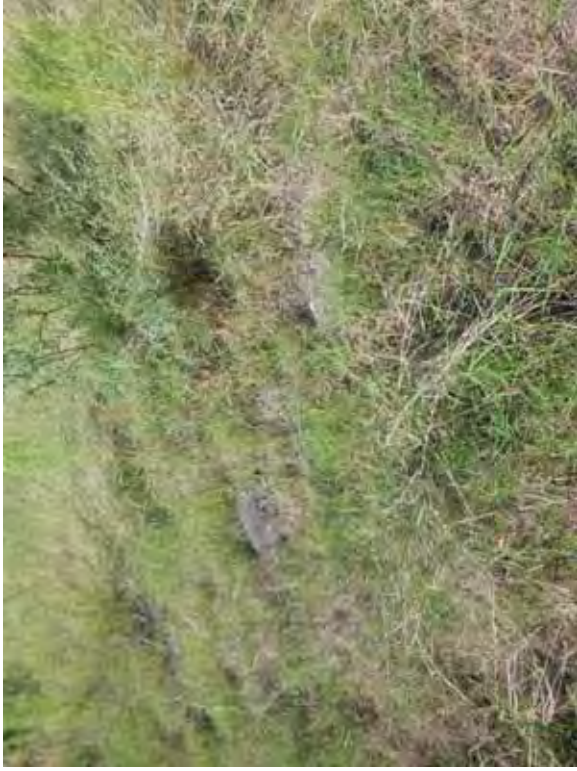
Photo 62: Loose soils on east embankment exterior slope.

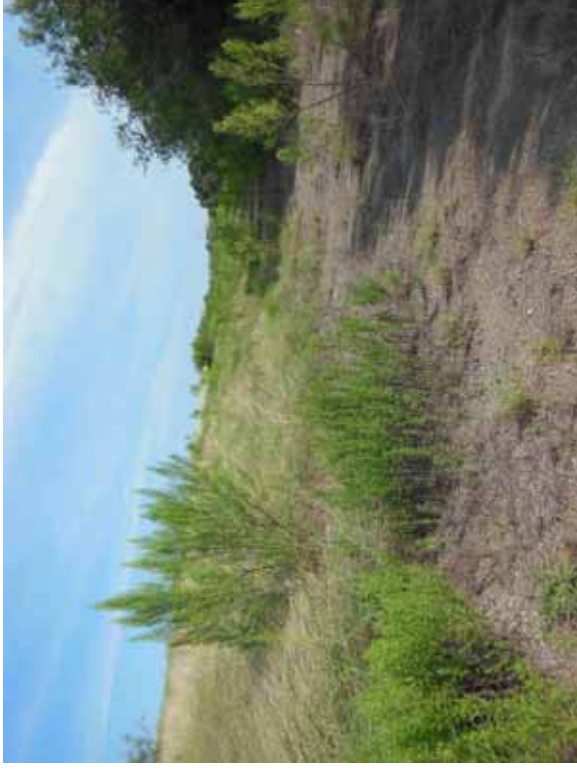
Photo 63: East embankment exterior toe, looking north.

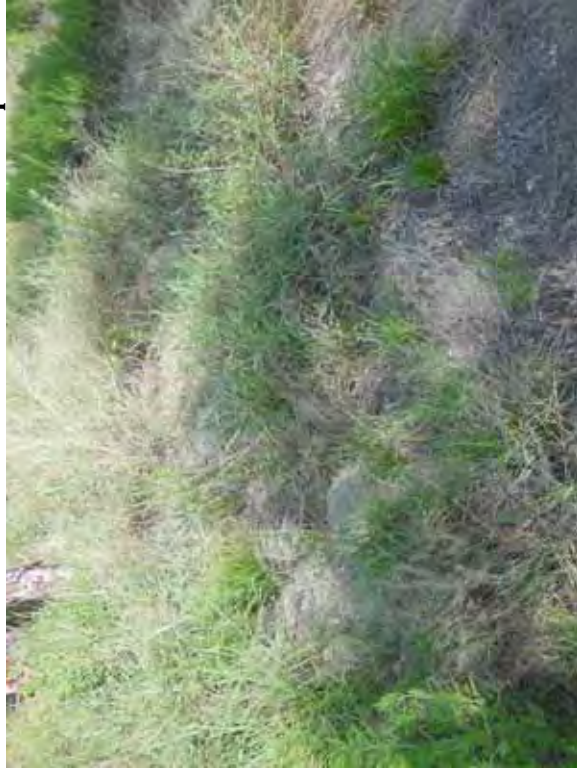
Photo 64: Loose soils near east embankment exterior toe.

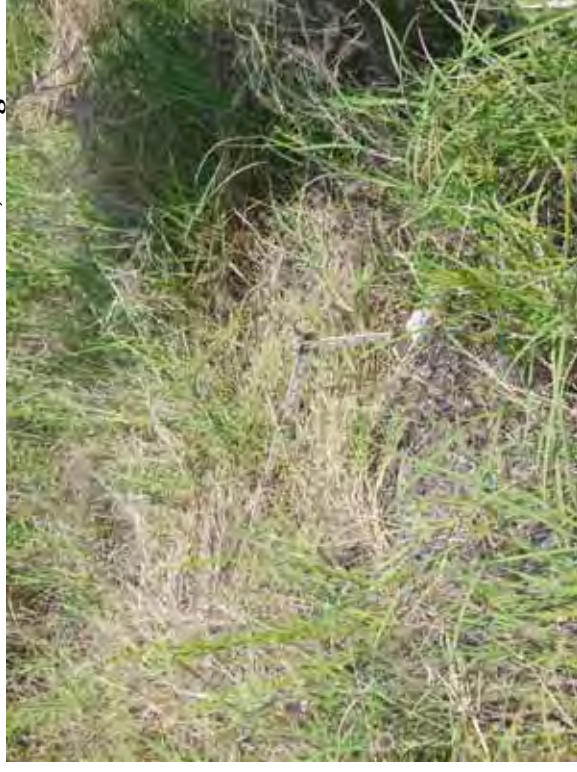
Photo 65: East embankment exterior slope measured approximately 4H:1V.
