January 13, 2017

Project No. 0352436

Subject: CCR Units - 2016 Annual Inspection
Calaveras Power Station
San Antonio, Texas

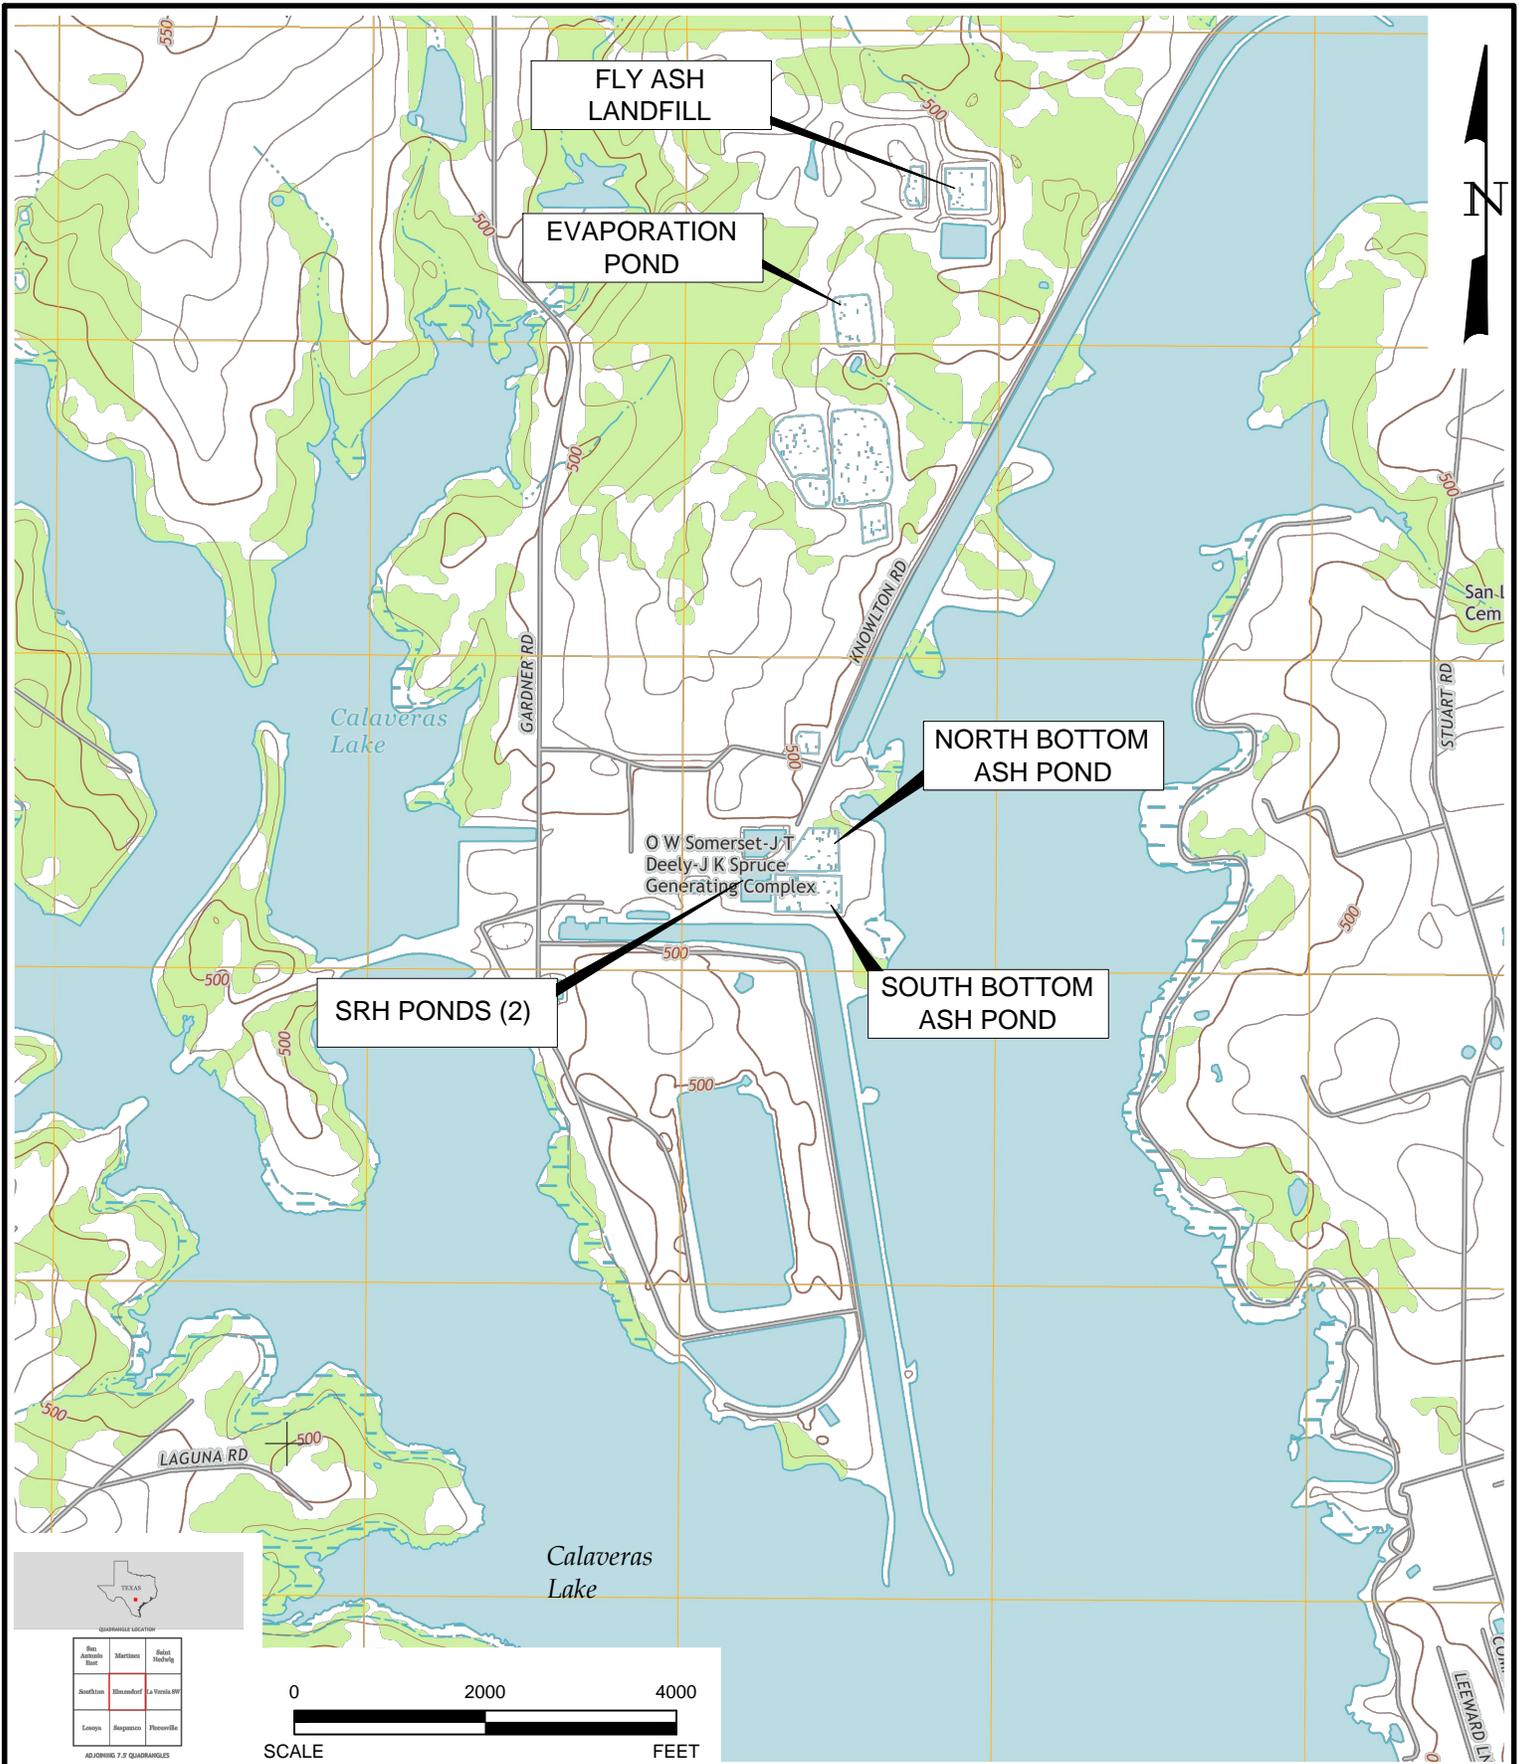
FIGURE 1
 CCR Unit Locations
 Calaveras Power Station
 CPS Energy
 San Antonio, Texas

All units are reportedly built with above-grade earthen embankments composed of sandy clay and clayey sand fill. Some units have CCR ash used in the surface roadways of the features (e.g., Fly Ash Landfill and Bottom Ash Ponds). Figure 1 shows the locations of each CCR unit. Dimensions of the CCR units were not measured during the annual inspection. Measurements used herein are based on an assessment conducted in June 2014 by CDM Smith, and checked using computer satellite mapping software.

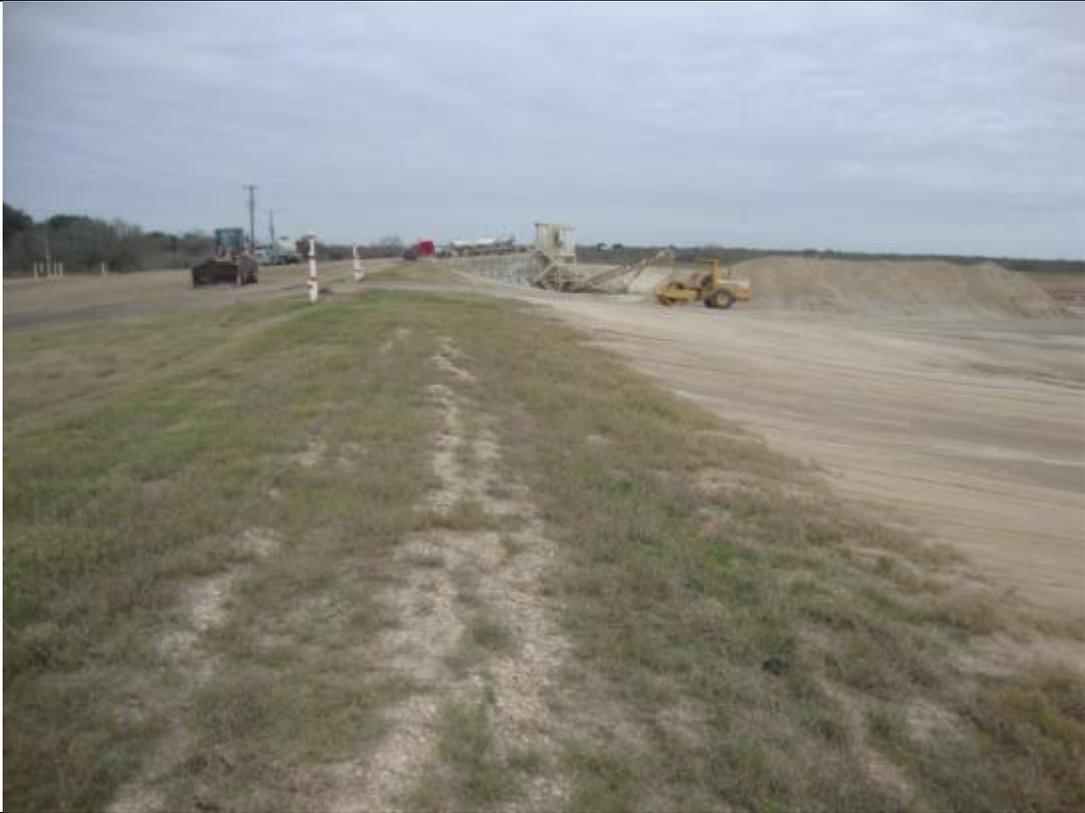
Photograph: 1 Fly Ash Landfill – standing on western berm – facing north. Mobile ash conditioning machine located in northwest corner of landfill. Photo taken 12/20/16.

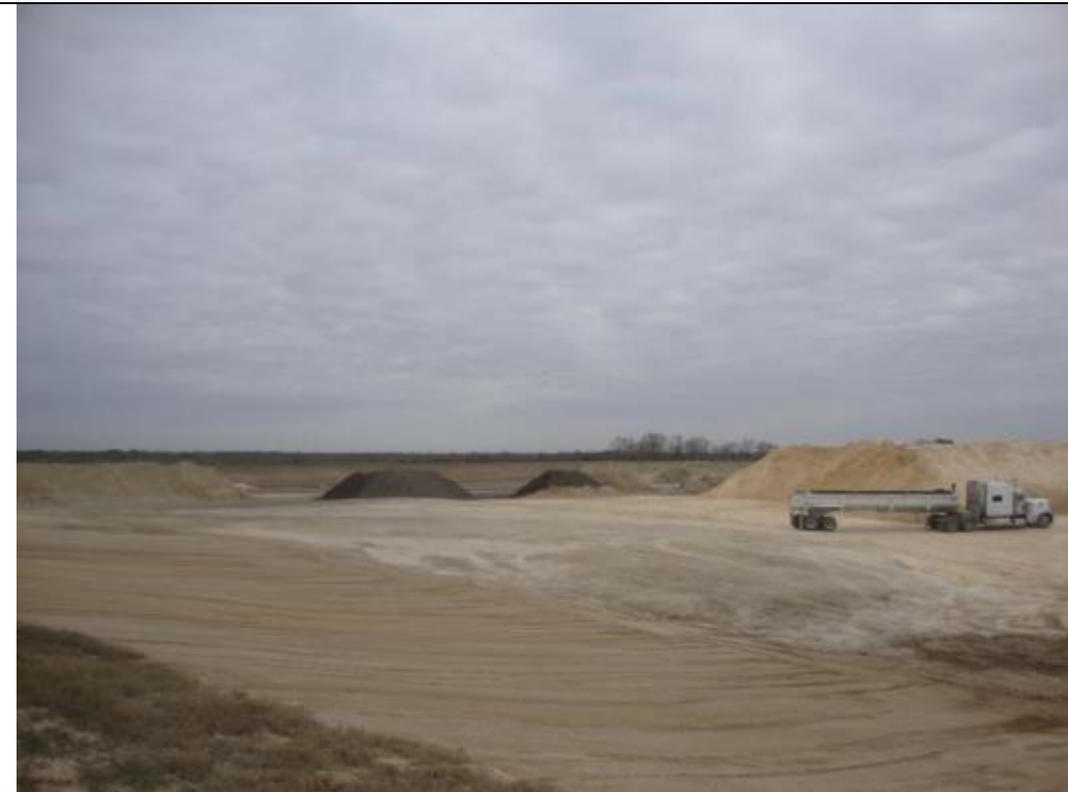
Photograph: 2 Fly Ash Landfill - standing on western berm – facing northeast. Photo taken 12/20/16.

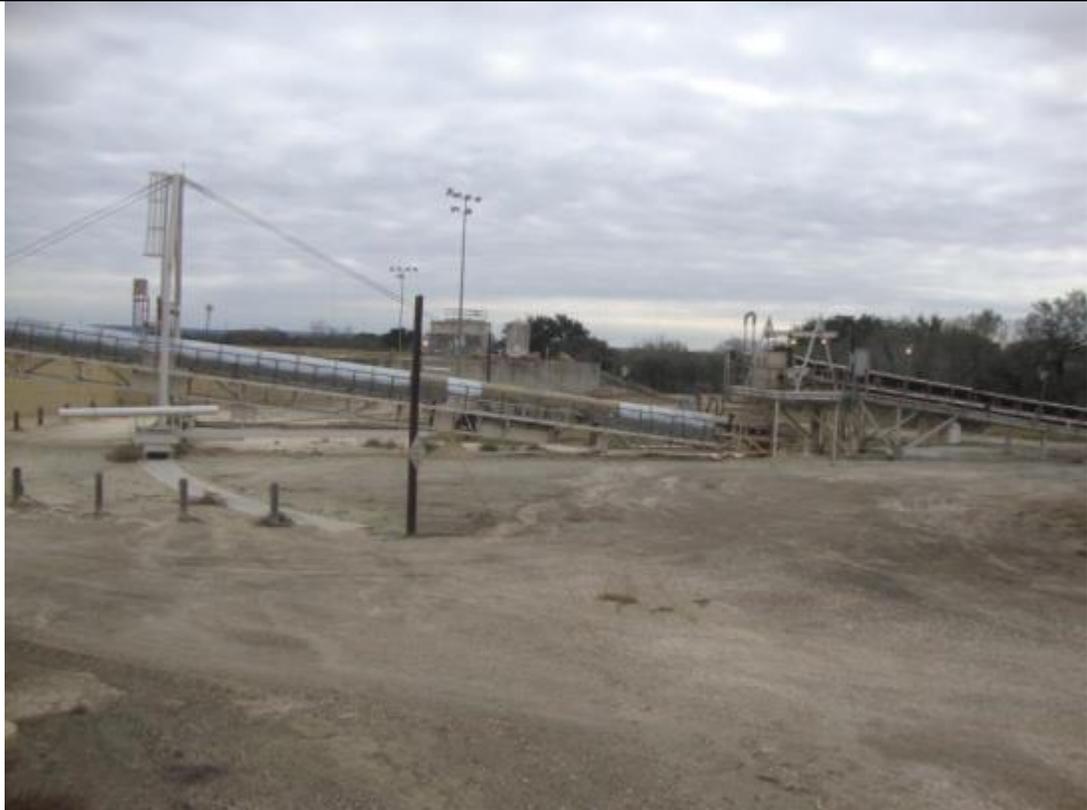
Photograph: 3 Fly Ash Landfill – standing on western berm – facing southeast. Radial stacker located in southwest corner of landfill. Photo taken 12/20/16.

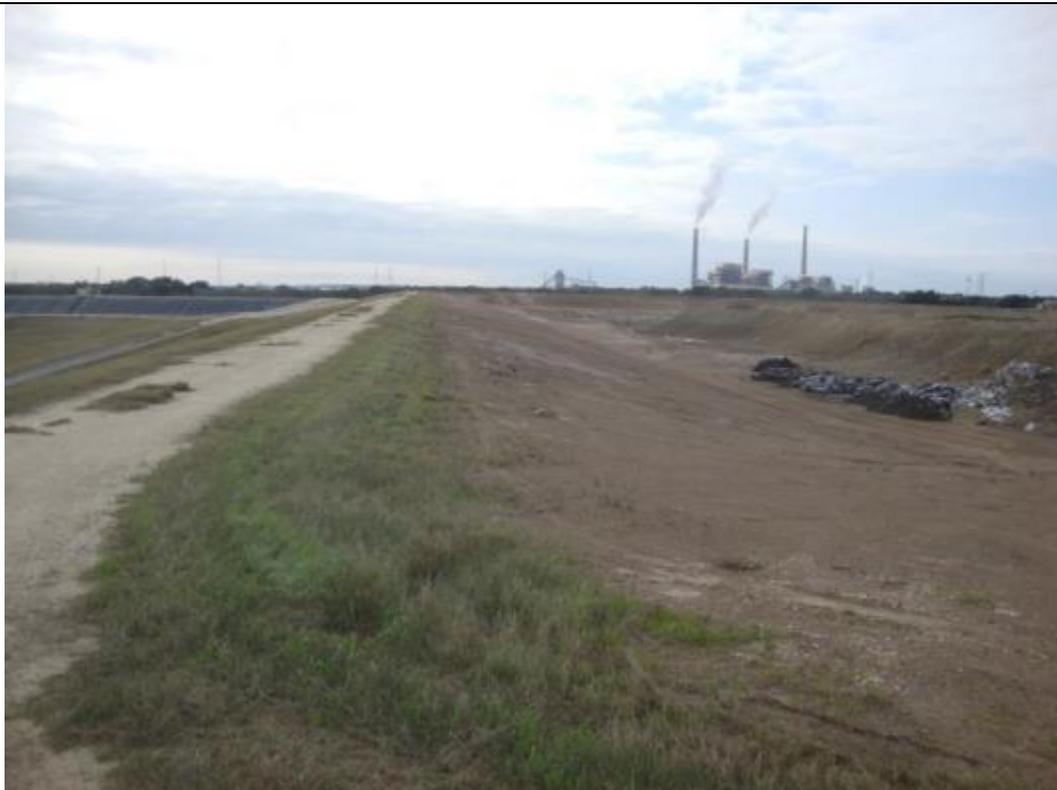
Photograph: 4 Fly Ash Landfill – standing on eastern berm - facing south. Photo taken 12/20/16.

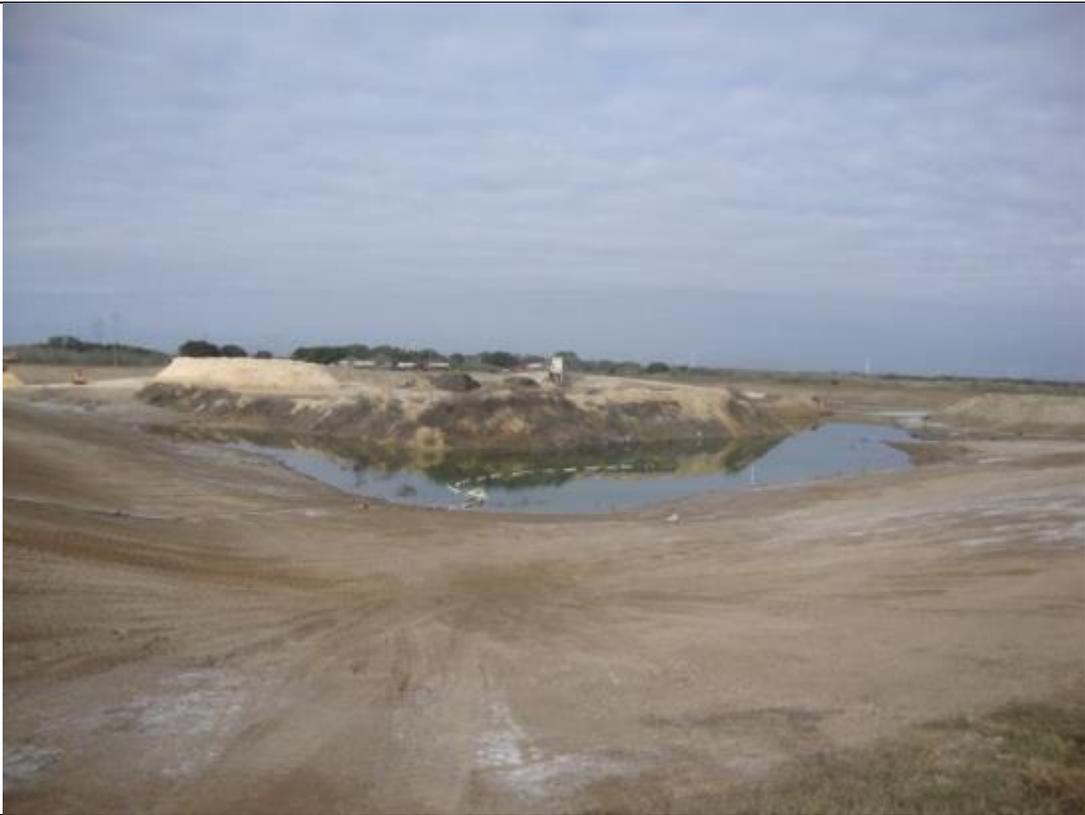
Photograph: 5 Fly Ash Landfill – standing on southeast corner of landfill – facing northwest. Rain water accumulates in southeast corner of landfill. Photo taken 12/20/16.

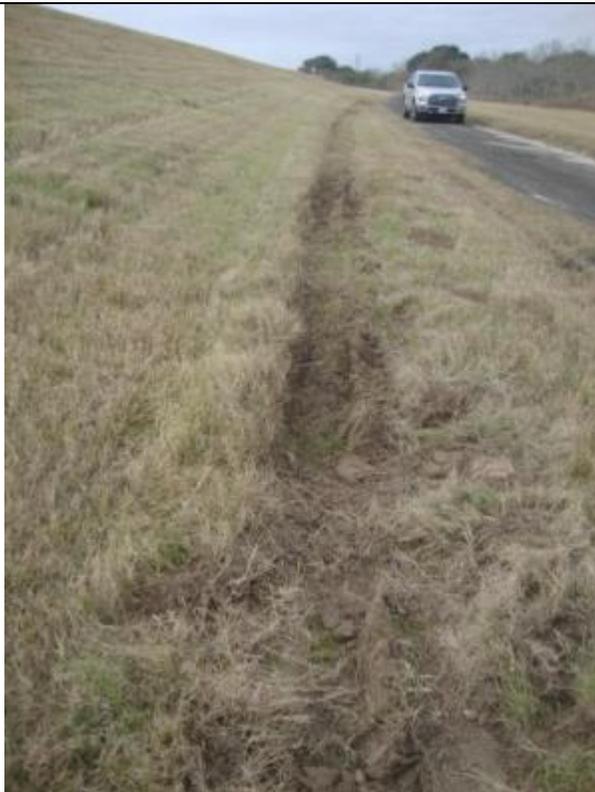
The Fly Ash Landfill (a.k.a. 5-Year Landfill) was at approximately 39.5% capacity based on calculations provided by CPS Energy. Approximately three acres of the landfill interior were covered with discrete piles of ash, the largest piles appearing to be less than 20 feet in height. Minor surface erosion was observed in the interior of the west embankment, and minor rutting from vehicle traffic at the exterior toe of the north embankment. Animal burrows were observed on the exterior of the north embankment, near the center of the landfill. Most of the observed burrows were one to two inches diameter, though one larger burrow (~six inches) was present. Grass on the exterior of the landfill was less than six inches in height, with no woody plants observed. The erosion and animal burrows do not appear to immediately impact unit stability.

Photograph: 6 Fly Ash Landfill – standing on northern berm – facing west. Rutting at base of slope from vehicles. Photo taken 12/20/16.

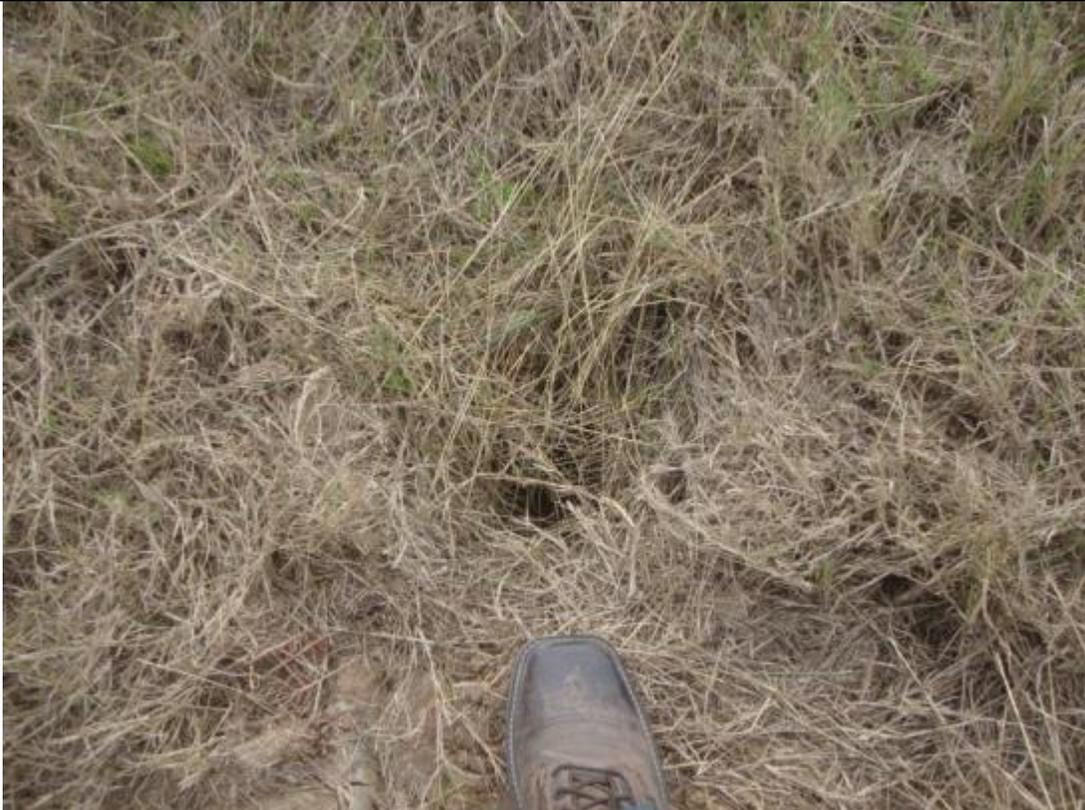
Photograph: 7 Fly Ash Landfill – standing on northern berm. Animal burrow in exterior slope. Photo taken 12/20/16.

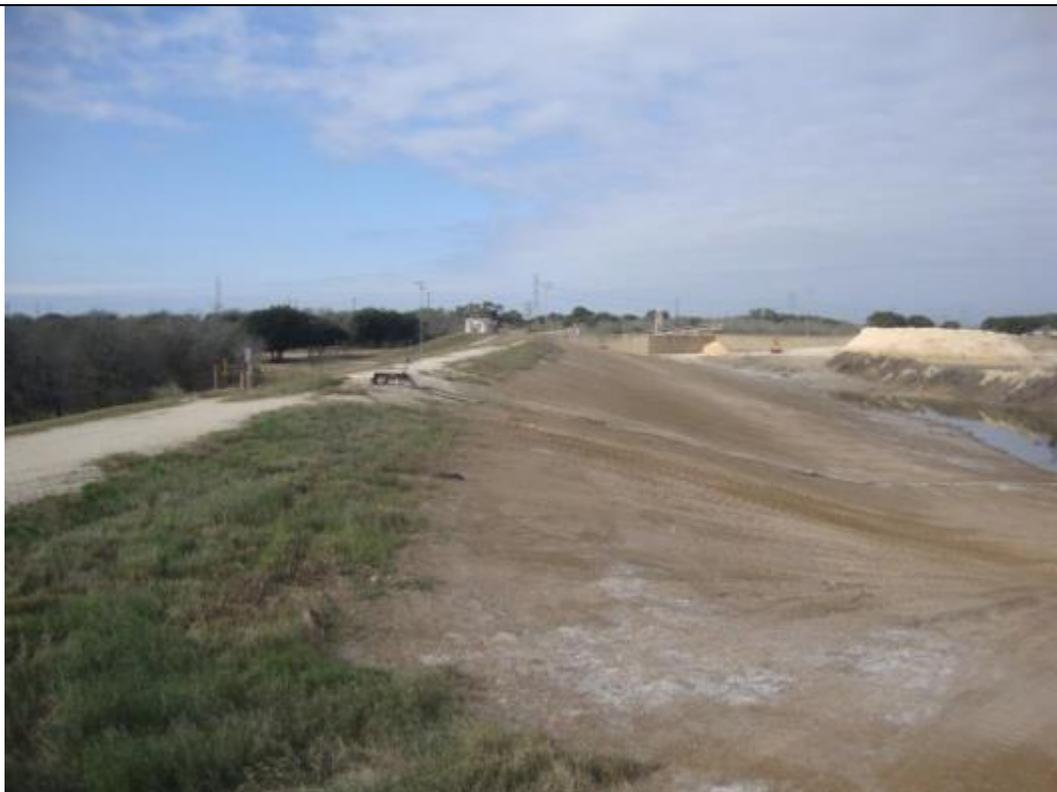
Photograph: 8 Fly Ash Landfill – standing on southern berm – facing west. Photo taken 12/20/16.

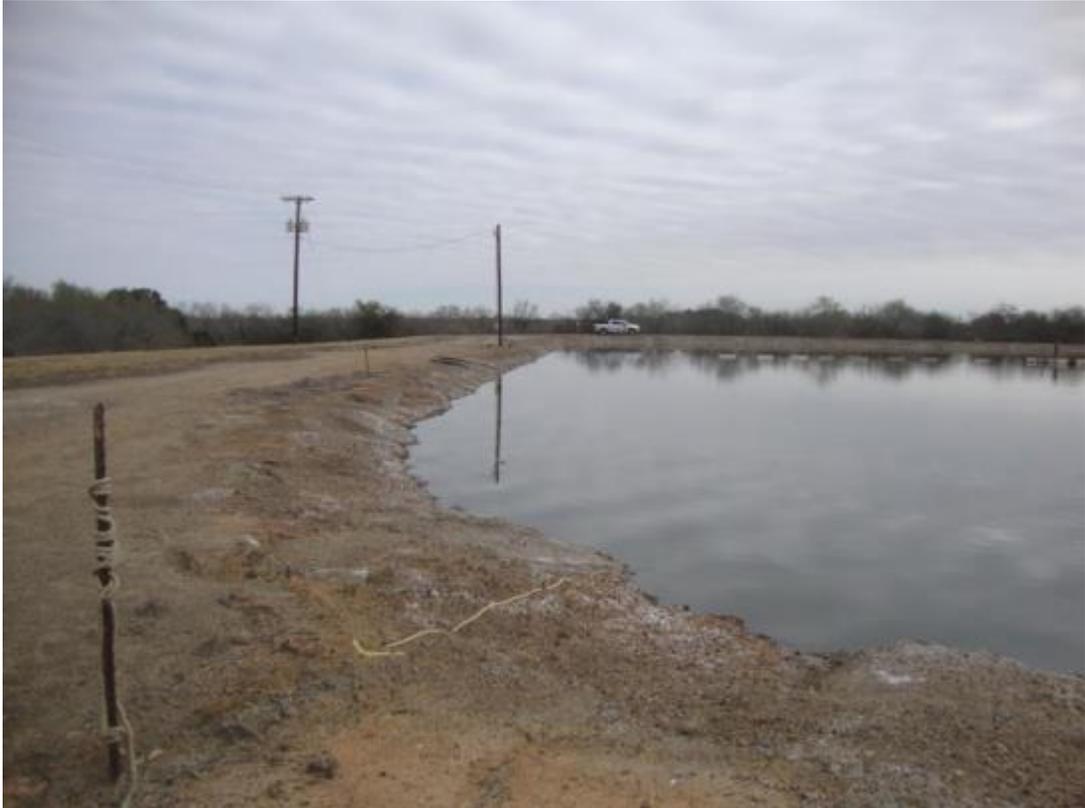
Photograph: 9 Evaporation Pond – standing on northwest corner – facing east. Photo taken 12/20/16.

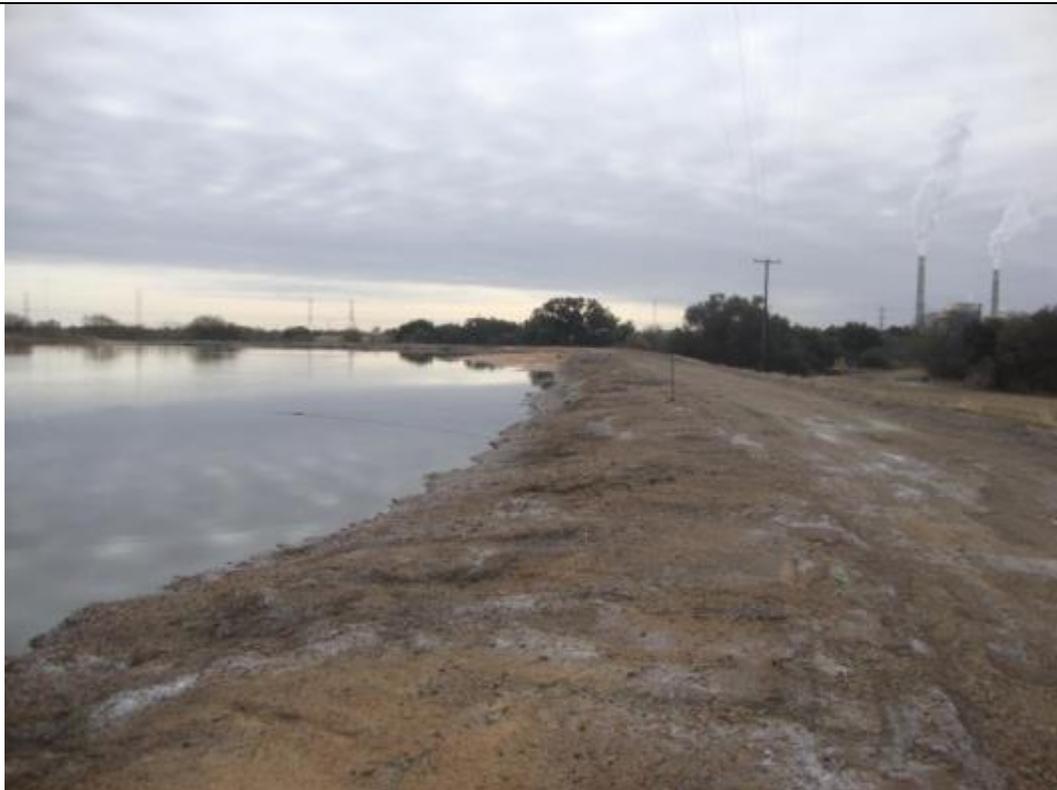
Photograph: 10 Evaporation Pond – standing on northwest corner – facing south. Photo taken 12/20/16.

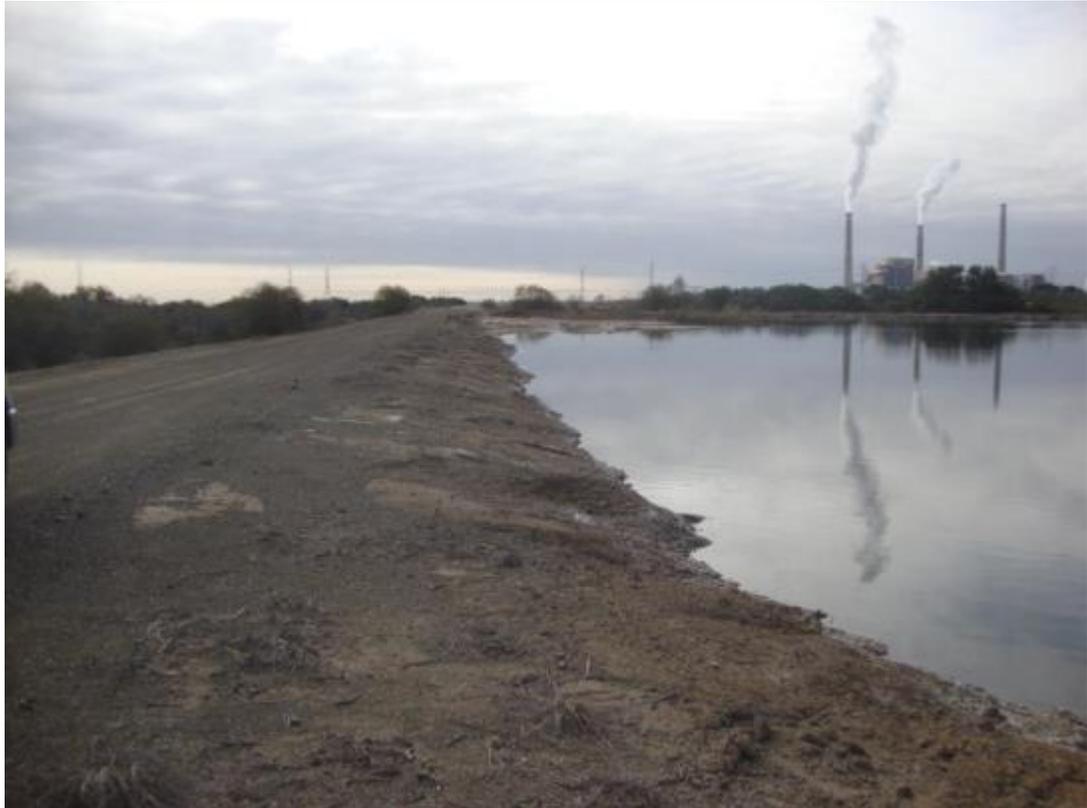
Photograph: 11 Evaporation Pond – standing on northeast corner – facing south. Photo taken 12/20/16.

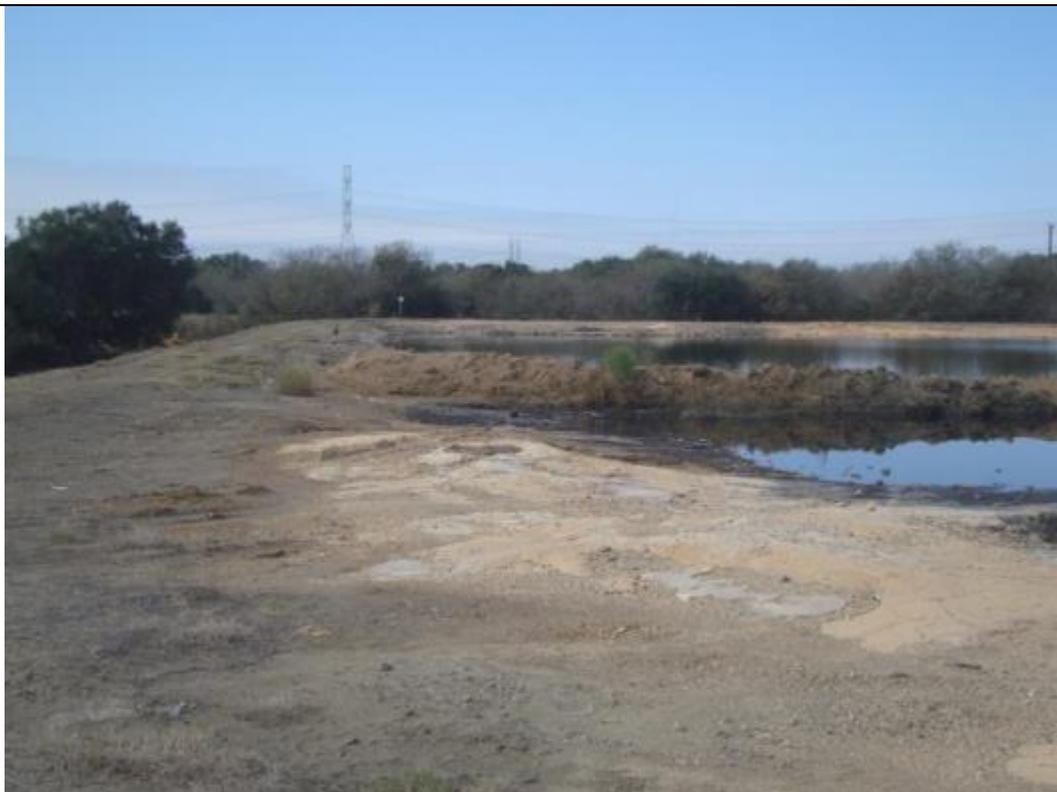
Photograph: 12 Evaporation Pond – standing on southwest corner of pond – facing east. Photo taken 12/20/16.

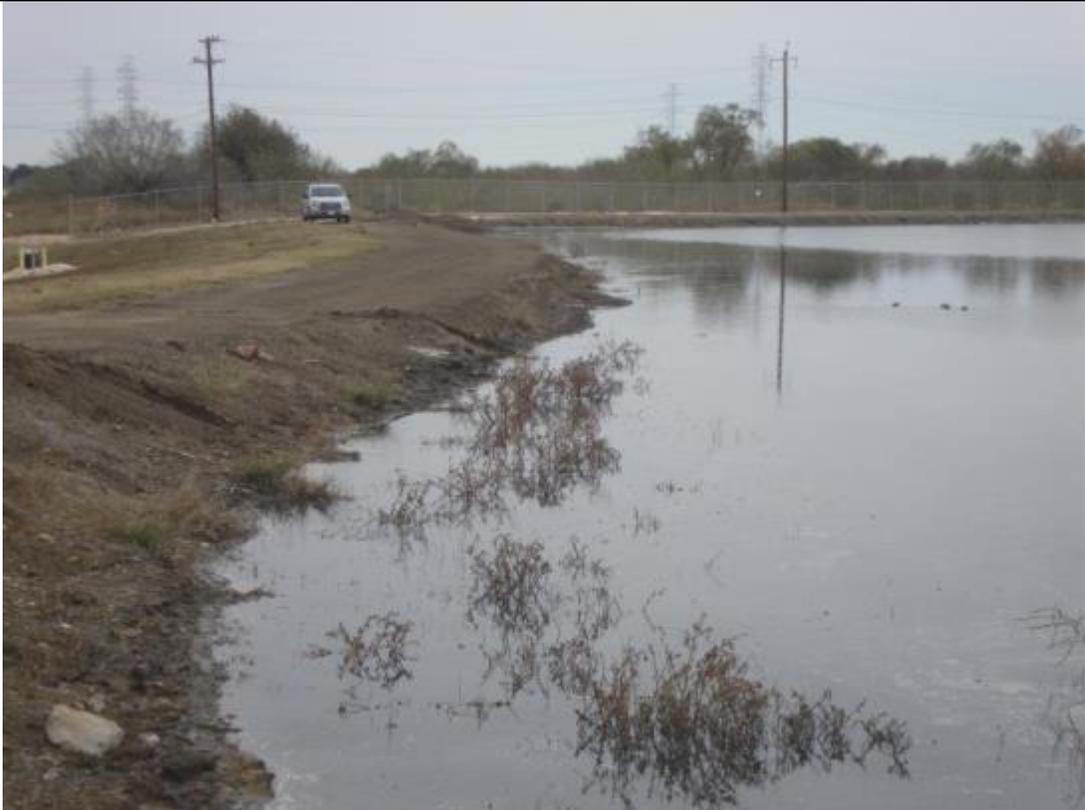
Photograph: 13 North Bottom Ash Pond – standing on southwestern corner – facing northeast. Photo taken 12/20/16.

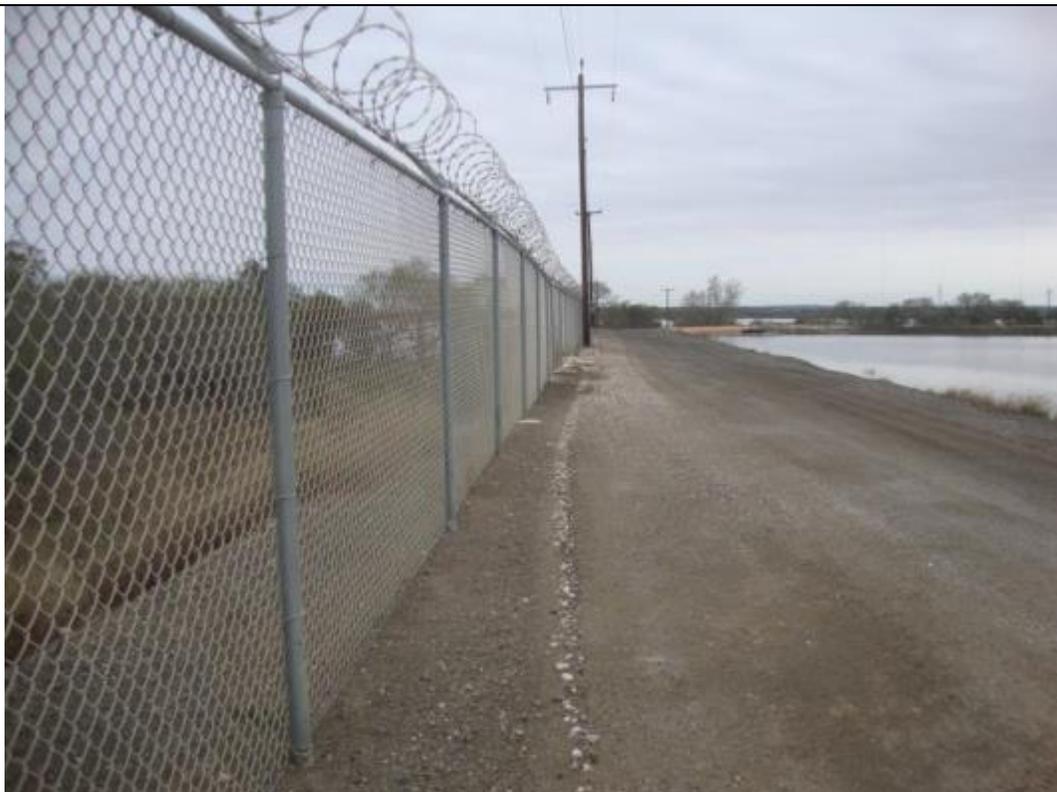
Photograph: 14 North Bottom Ash Pond – standing on northern berm – facing east. Photo taken 12/20/16.

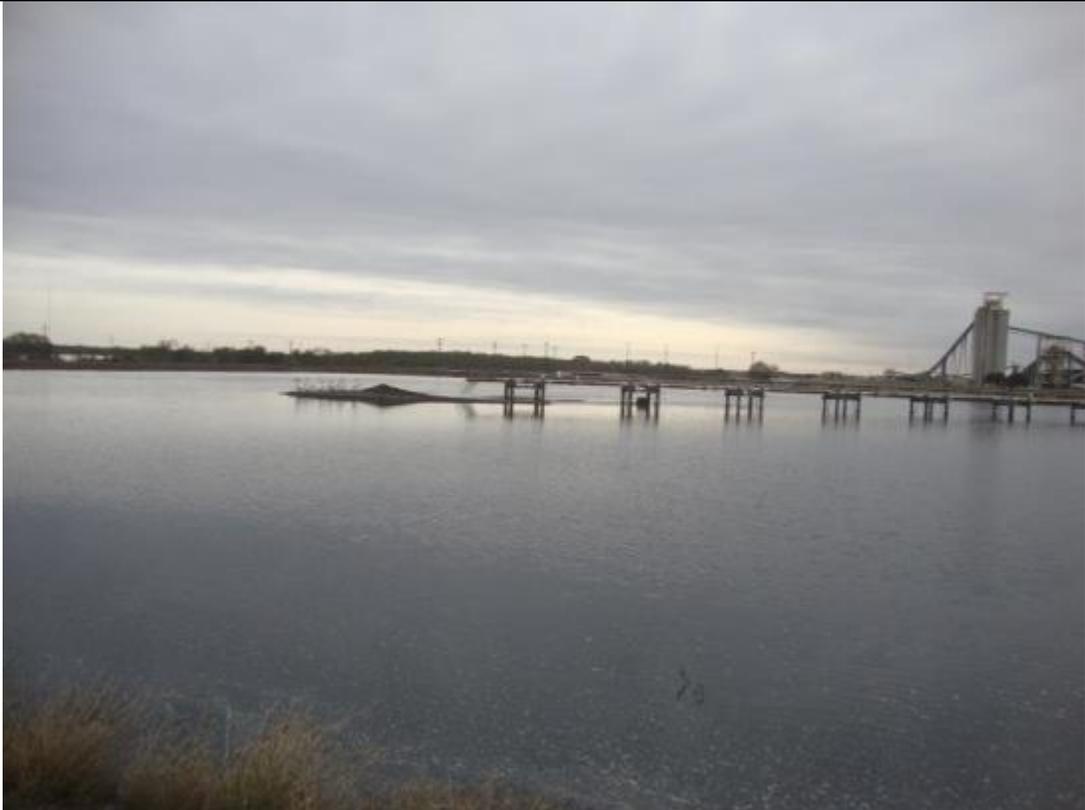
Photograph: 15 North Bottom Ash Pond – standing on northern berm – facing south.
Photo taken 12/20/16.

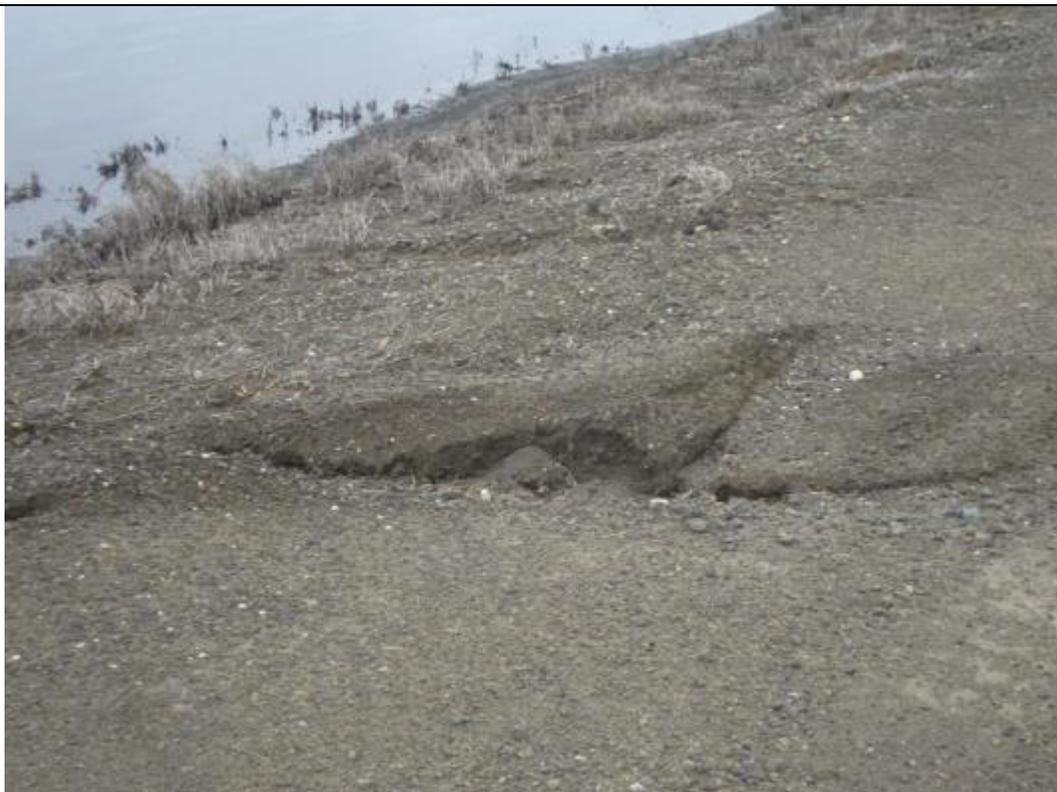
The North BAP was in use during the inspection, with an estimated freeboard of approximately two feet. This is the maximum operating capacity, corresponding to approximately 11.3 acre-feet of capacity, with approximately 55.5 acre-feet of water and CCR contained. Erosion was observed on the interior of the west and northwest embankments. The eroded material appears to be mostly ash, with no evidence of damage to underlying clay. This erosion does not appear to impact unit stability. No obstruction of or damage to outfall structures was observed. Grass along the external slope of the embankment was observed to be less than six inches high.

Photograph: 16 North Bottom Ash Pond – Erosion features on inside of eastern berm.
Photo taken 12/20/16.

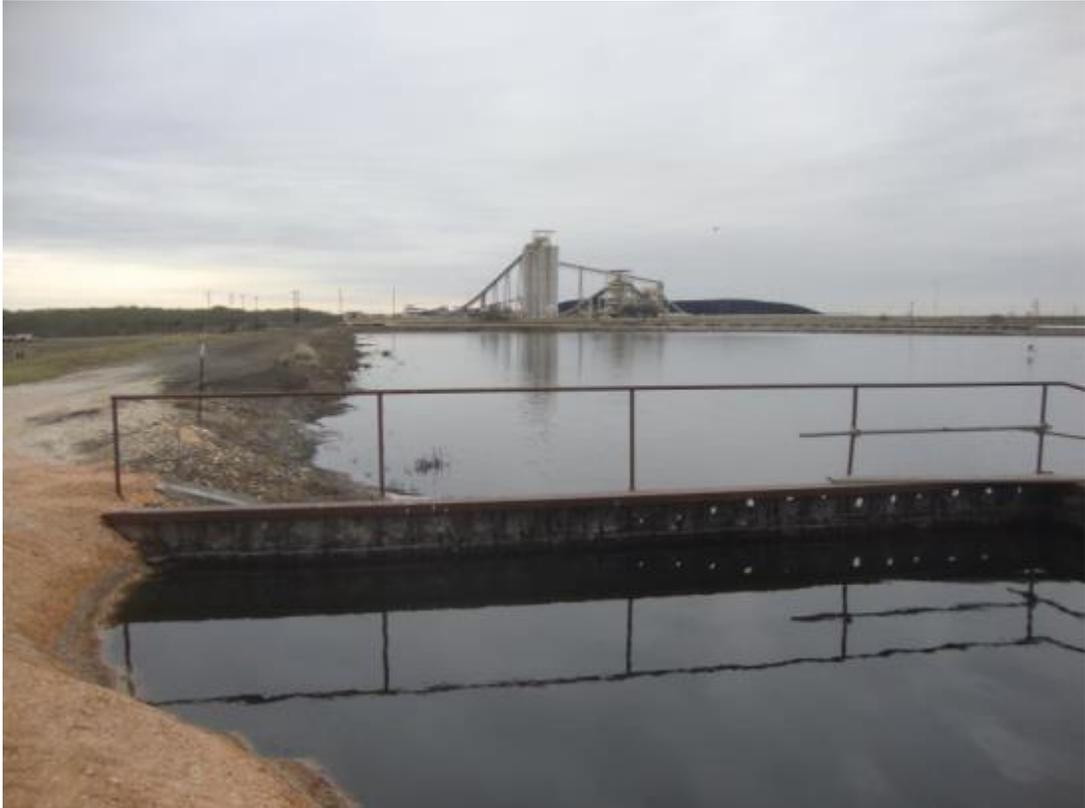
Photograph: 17 North Bottom Ash Pond – standing on northeast corner – facing south. Photo taken 12/20/16.

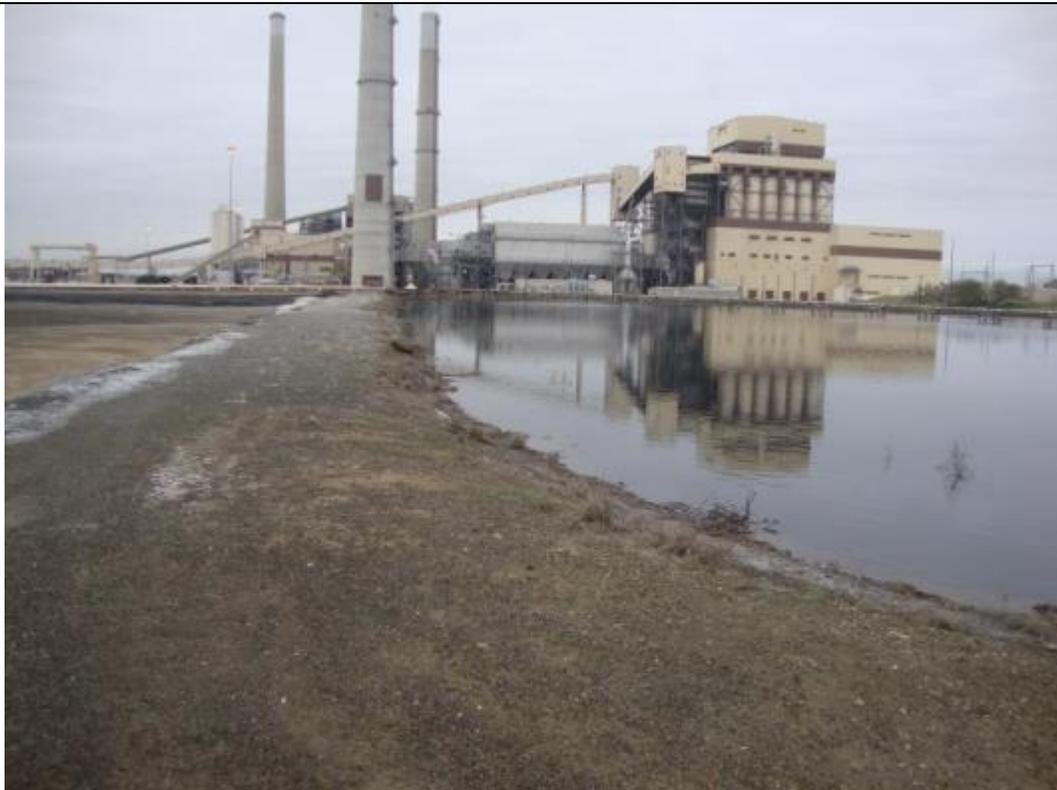
Photograph: 18 North Bottom Ash Pond – standing on southern berm – facing west. Photo taken 12/20/16.

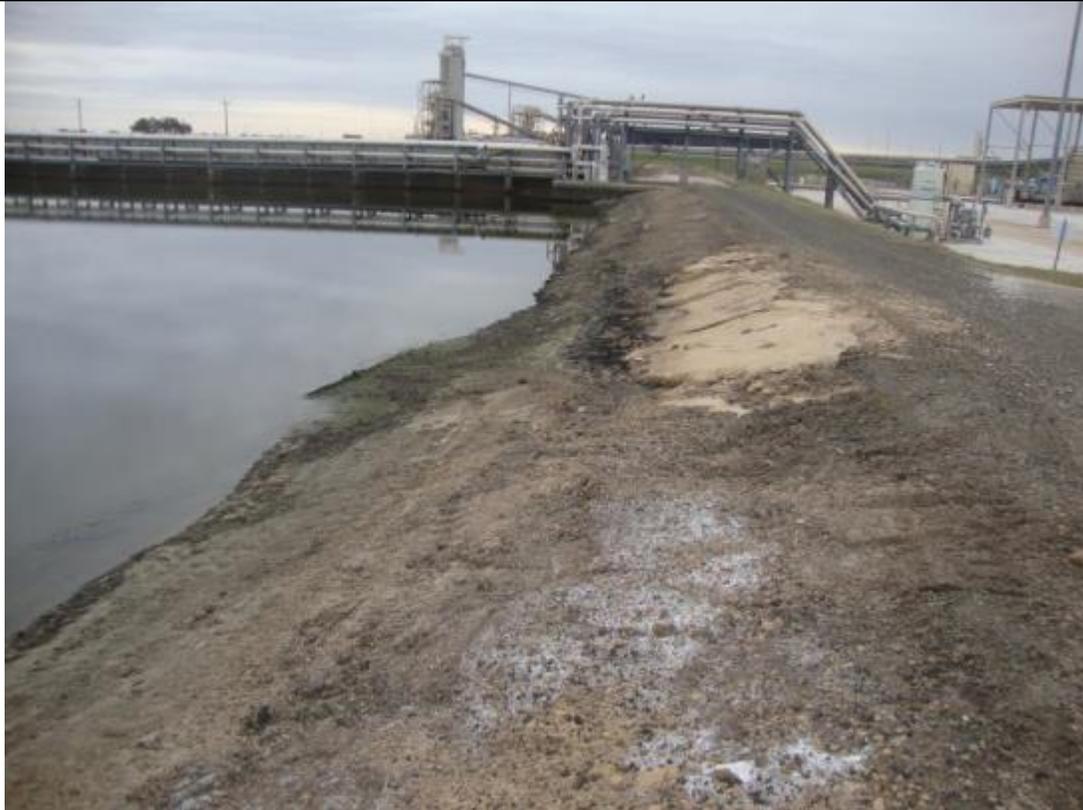
Photograph: 19 North SRH Pond – standing on northwest corner – facing south. Photo taken 12/20/16.

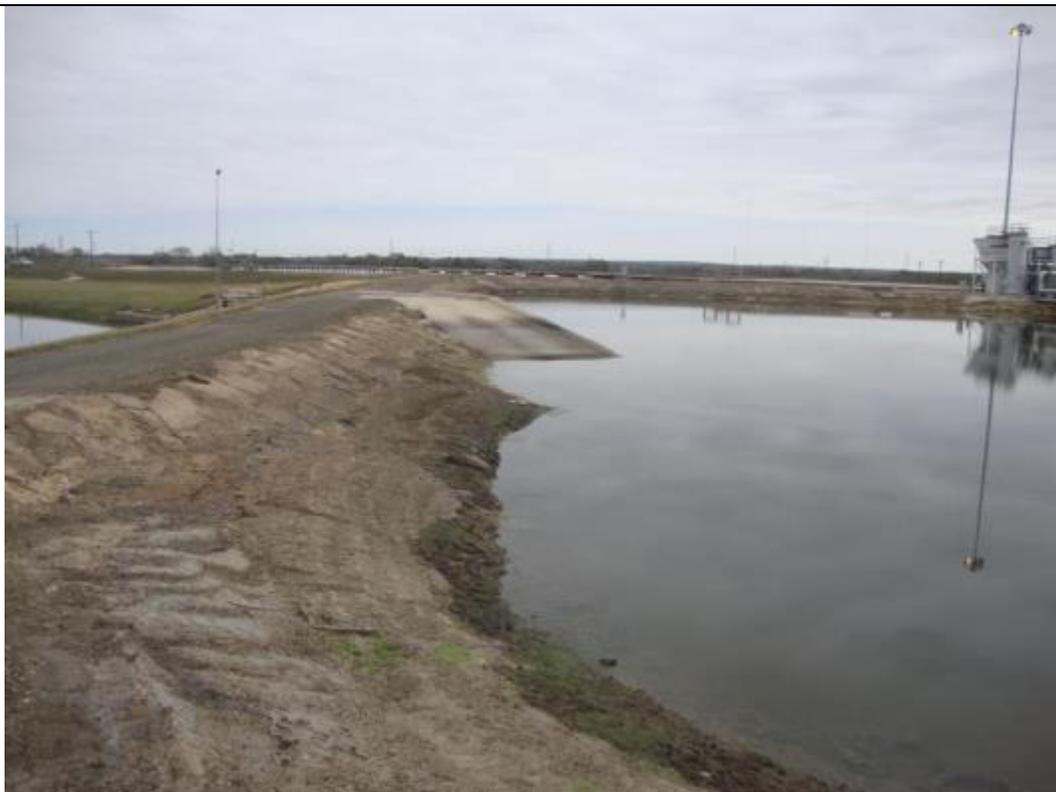
Photograph: 20 North SRH Pond – standing on northwest corner – facing east. Photo taken 12/20/16.

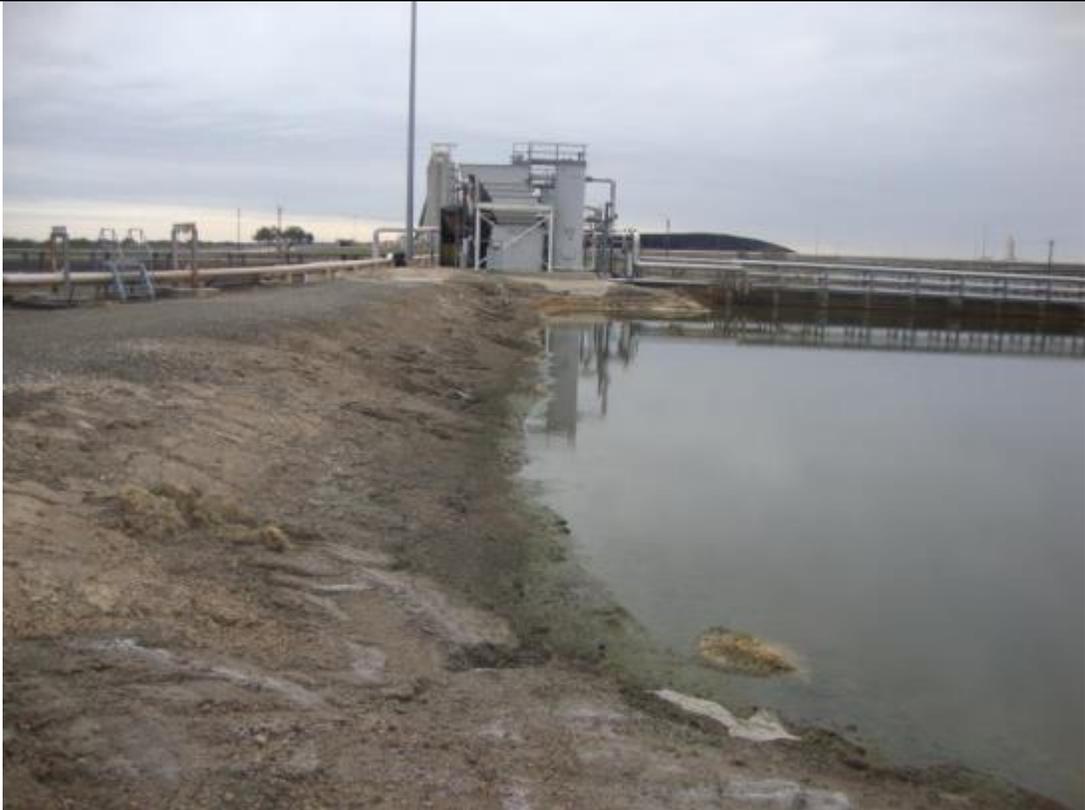
Photograph: 21 North SRH Pond – standing on northeast corner – facing south. Photo taken 12/20/16.

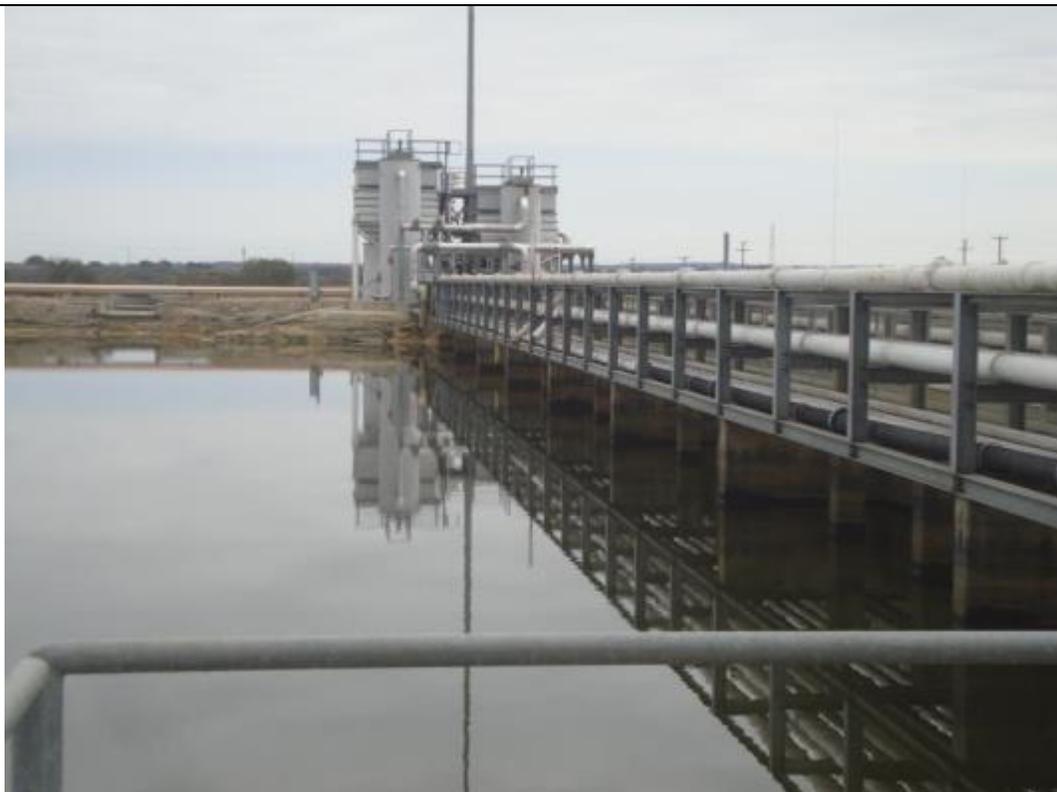
Photograph: 22 North SRH Pond – standing on southeastern corner – facing east. Photo taken 12/20/16.
