January 13, 2017

Project No. 0352436

Subject: CCR Units - 2016 Annual Inspection
Calaveras Power Station
San Antonio, Texas

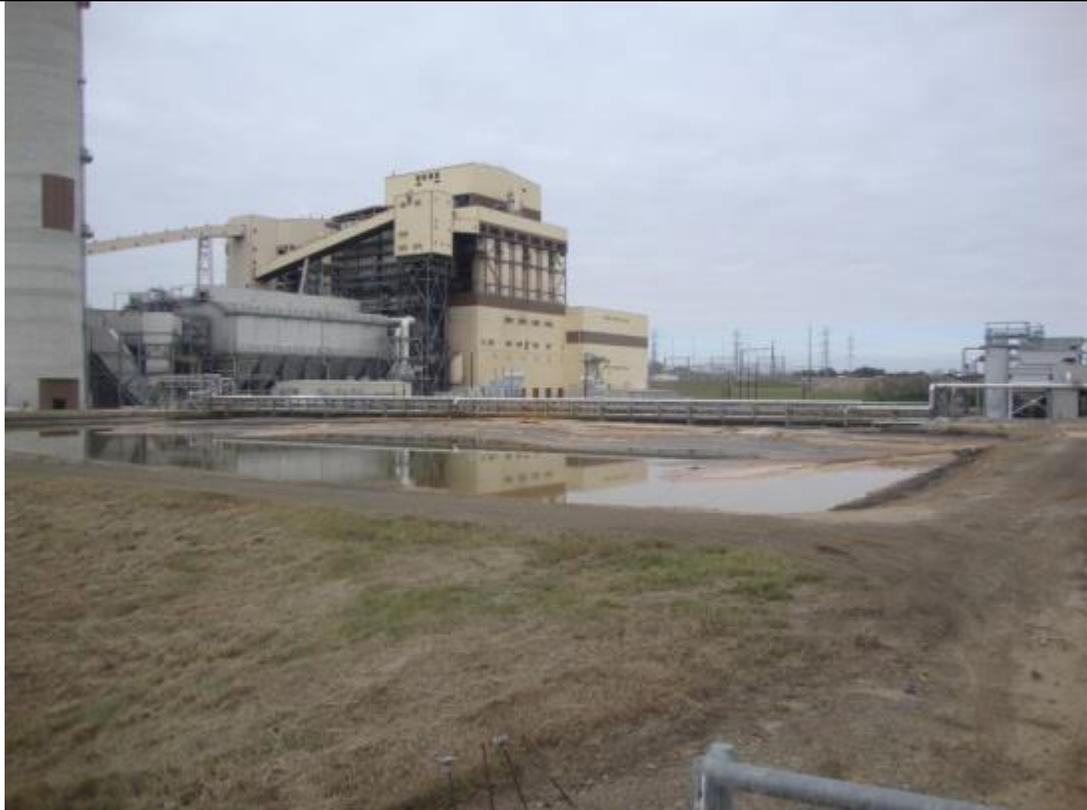
Photograph: 23 South SRH Pond – standing at southeastern corner – facing northwest. Photo taken 12/20/16.

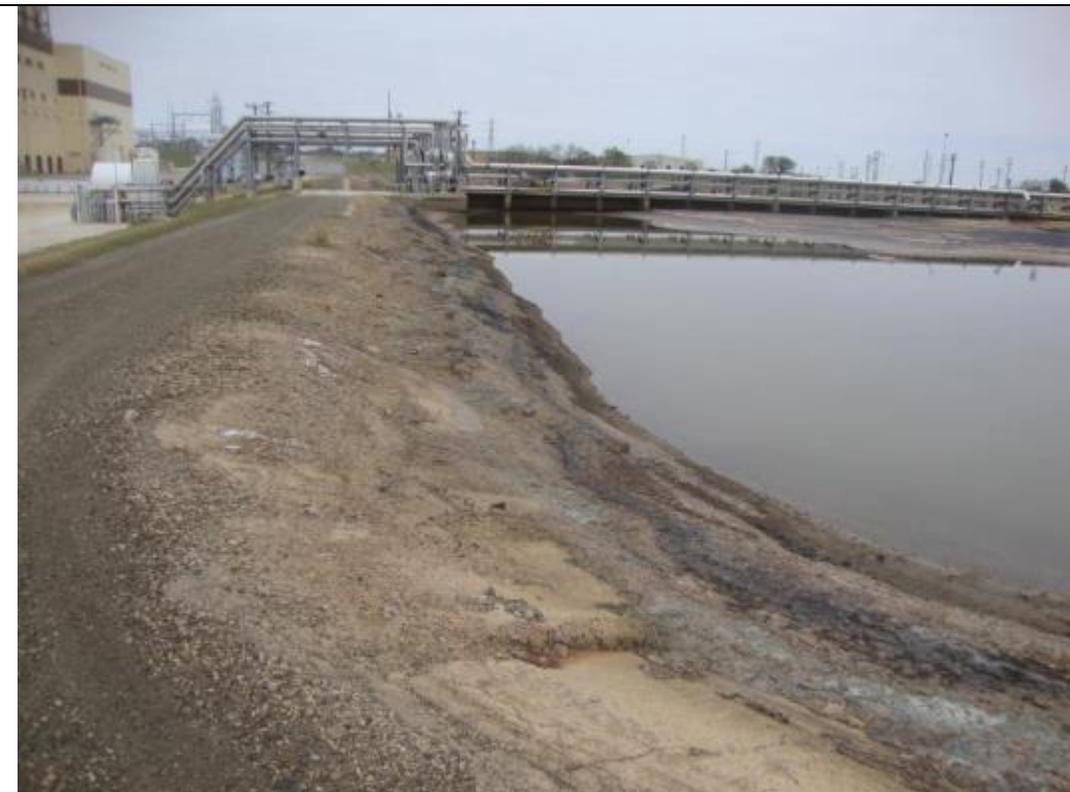
Photograph: 24 South SRH Pond – standing on western berm – facing north. Photo taken 12/20/16.

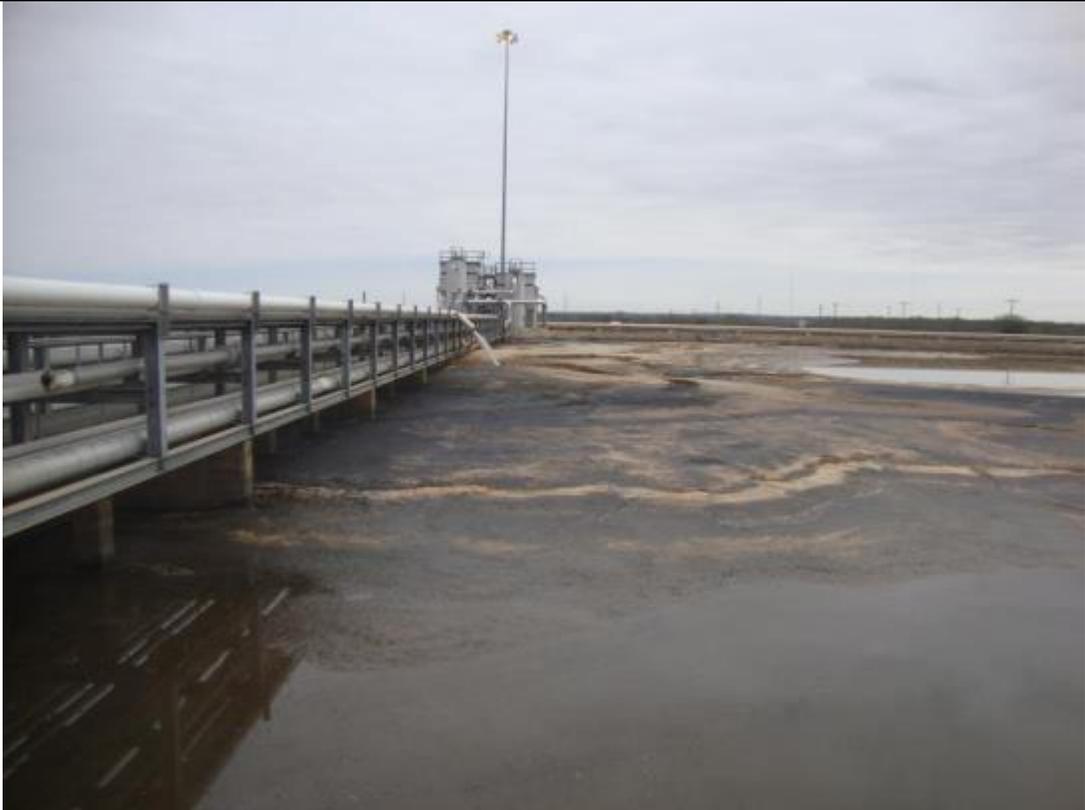
Photograph: 25 South SRH Pond – standing on northwestern corner – facing east. Photo taken 12/20/16.

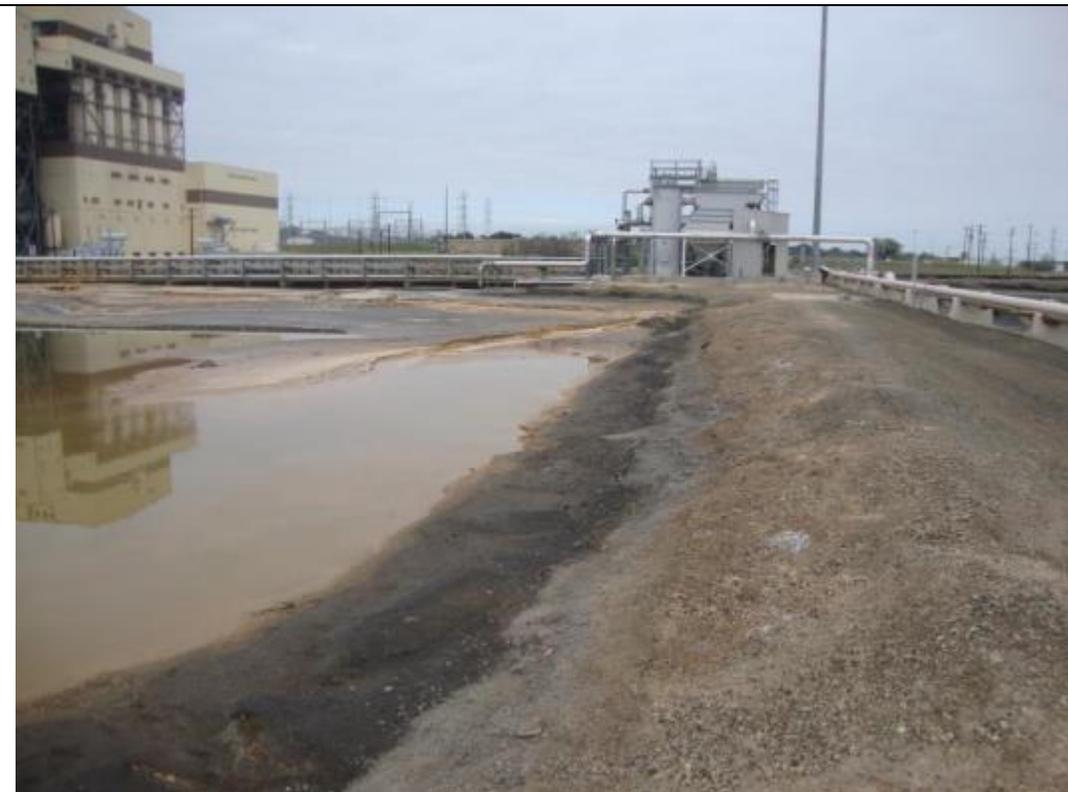
Photograph: 26 South SRH Pond – standing on eastern berm – facing north. Photo taken 12/20/16.

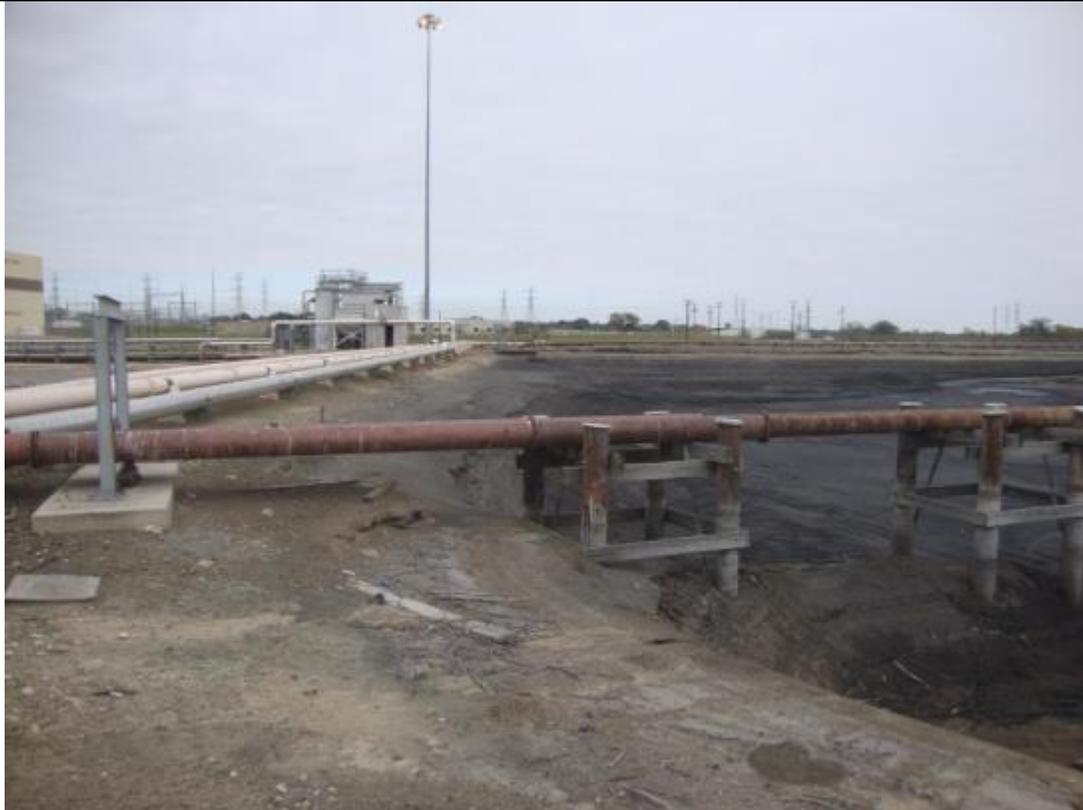
Photograph: 27 South Bottom Ash Pond – standing on southwestern corner – facing north. Photo taken 12/20/16.

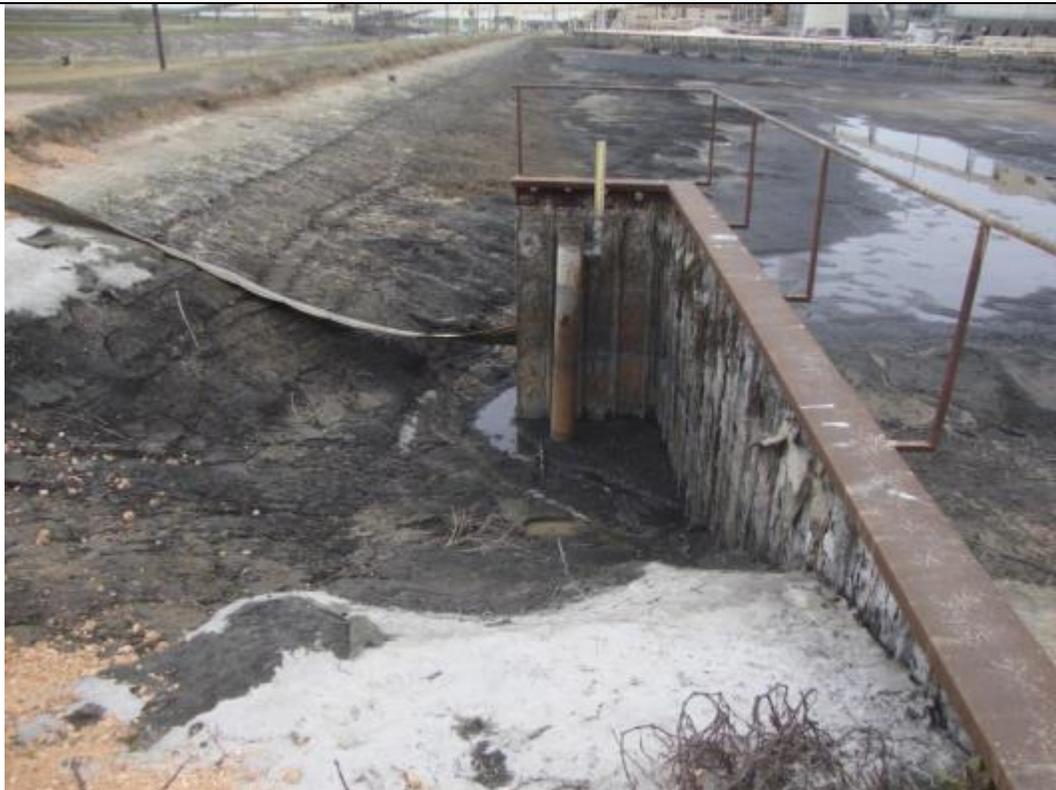
Photograph: 28 South Bottom Ash Pond – standing on southern berm – facing west. Outfall structure visible. Photo taken 12/20/16.

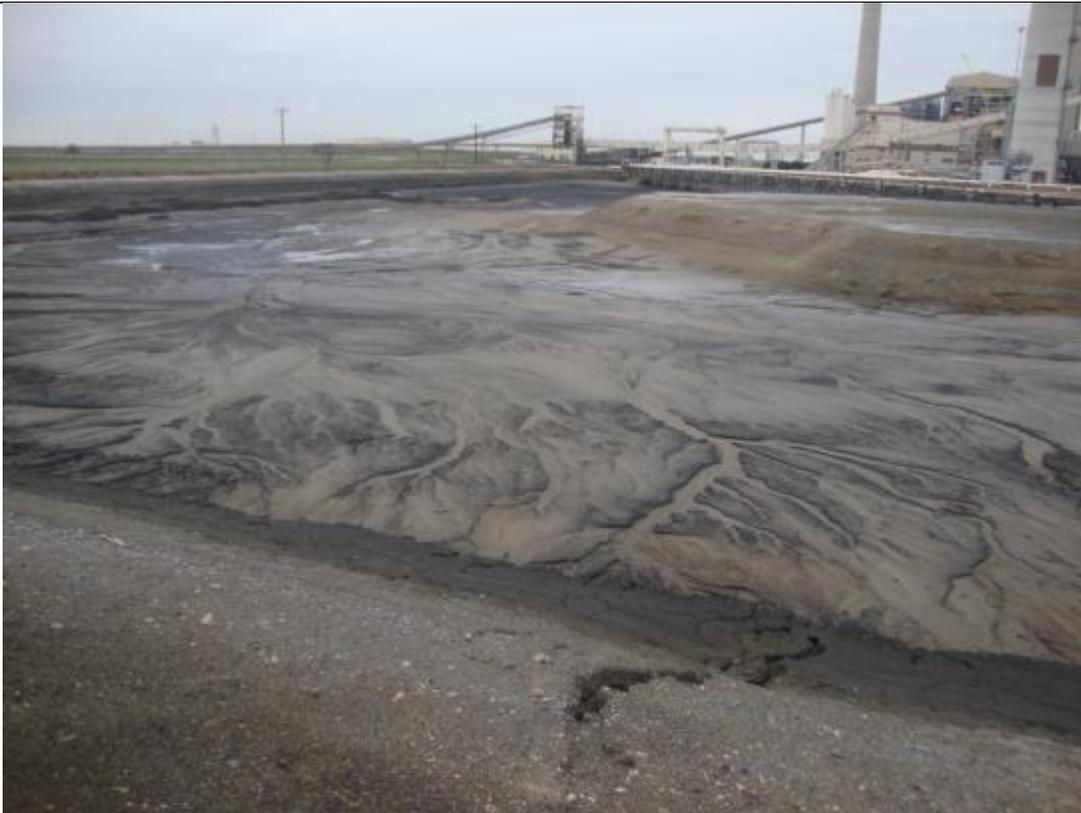
The South BAP was offline and completely drained of liquid during the inspection. Some shallow (i.e., less than one foot deep) erosion channels were observed on interior of the west embankment of the South BAP. The eroded material appears to be mostly ash, with no evidence of damage to underlying clay. This erosion does not appear to impact unit stability. No obstruction of or damage to outfall structures were observed. Grass along the external slope of the embankment was observed to be less than six inches high.

Photograph: 29 South Bottom Ash Pond – standing on eastern berm – facing southwest. Erosional features on eastern berm. Photo taken 12/20/16.

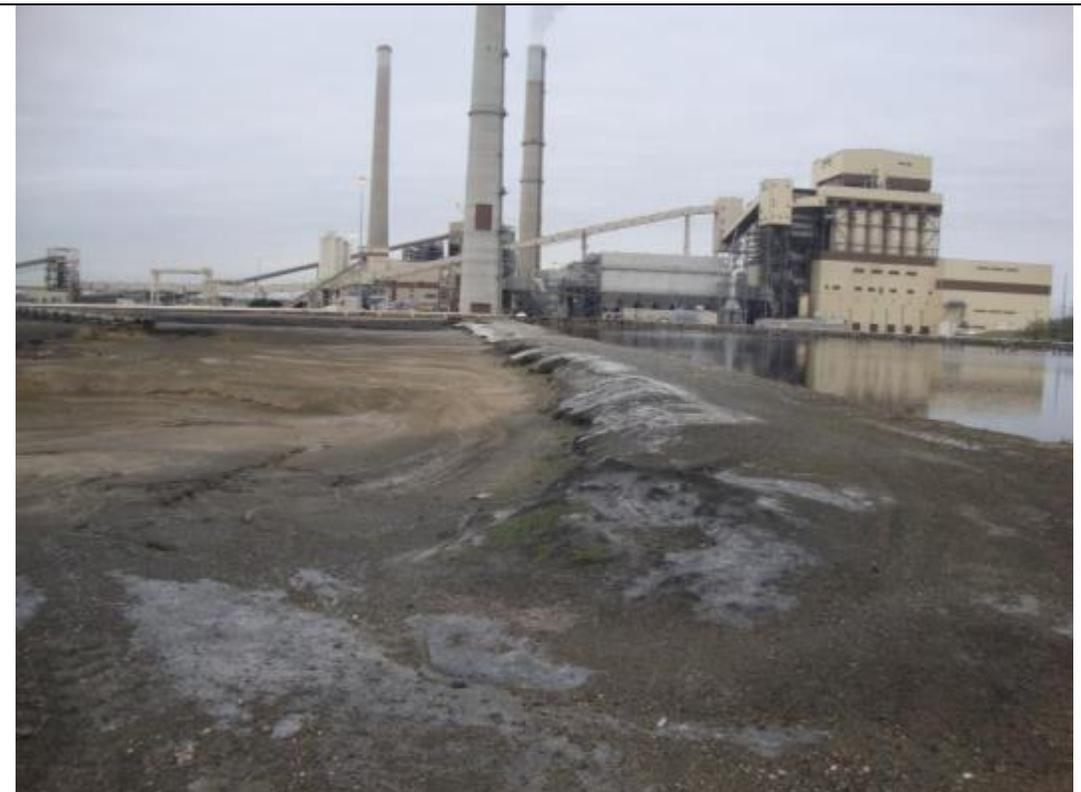
Photograph: 30 South Bottom Ash Pond – standing on northwest corner of pond – facing west. Pond was drained to remove residuals. Photo taken 12/20/16.
