Project No. 0328985

Subject: CCR Units - 2015 Annual Inspection
Calaveras Power Station
San Antonio, Texas

Photo Log
Attachment 1

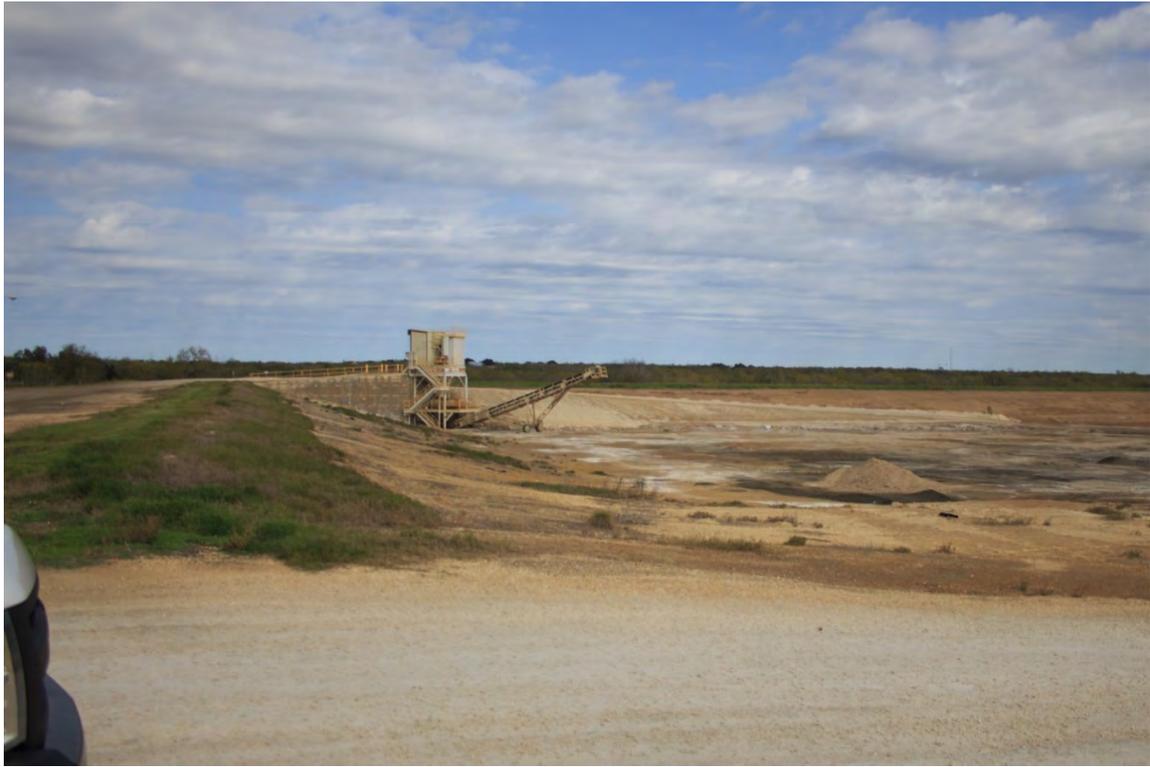
Photograph: 1 Fly Ash Landfill – standing on western berm – facing north. Mobile ash conditioning machine located in northwest corner of landfill. Photo taken 12/16/15.

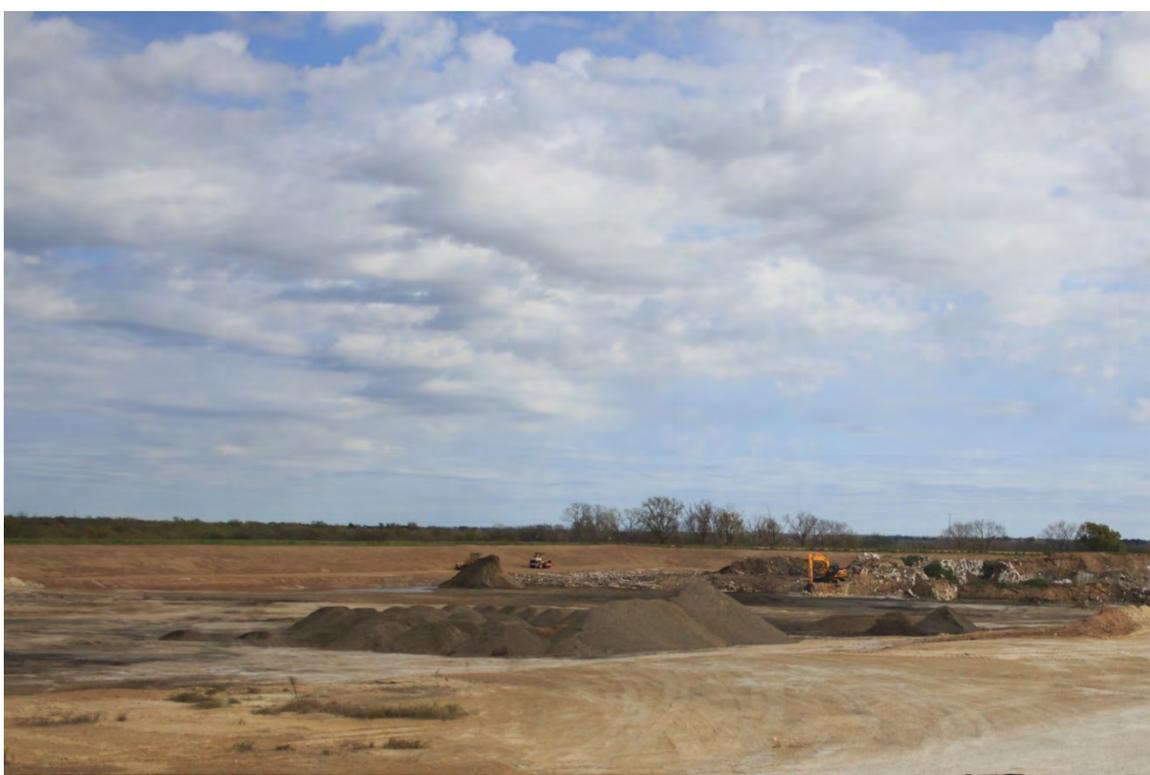
Photograph: 2 Fly Ash Landfill - standing on western berm – facing northeast. Photo taken 12/16/15.

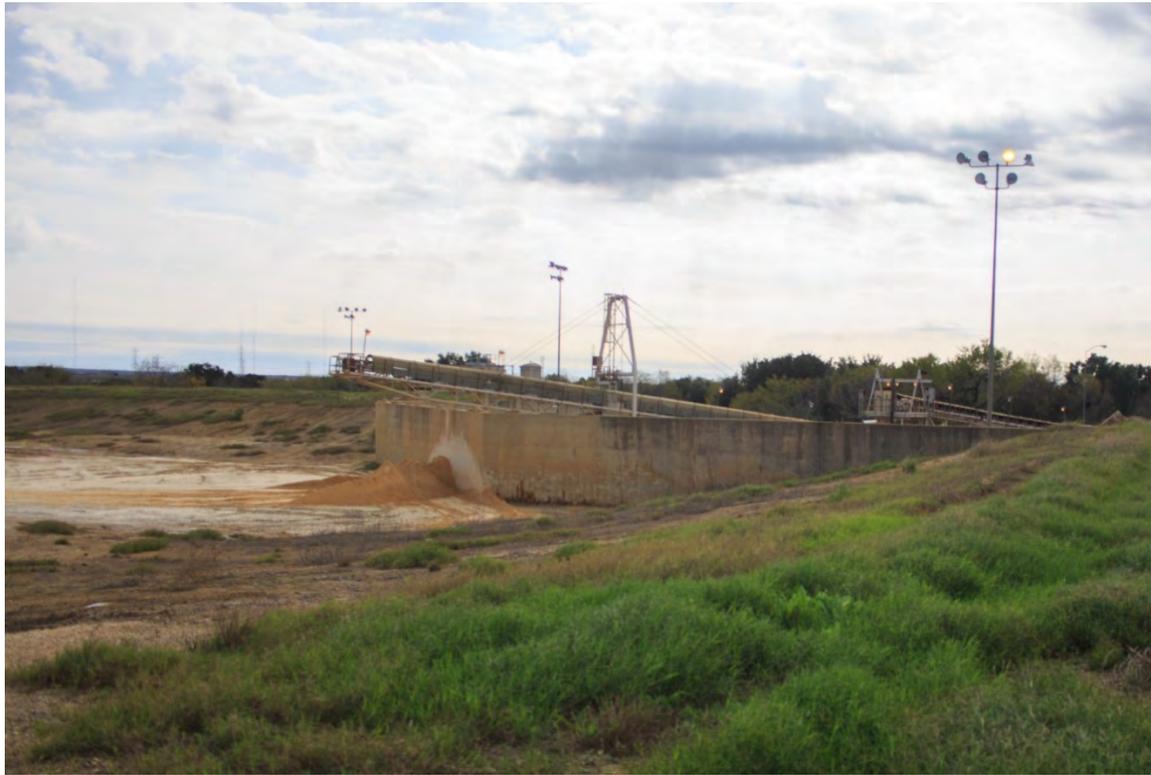
Photograph: 3 Fly Ash Landfill – standing on western berm – facing southeast. Radial stacker located in southwest corner of landfill. Photo taken 12/16/15.

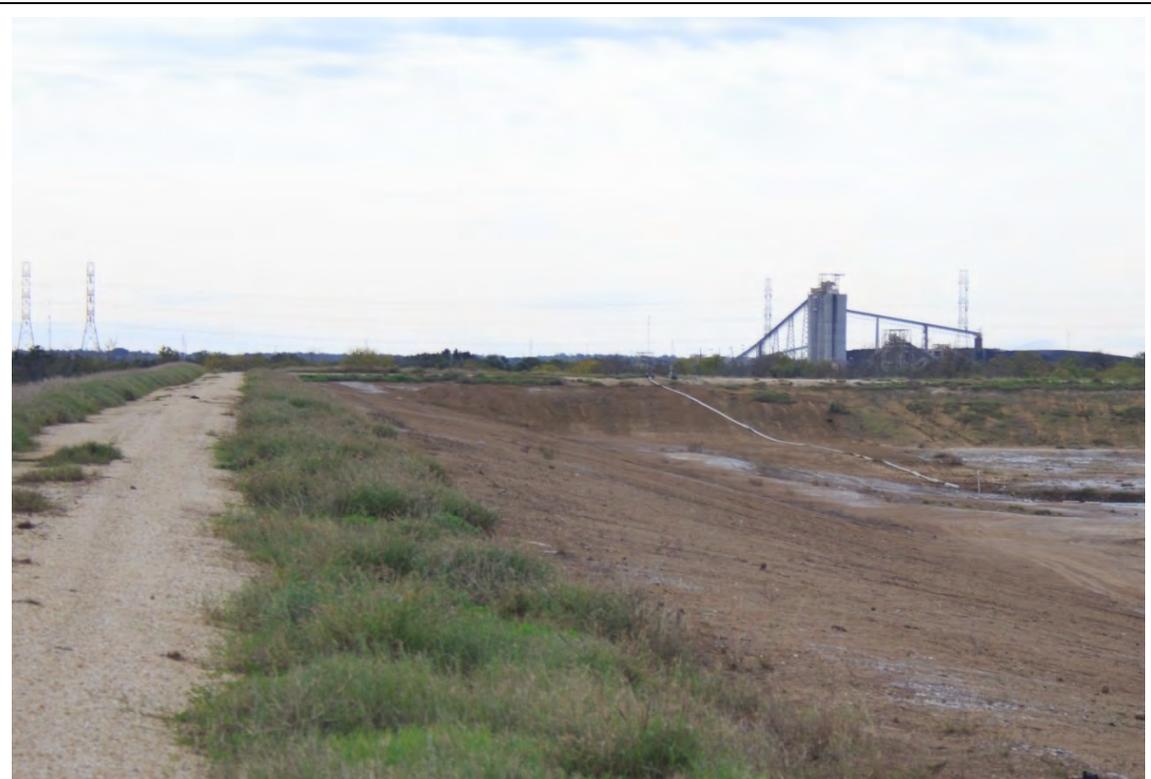
Photograph: 4 Fly Ash Landfill – standing on eastern berm - facing south. Photo taken 12/16/15.

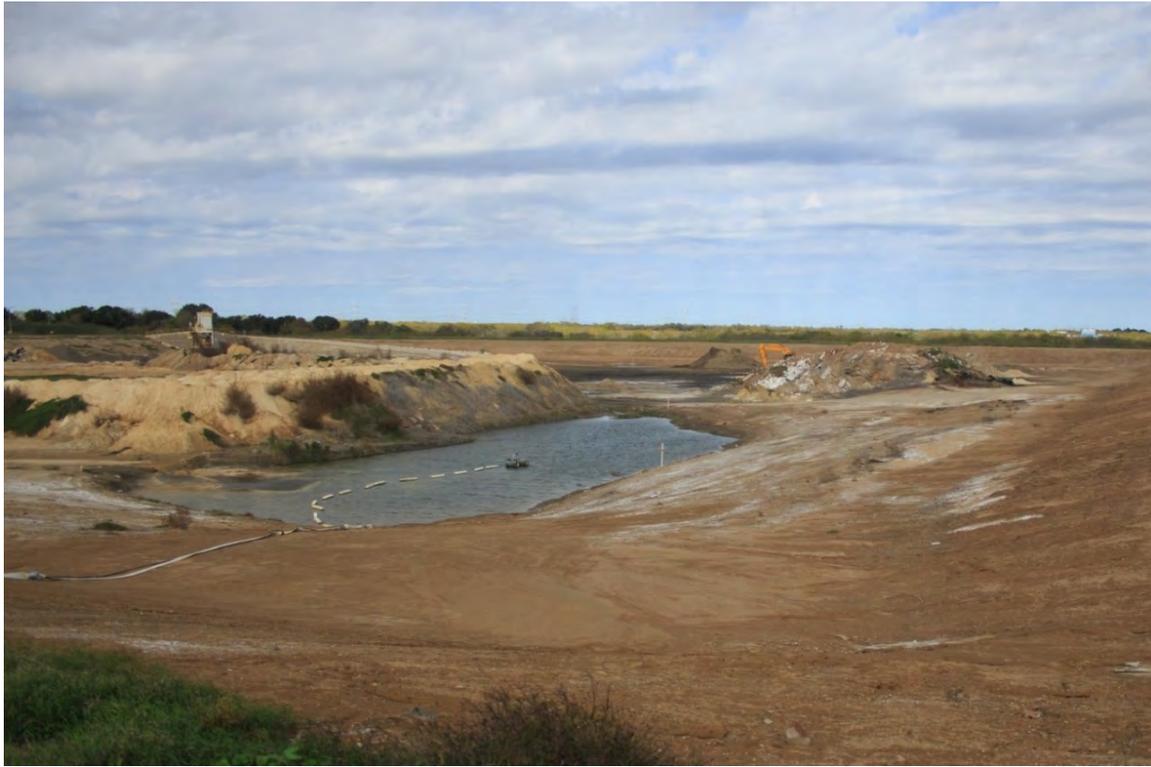
Photograph: 5 Fly Ash Landfill – standing on southeast corner of landfill – facing north. Rain water accumulates in southeast corner of landfill. Photo taken 12/16/15.

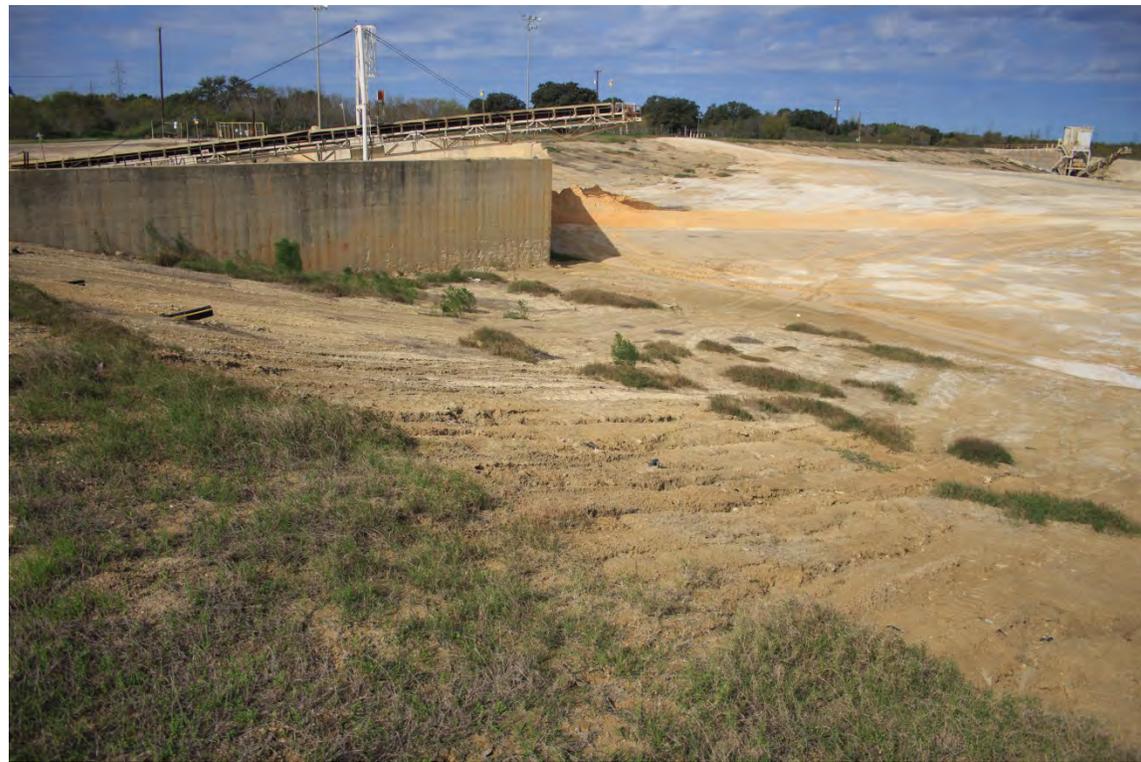
The Fly Ash Landfill (a.k.a. 5-Year Landfill) was at approximately 33% capacity based on calculations provided by CPS Energy. Approximately two acres of the landfill interior were covered with discrete piles of ash, the largest piles appearing to be less than 20 feet in height. Minor surface erosion was observed in the interior of the south embankment. An animal burrow was observed on the exterior of the east embankment, near the northeast corner of the landfill. Grass on the exterior of the landfill was over two feet high. It is recommended that the grass on the slopes be mowed to facilitate desired grass growth and to prevent the formation of woody plant materials. The erosion and animal burrow does not appear to immediately impact unit stability.

Photograph: 6 Fly Ash Landfill – standing on southern berm – facing northwest. Erosion features on southern berm near radial stacker. Photo taken 12/16/15.

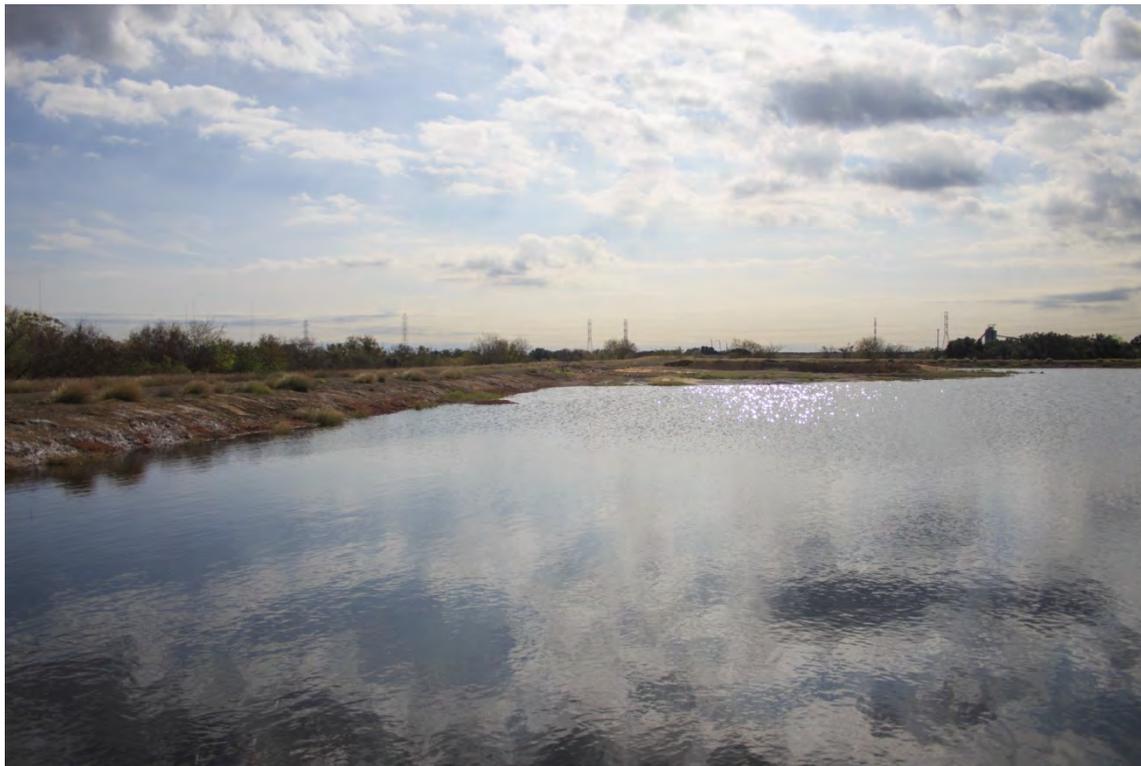
Photograph: 7 | Evaporation Pond – standing on northern berm – facing southeast. Photo taken 12/16/15.

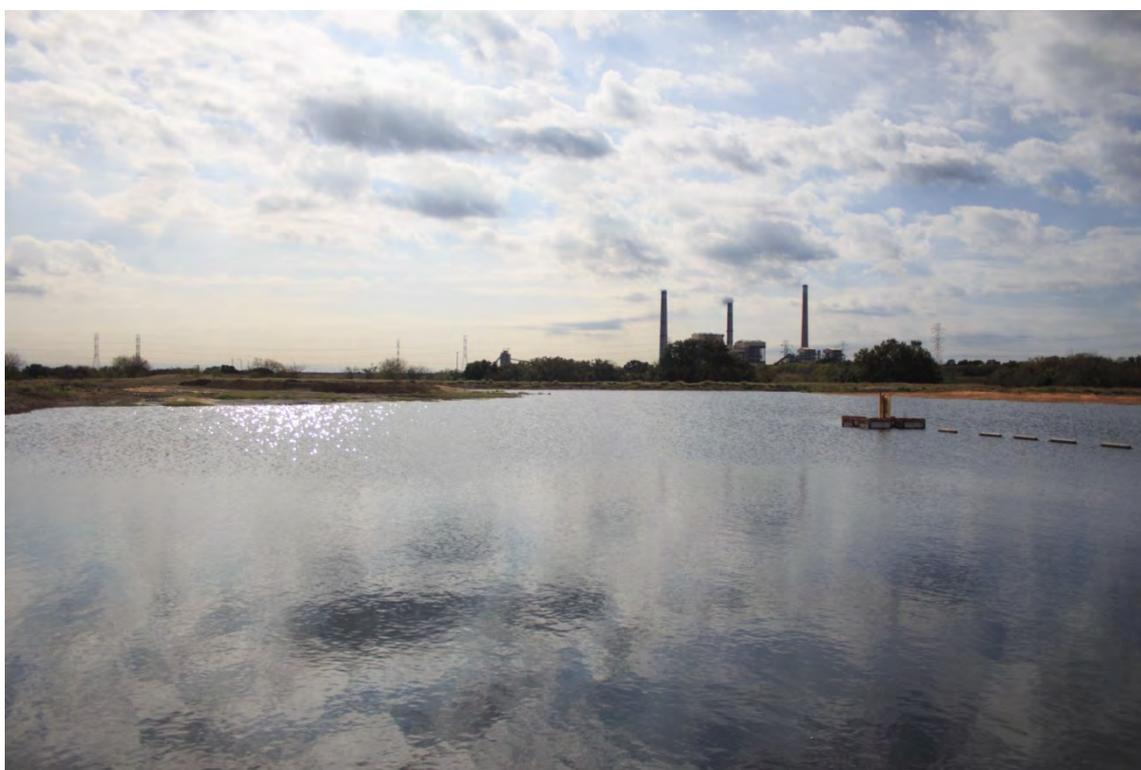
Photograph: 8 | Evaporation Pond – standing on northern berm – facing south. Photo taken 12/16/15.

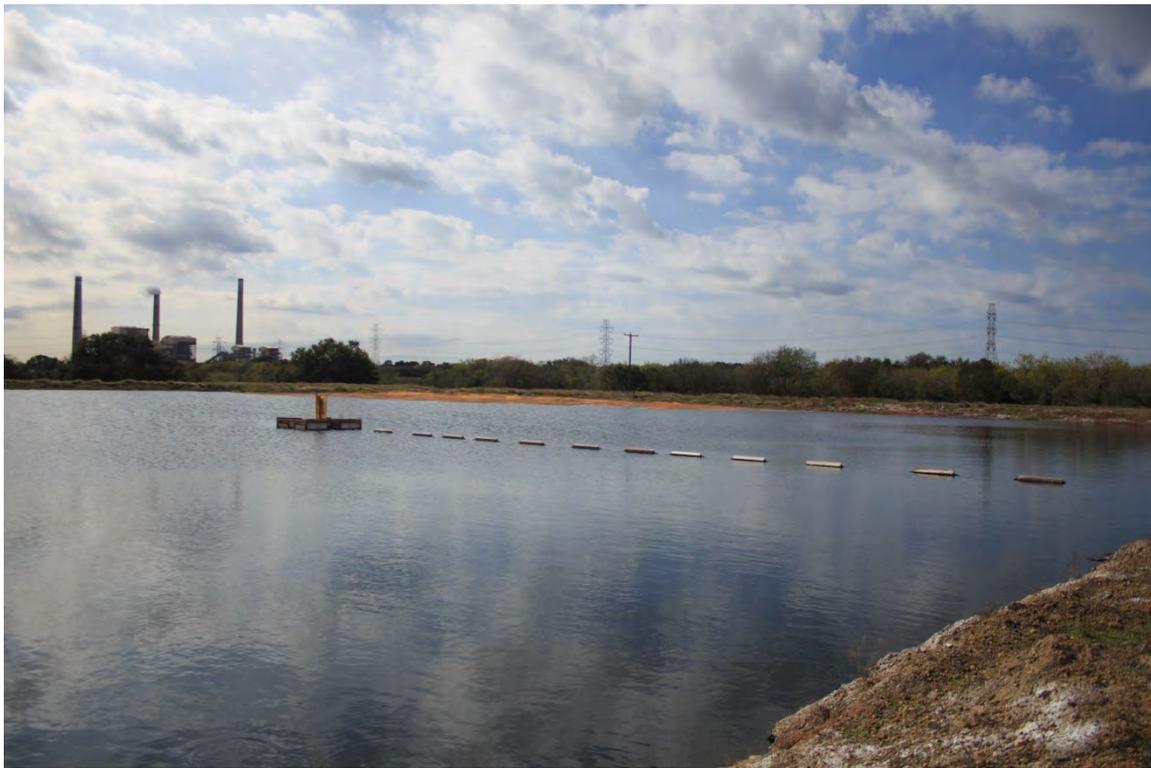
Photograph: 9 | Evaporation Pond – standing on northern berm – facing southwest. Photo taken 12/16/15.

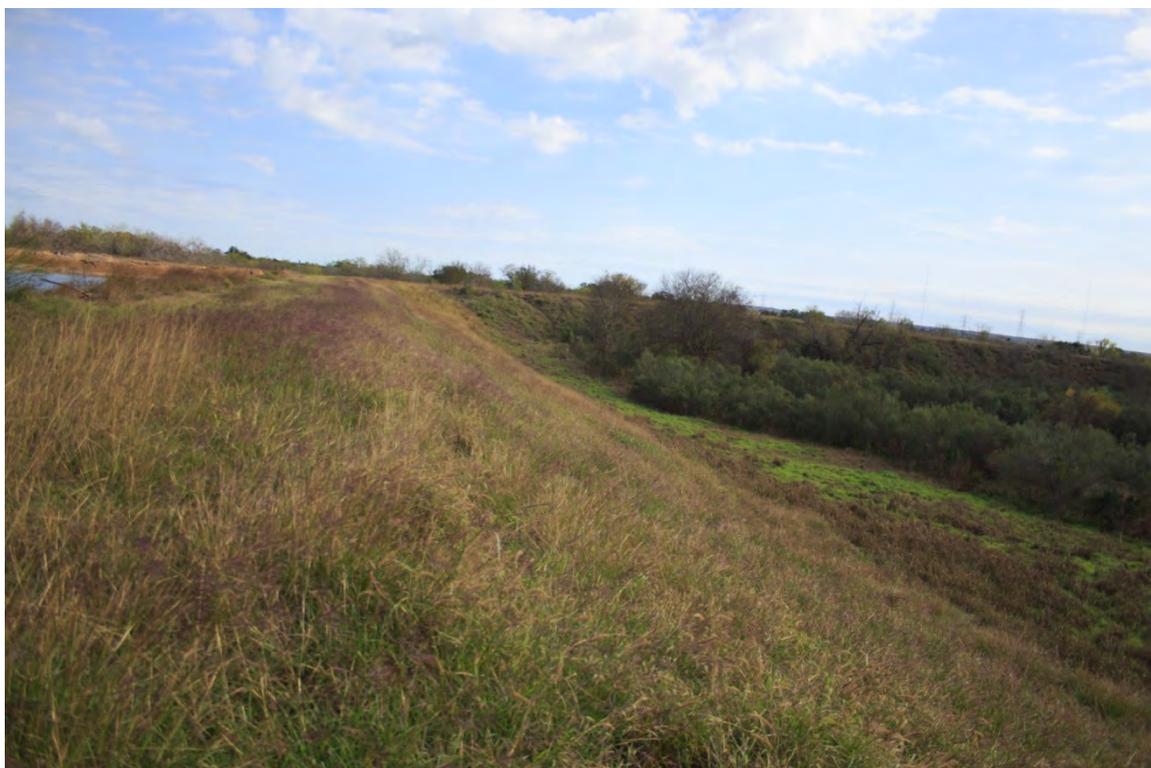
Photograph: 10 | Evaporation Pond – standing on southwest corner of pond – facing east. Photo taken 12/16/15.

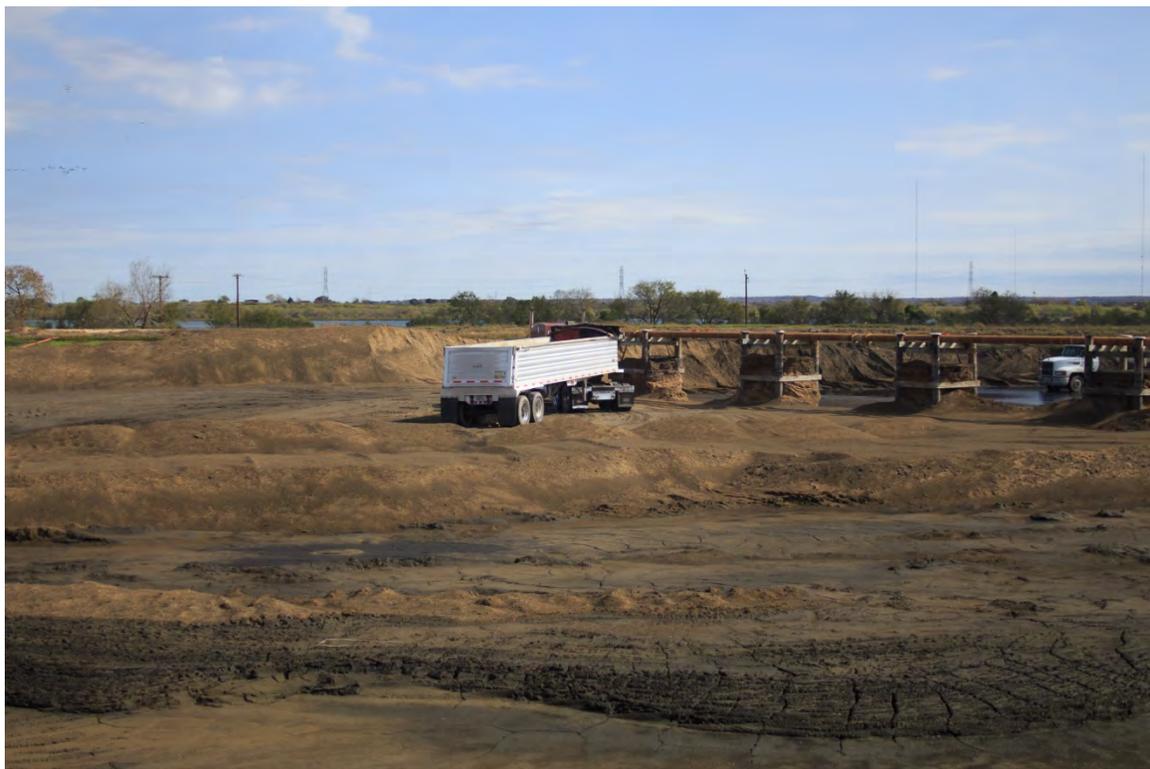
Photograph: 11 North Bottom Ash Pond – standing on western berm – facing northeast. Pond was drained to remove residuals. Photo taken 12/16/15.

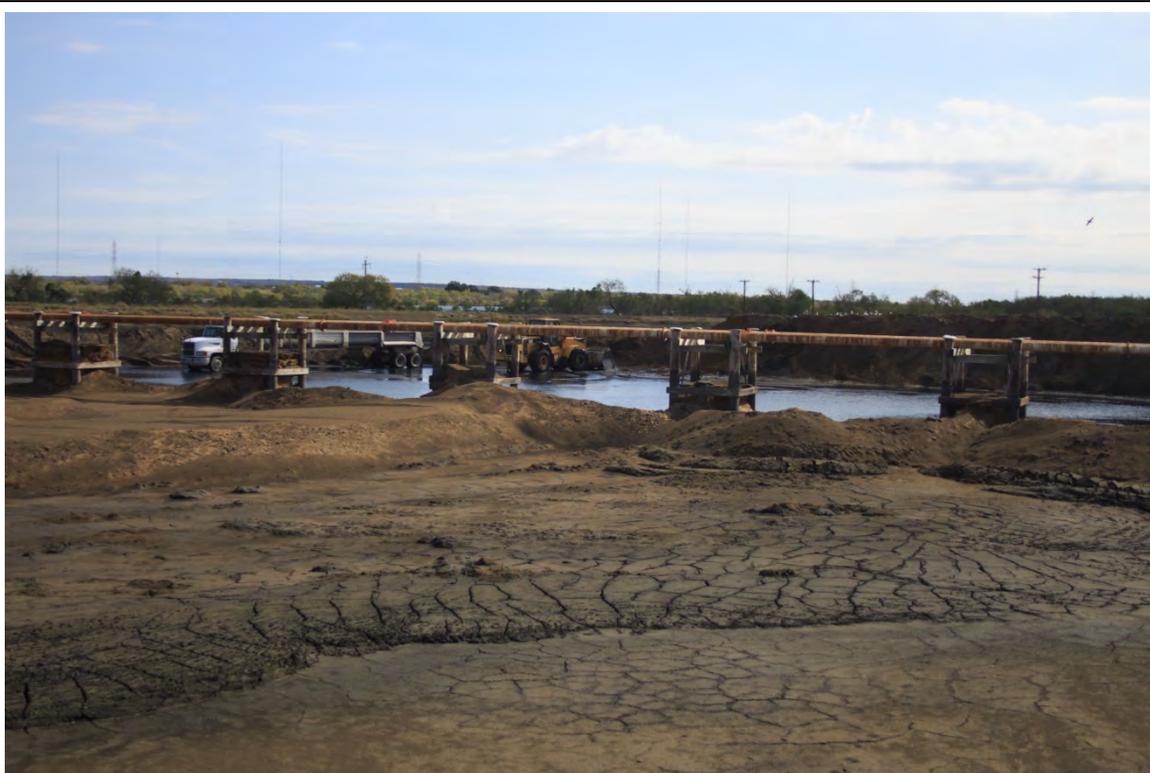
Photograph: 12 North Bottom Ash Pond – standing on western berm – facing east. Pond was drained to remove residuals. Photo taken 12/16/15.

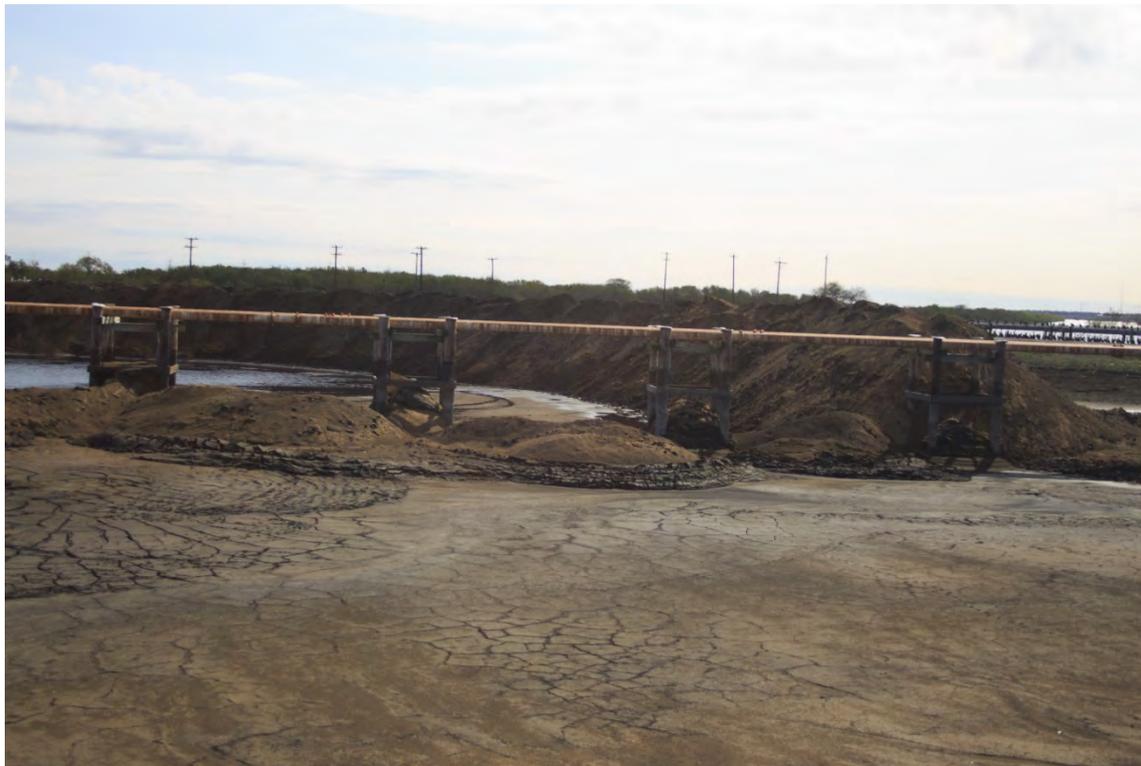
Photograph: 13 North Bottom Ash Pond – standing on western berm – facing southeast. Pond was drained to remove residuals. Photo taken 12/16/15.

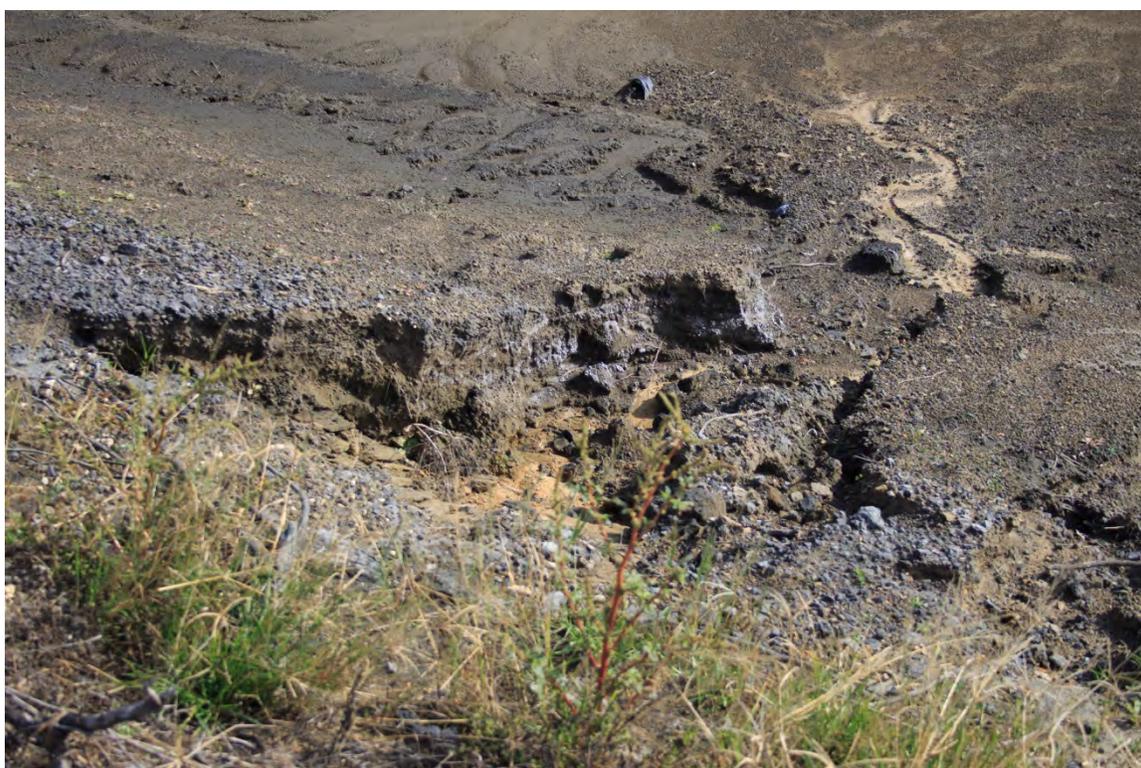
The North BAP was offline and completely drained of liquid during the inspection. Ash was being excavated from the pond and transported offsite for beneficial use by a third party. Some shallow (i.e., less than one foot deep) erosion channels were observed on interior embankments of the North BAP in the northwest corner, and the west and east embankments. The erosion was mostly concentrated near the bottom of the slope. It appeared to be primarily of ash, with underlying clay relatively undisturbed. This erosion does not appear to impact unit stability. No obstruction of or damage to outfall structures were observed. Grass along the external slope of the embankment was observed to be over 12 inches high. It is recommended to that the grass on the slopes be mowed to facilitate desired grass growth and to prevent the formation of woody plant materials.

Photograph: 14 North Bottom Ash Pond – standing on western berm – facing east. Erosion features on inside of western berm. Photo taken 12/16/15.

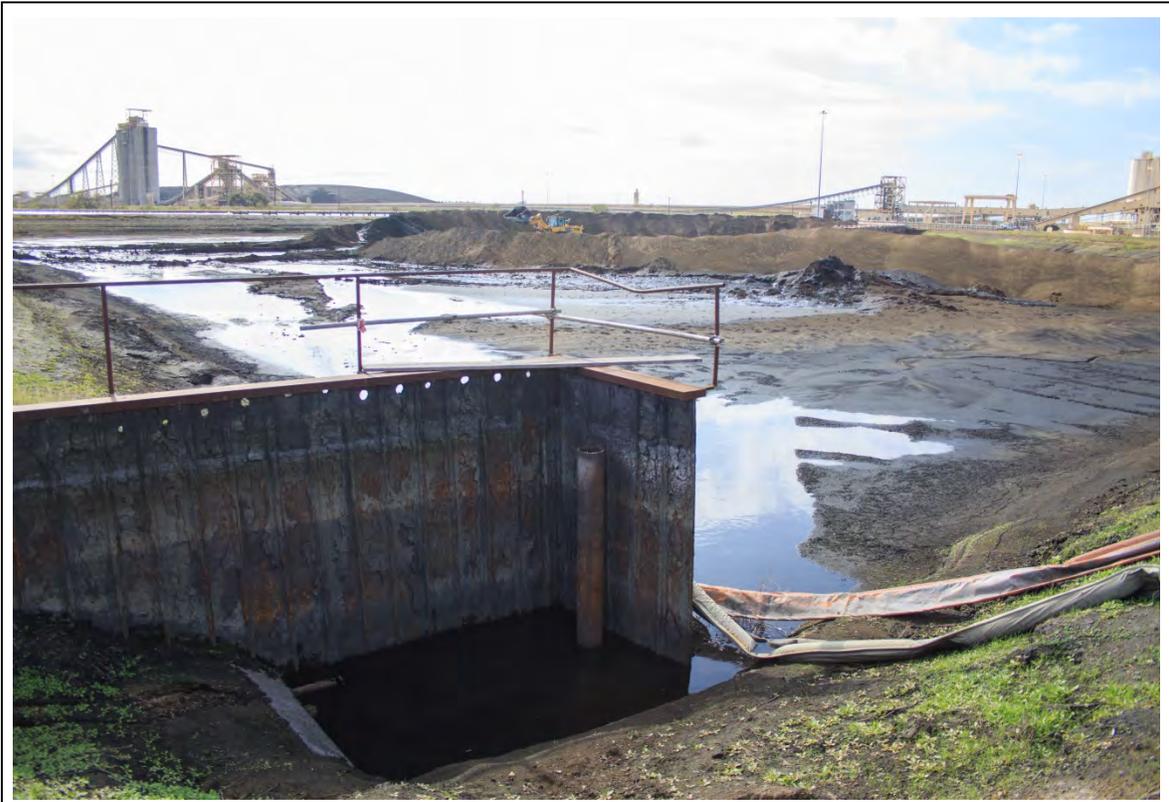
Photograph: 15 North Bottom Ash Pond – standing on northeast corner of pond – facing southwest. Outlet pipe in northeast corner of pond. Photo taken 12/16/15.

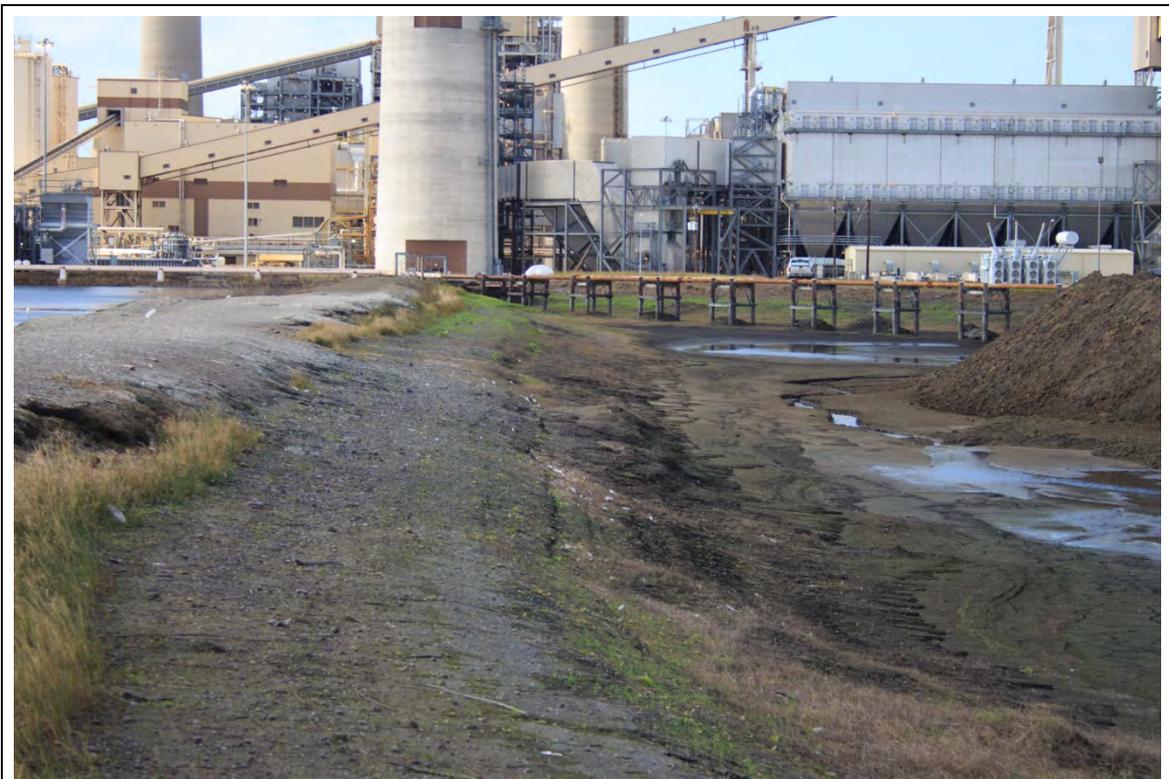
Photograph: 16 North Bottom Ash Pond – standing on southern berm – facing west. Photo taken 12/16/15.

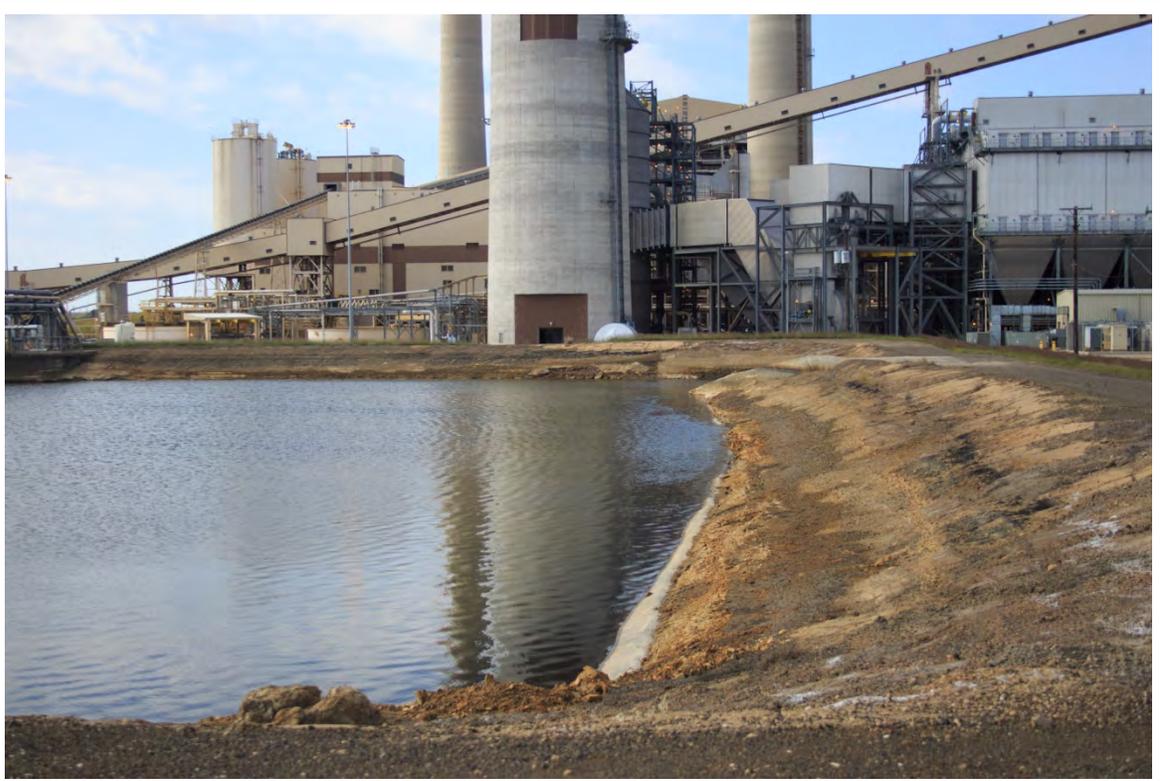
Photograph: 17 North SRH Pond – standing on northeast corner of pond – facing west. Photo taken 12/16/15.

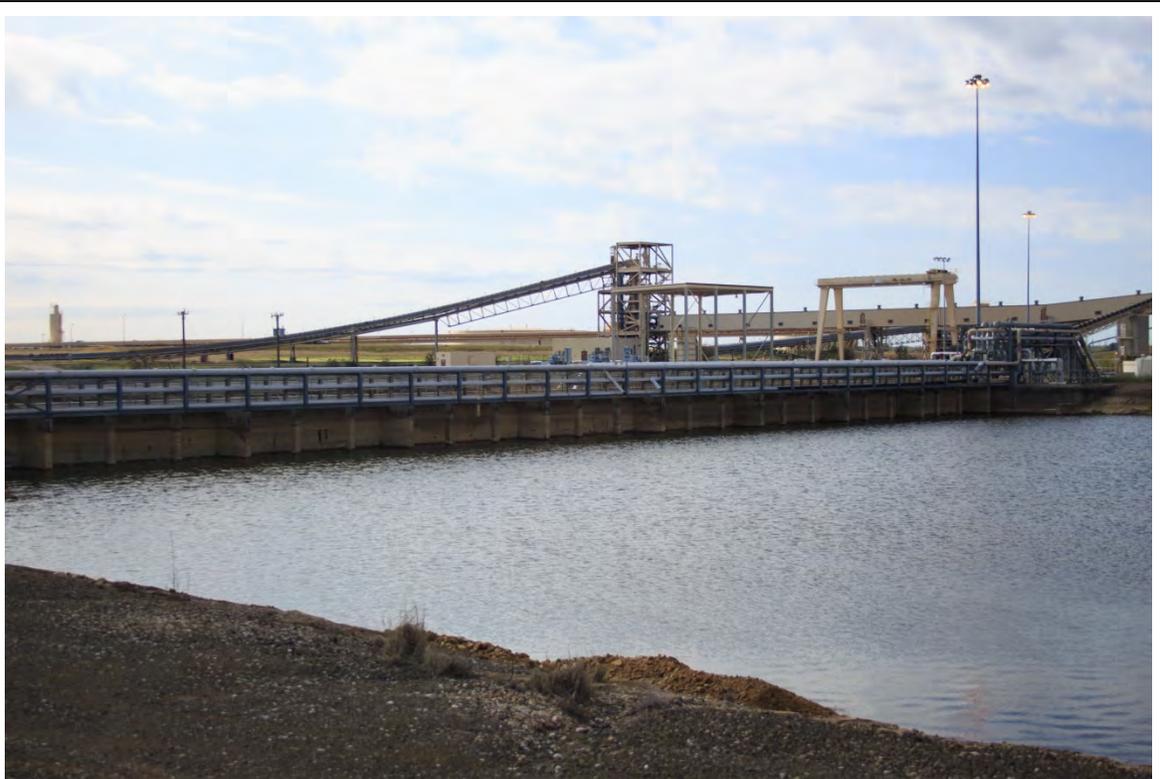
Photograph: 18 North SRH Pond – standing on eastern berm – facing southwest. Photo taken 12/16/15.

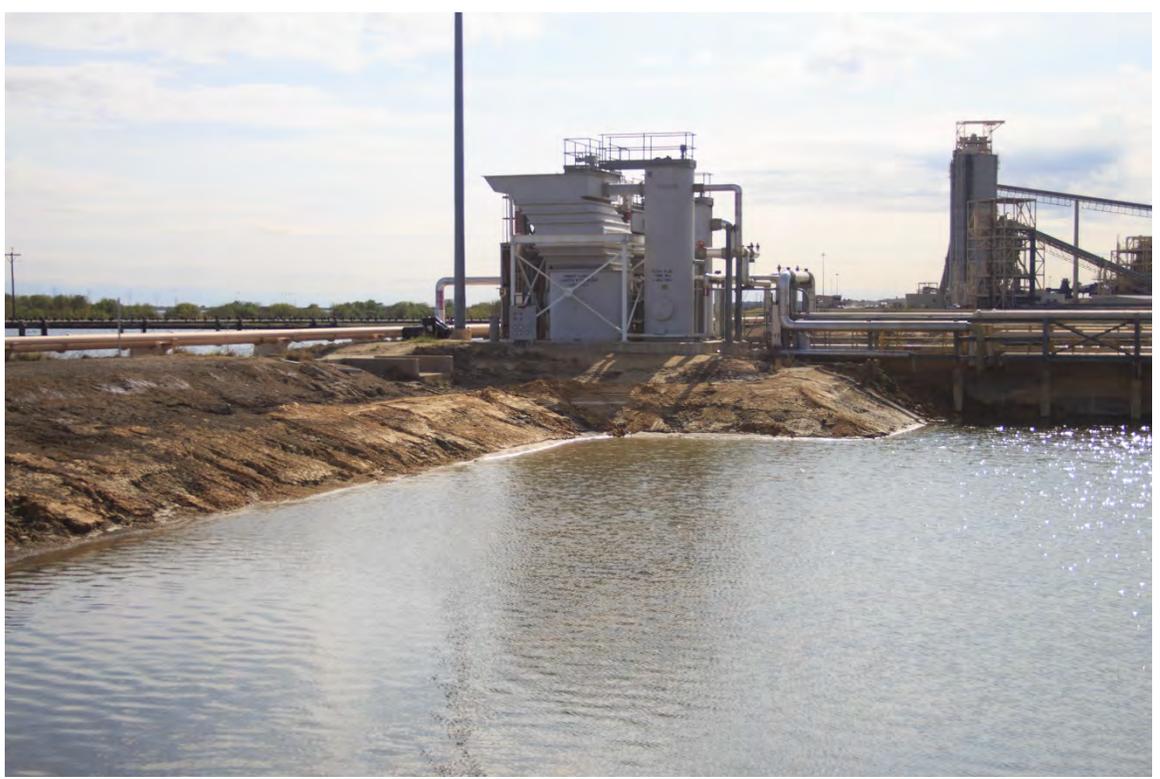
Photograph: 19 North SRH Pond – standing on northern berm – facing southeast. Photo taken 12/16/15.

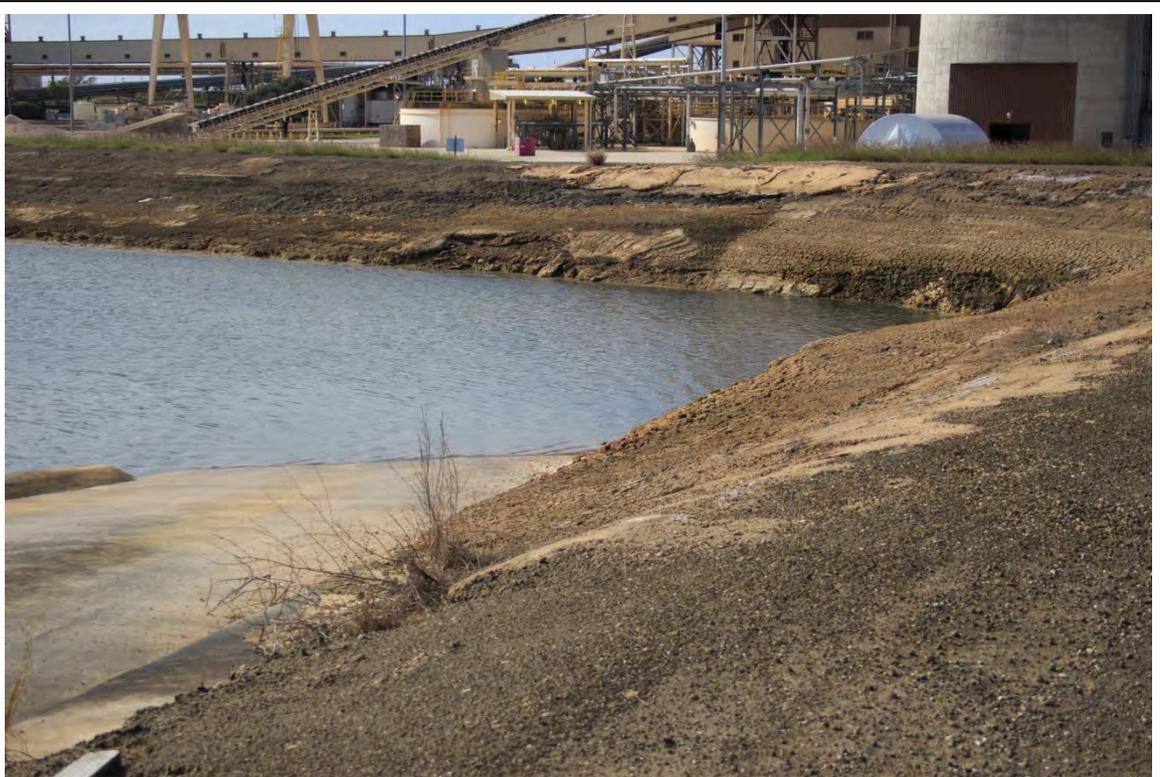
The SRH Ponds contained water at the time of the inspection. The gate on the divider wall between the SRH Ponds was open, with water one to two feet deep. This corresponds to an approximate available capacity of 26.8 acre-feet, with approximately 3.4 acre-feet of water and CCR contained. Some erosion channels were observed on interior embankments of the SRH Ponds near the spillway on the South SRH Pond, and the interior east embankment. The erosion was mostly concentrated near the bottom of the slope and appeared to be primarily of ash, with underlying clay relatively undisturbed. This erosion does not appear to impact the underlying HDPE liner or the unit stability. No obstruction of or damage to outfall structures was observed.

Photograph: 20 North SRH Pond – standing on northern berm – facing southwest. Erosional features on western berm. Photo taken 12/16/15.

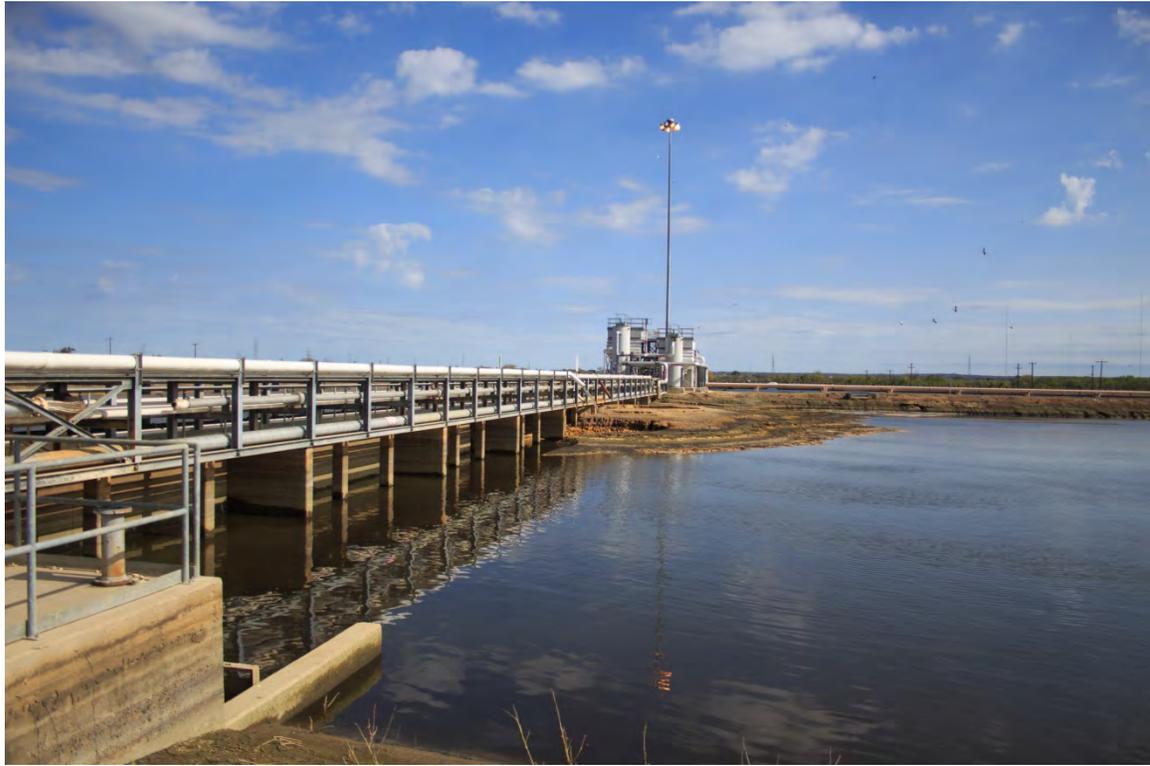
Photograph: 21 South SRH Pond – standing on western berm – facing east. Photo taken 12/16/15.

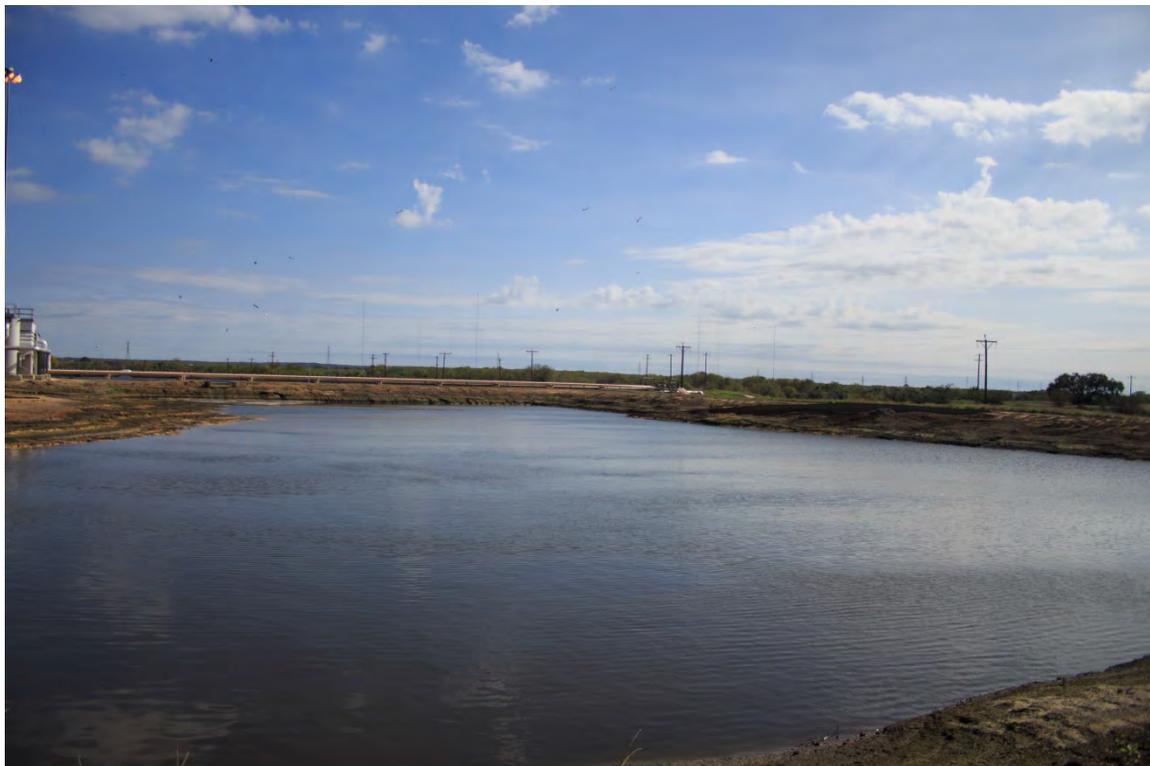
Photograph: 22 South SRH Pond – standing on western berm – facing southeast. Photo taken 12/16/15.

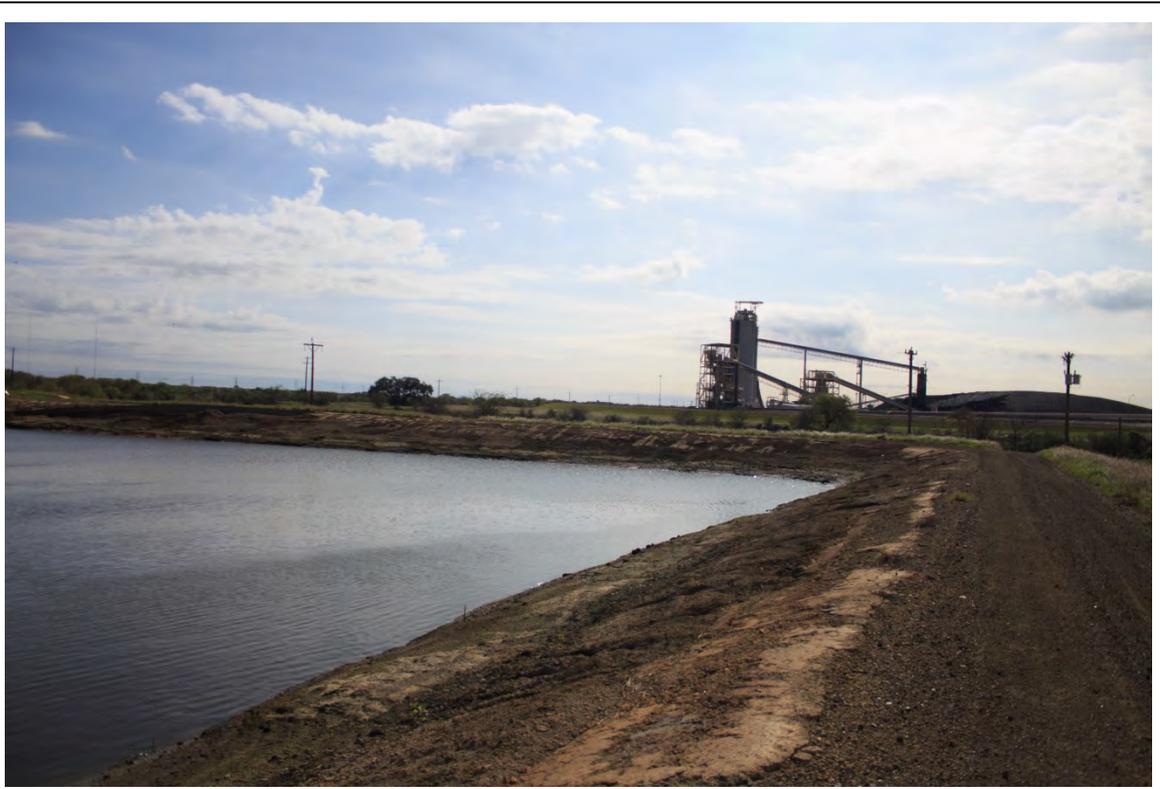
Photograph: 23 South SRH Pond – standing on western berm – facing south. Photo taken 12/16/15.

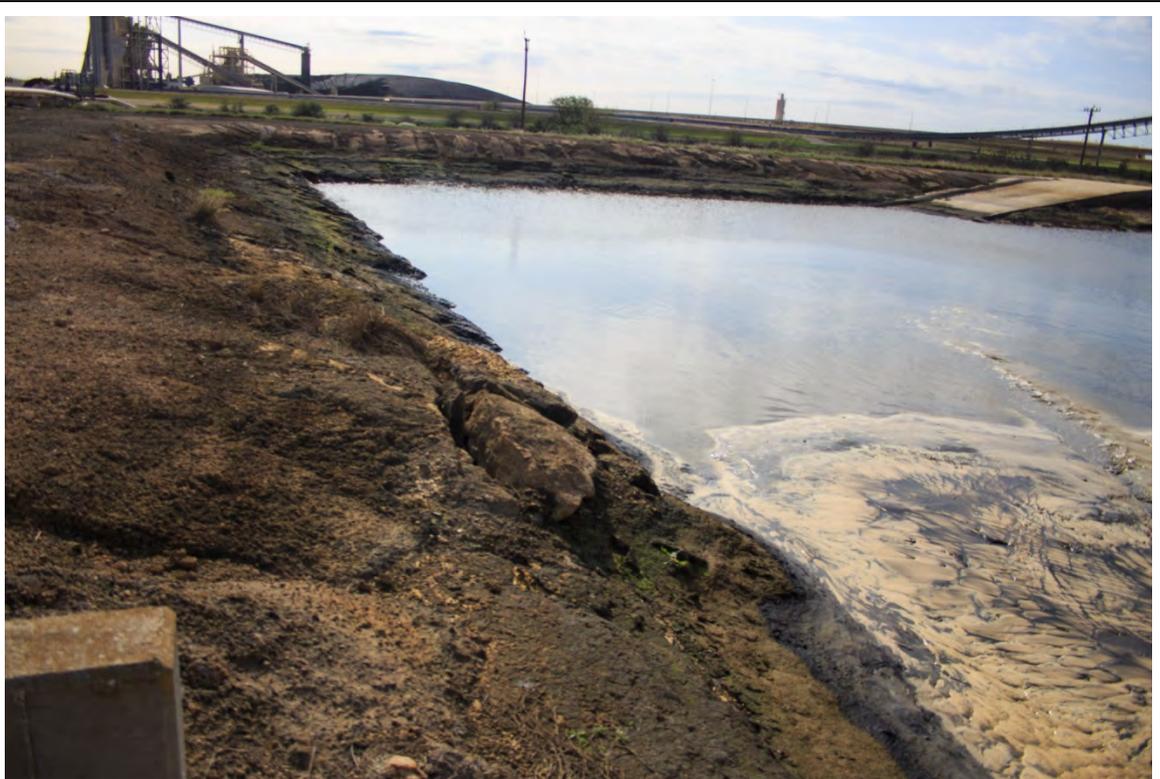
Photograph: 24 South SRH Pond – standing on eastern berm – facing south. Erosional features on eastern berm. Photo taken 12/16/15.
