Project No. 0328985

Subject: CCR Units - 2015 Annual Inspection
Calaveras Power Station
San Antonio, Texas

Photo Log
Attachment 1

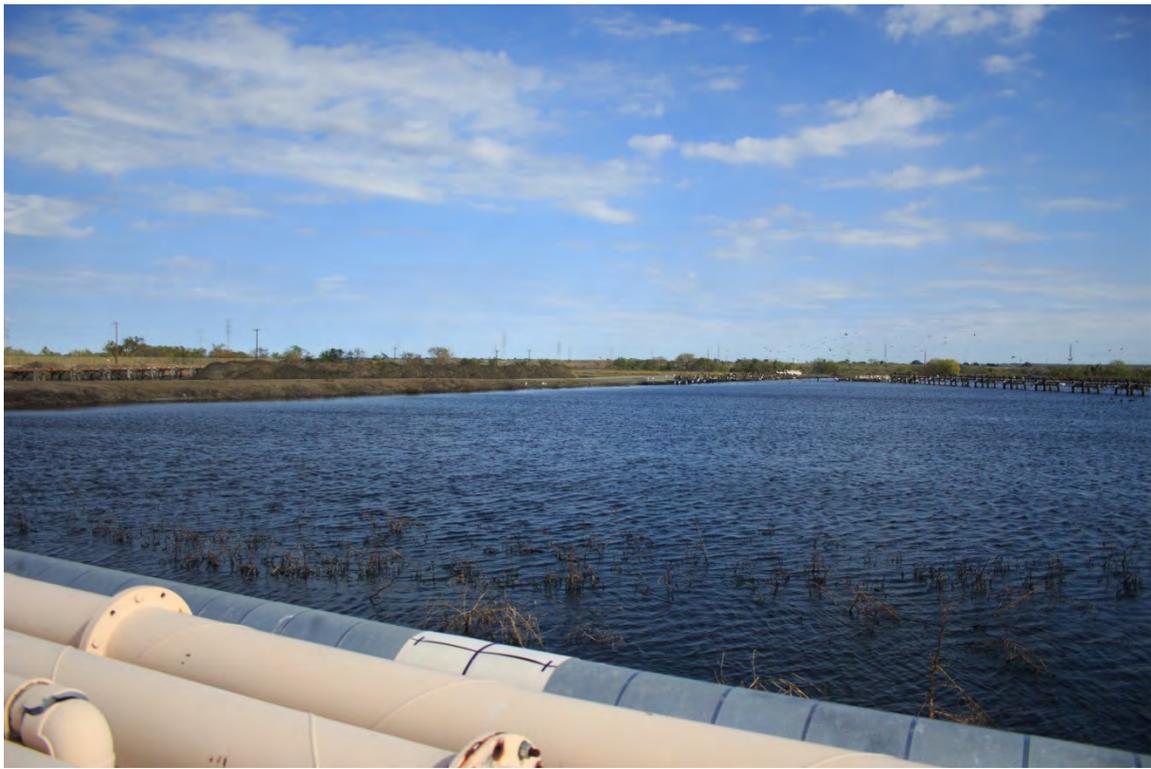
Photograph: 25 South Bottom Ash Pond – standing on western berm – facing northeast. Photo taken 12/16/15.

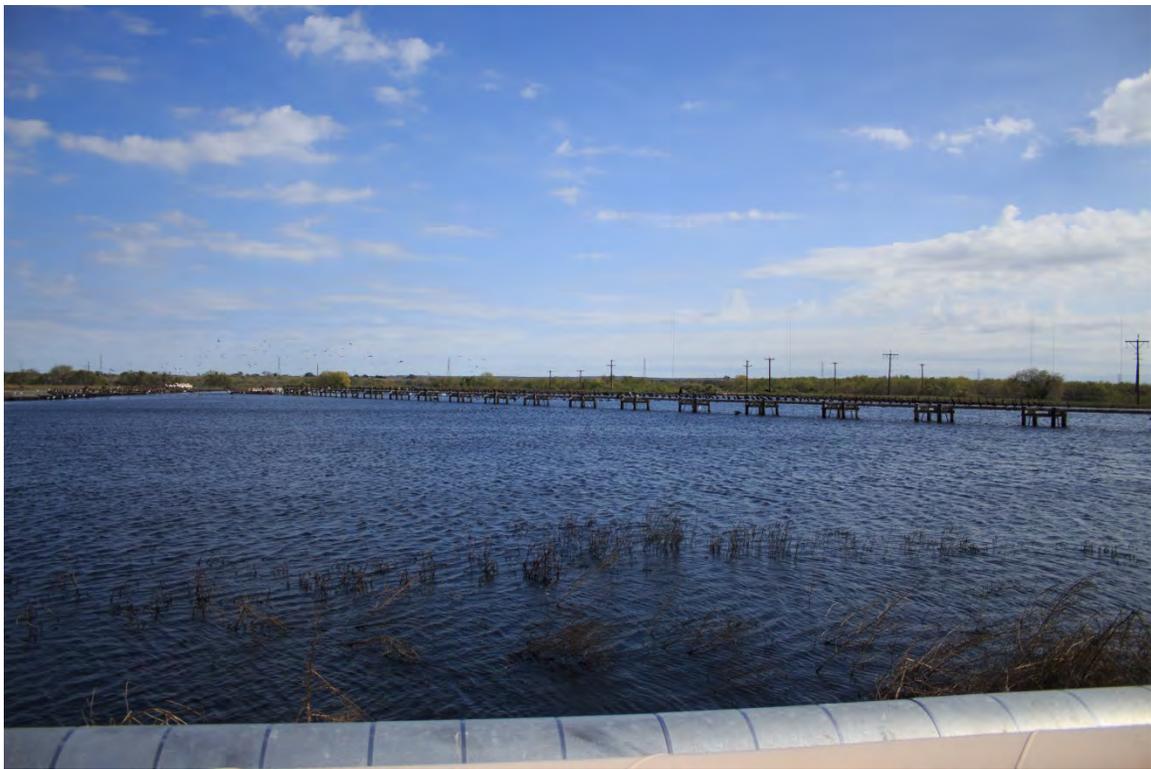
Photograph: 26 South Bottom Ash Pond – standing on western berm – facing east. Photo taken 12/16/15.

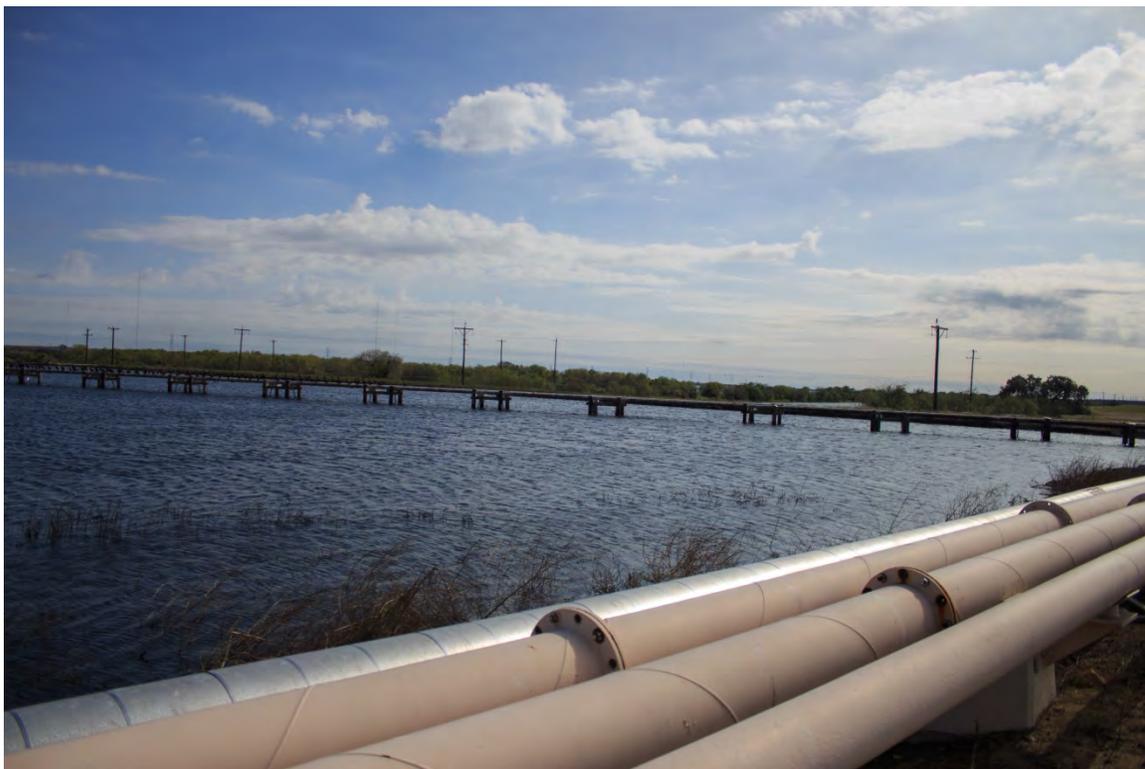
Photograph: 27 South Bottom Ash Pond – standing on western berm – facing southeast. Photo taken 12/16/15.

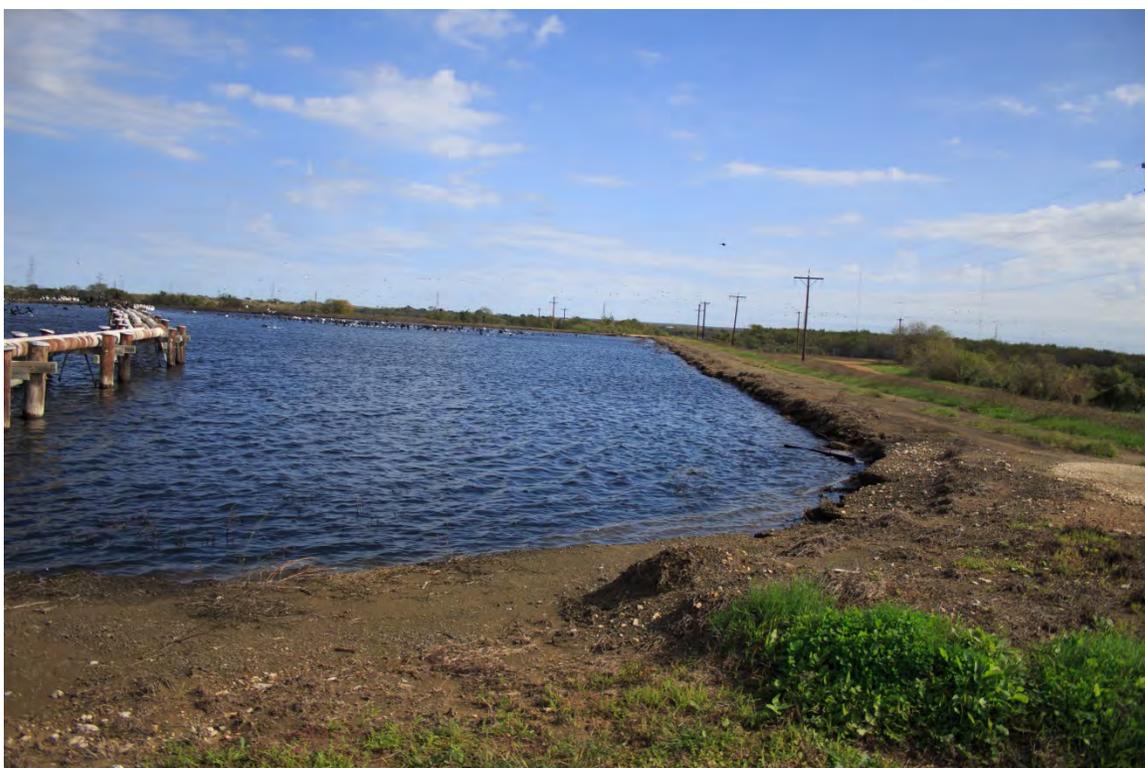
Photograph: 28 South Bottom Ash Pond – standing on southwest corner of pond – facing east. Photo taken 12/16/15.
