Facility Name: Calaveras Plant Site

**SUBJECT**  
CCR Units – 2025 Annual Inspection and  
Fugitive Dust Control Report  
Calaveras Power Station  
San Antonio, Texas

The annual inspection was conducted by Mr. Charles Johnson, P.E. (Texas), on November 10, 2025. Photographs taken during the inspection are provided in Attachment 1. No issues were observed that indicated immediate stability or operational issues at the CCR units. Details of the observations made by Mr. Johnson are provided below.

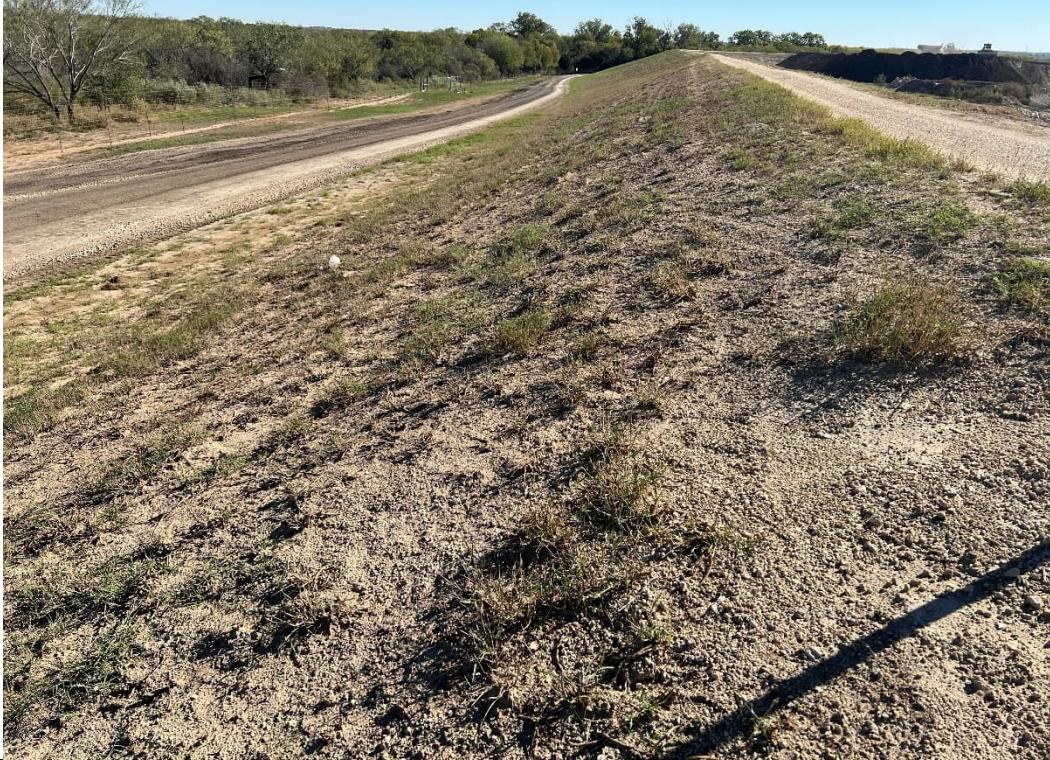
Grass along the exterior embankment slopes of the FAL had some bare spots, which could be due to lack of rain in recent months; grass may naturally return with more moisture and warmer weather. Otherwise, grass along the other exterior embankment slopes was observed to be generally well maintained and no woody plants were observed. No significant rutting, erosion, or other problems were observed at the time of the annual inspection.

**Photograph: 1** Fly Ash Landfill – standing on west berm – facing north. Some bare spots noted – no significant erosion.  
Photo taken 11/10/2025.

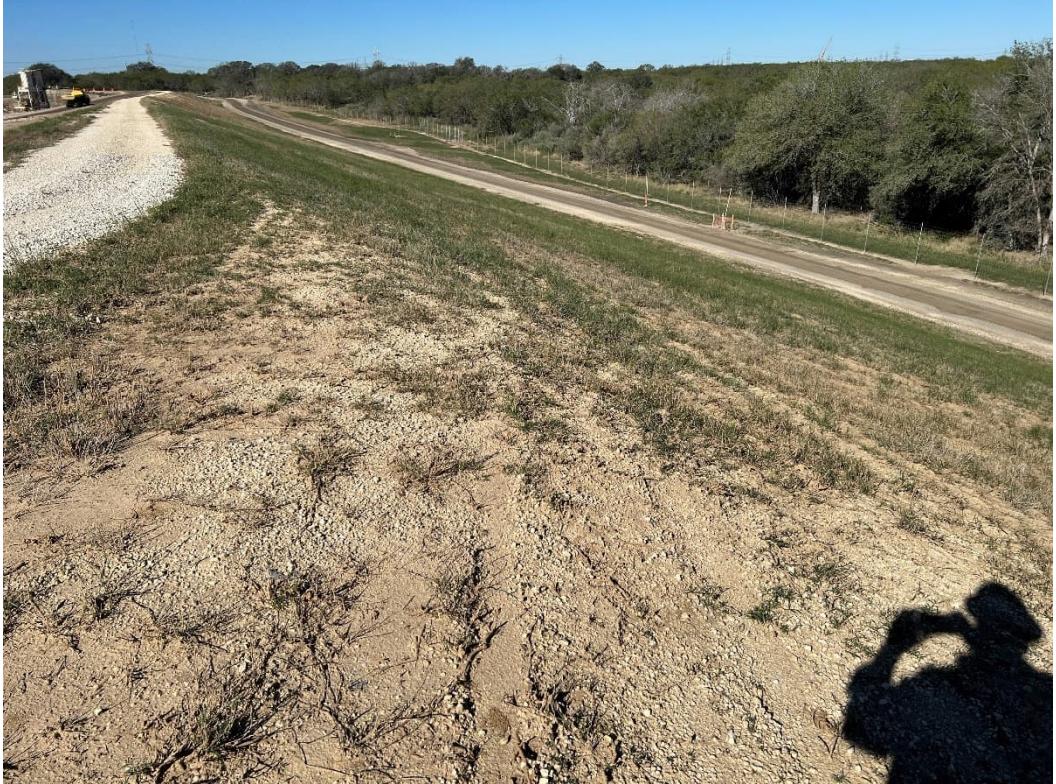
**Photograph: 3** Fly Ash Landfill – standing on northeast corner – facing west. Some bare spots noted – no significant erosion. Photo taken 11/10/2025.

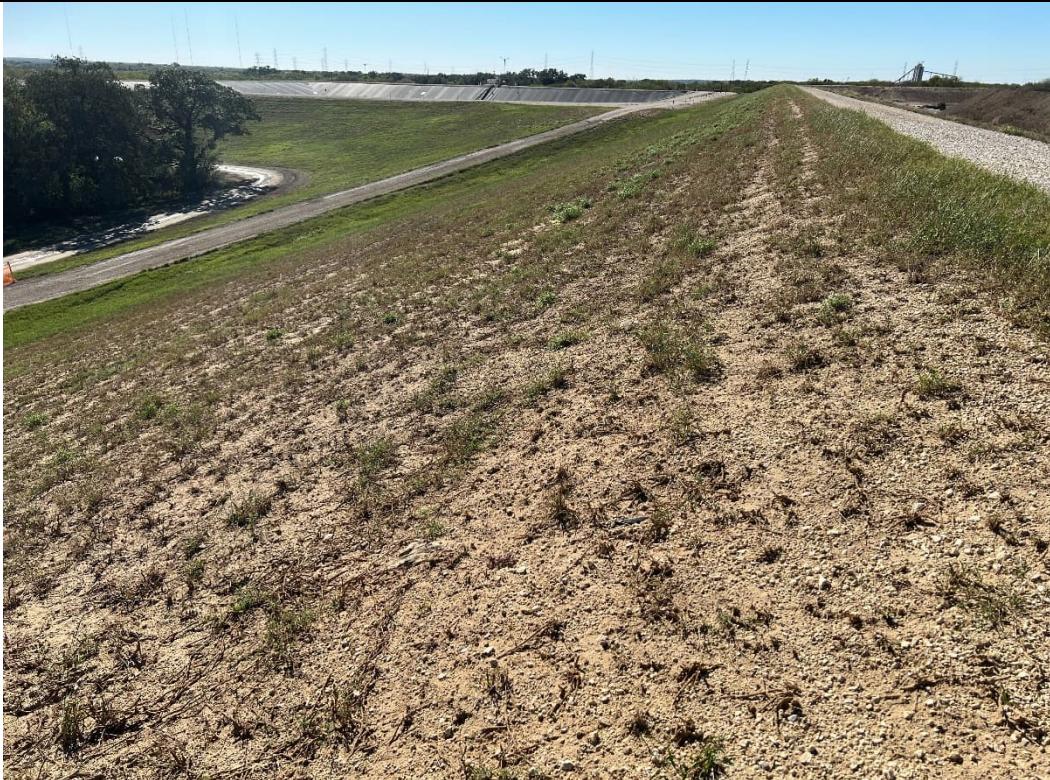
**Photograph: 6** Fly Ash Landfill – standing on northeast corner – facing south. Some bare spots noted – no significant erosion.  
Photo taken 11/10/2025.

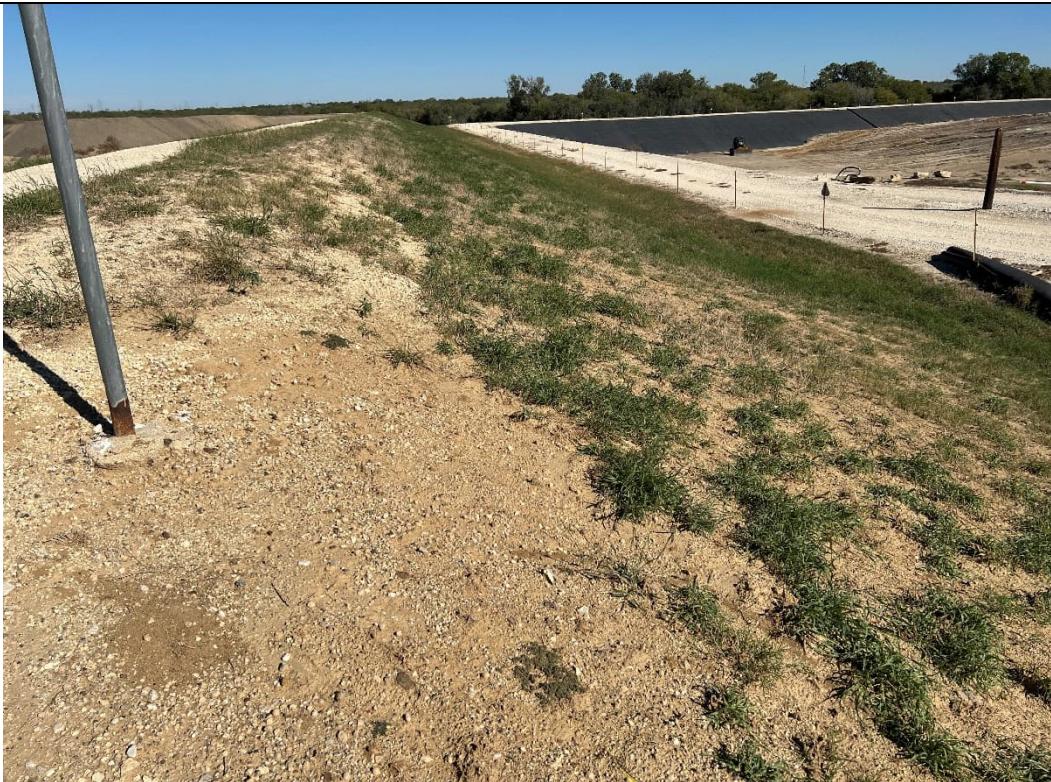
**Photograph: 8** Fly Ash Landfill – standing on east berm – facing north. Some bare spots noted – no significant erosion.  
Photo taken 11/10/2025.

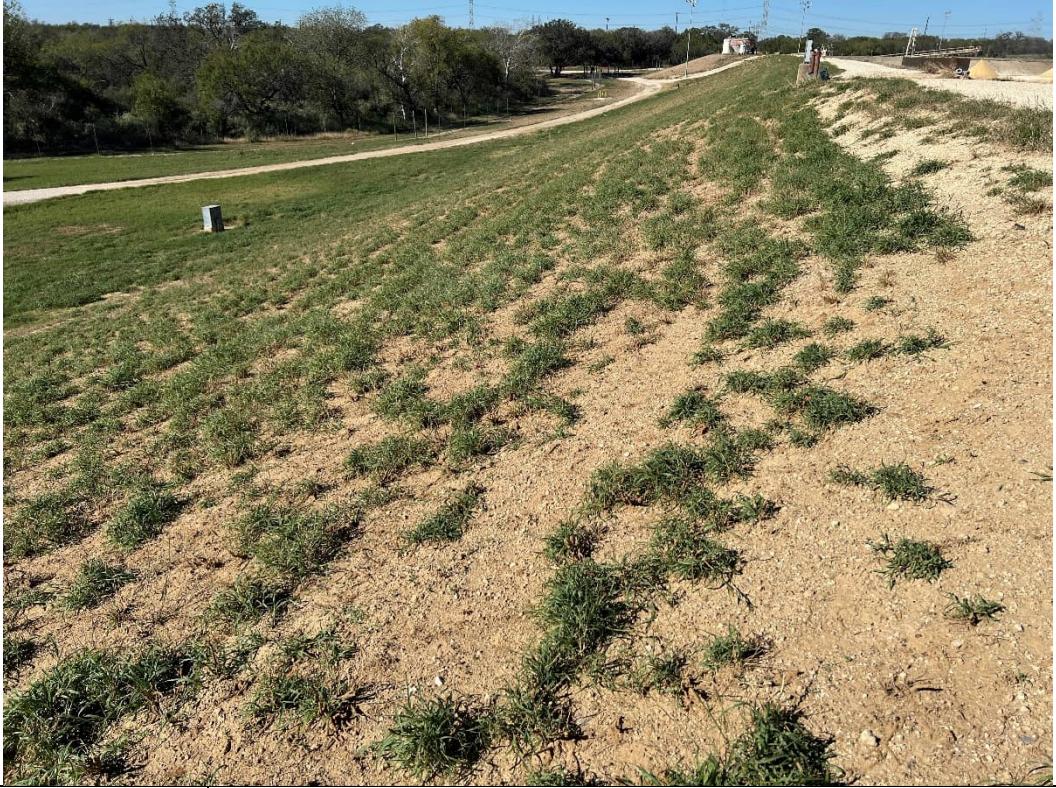
**Photograph: 10** Fly Ash Landfill – standing on south berm – facing west. Some bare spots noted – no significant erosion. Photo taken 11/10/2025.

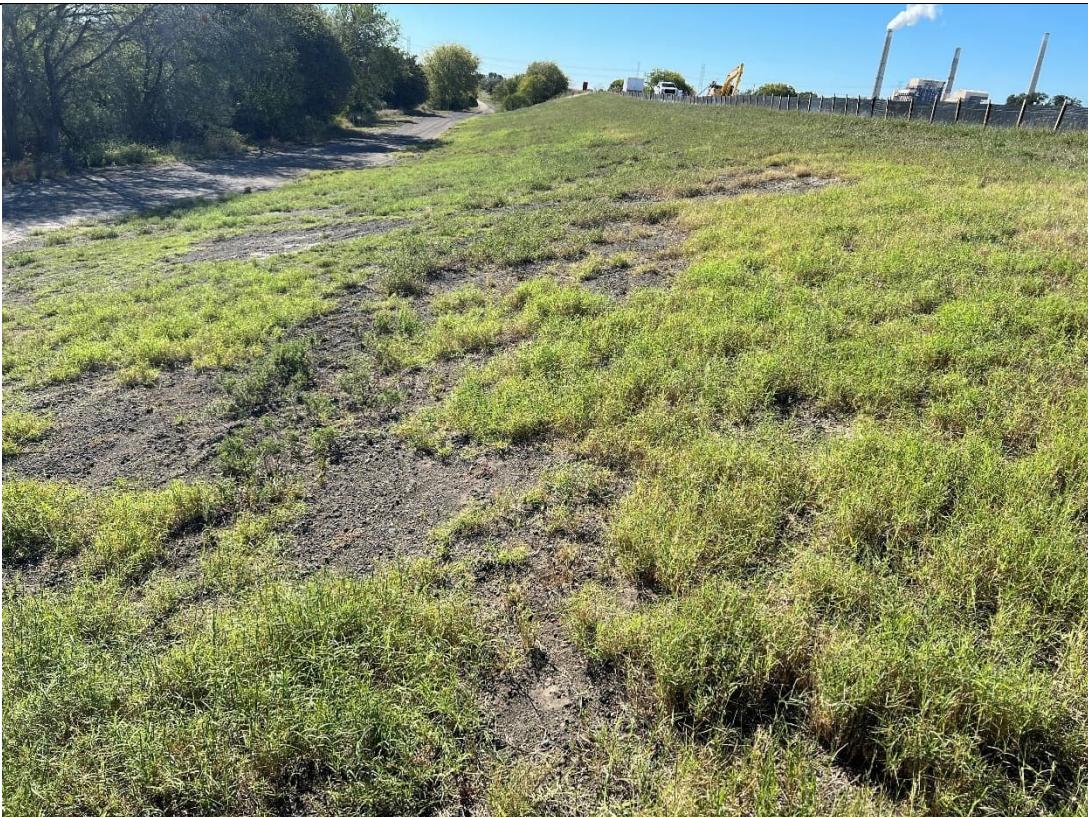
Grass along the exterior embankment slopes of the EP had some bare spots, which could be due to lack of rain in recent months; grass may naturally return with more moisture and warmer weather. Otherwise, grass along the other exterior embankment slopes was observed to be generally well maintained and no woody plants were observed. Some minor erosion on the west exterior side slope was observed; otherwise no significant rutting, erosion, or other problems were observed at the time of the annual inspection.

**Photograph: 13** Evaporation Pond – standing on northeast corner – facing south. Some bare spots noted – no significant erosion. Photo taken 11/10/2025.

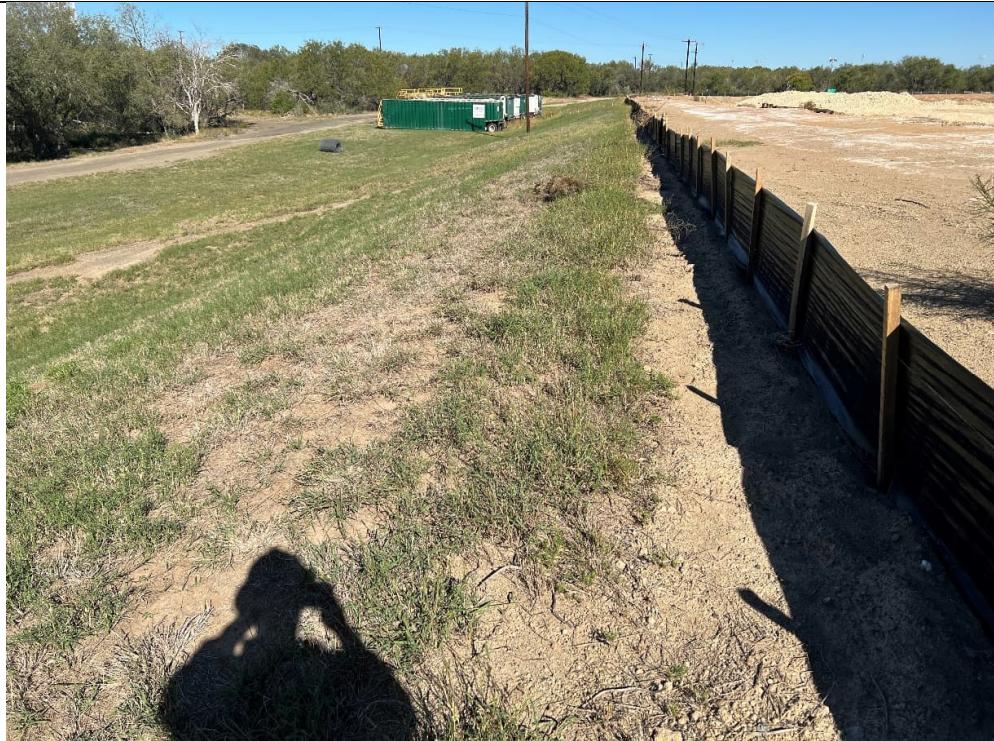
**Photograph: 16** Evaporation Pond – standing on southwest corner – facing north. Some bare spots noted – no significant erosion. Photo taken 11/10/2025.

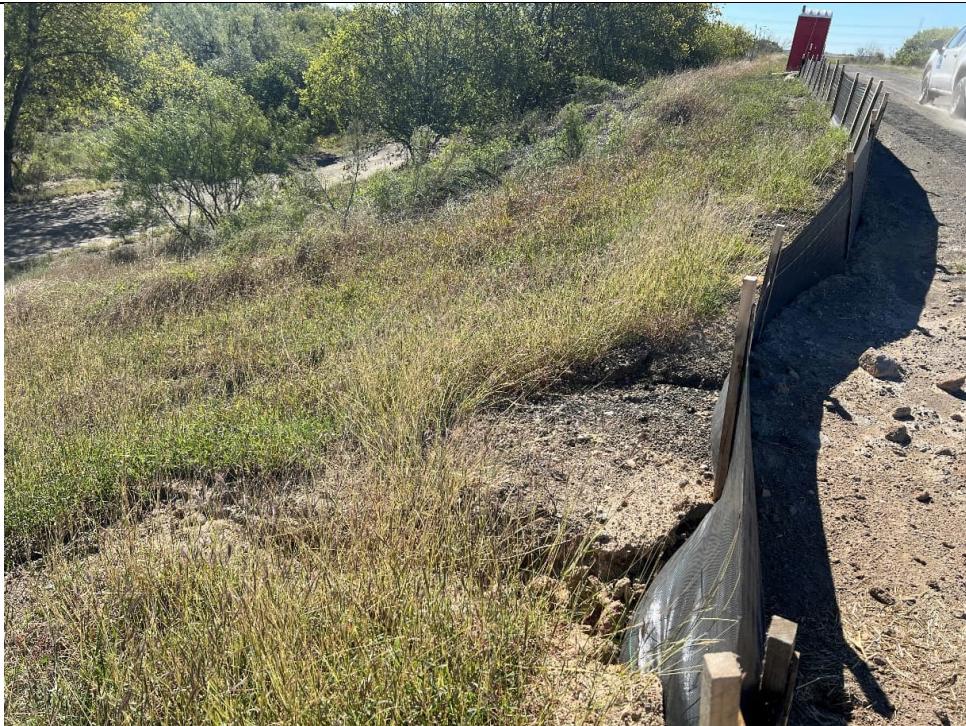
**Photograph: 18** Evaporation Pond – standing on east berm – facing south. Some erosion noted at exterior top of berm and silt fence. Photo taken 11/10/2025.
