January 17, 2019

Project No. 0352456

Subject: CCR Units - 2018 Annual Inspection and Fugitive Dust  
Control Report  
Calaveras Power Station  
San Antonio, Texas

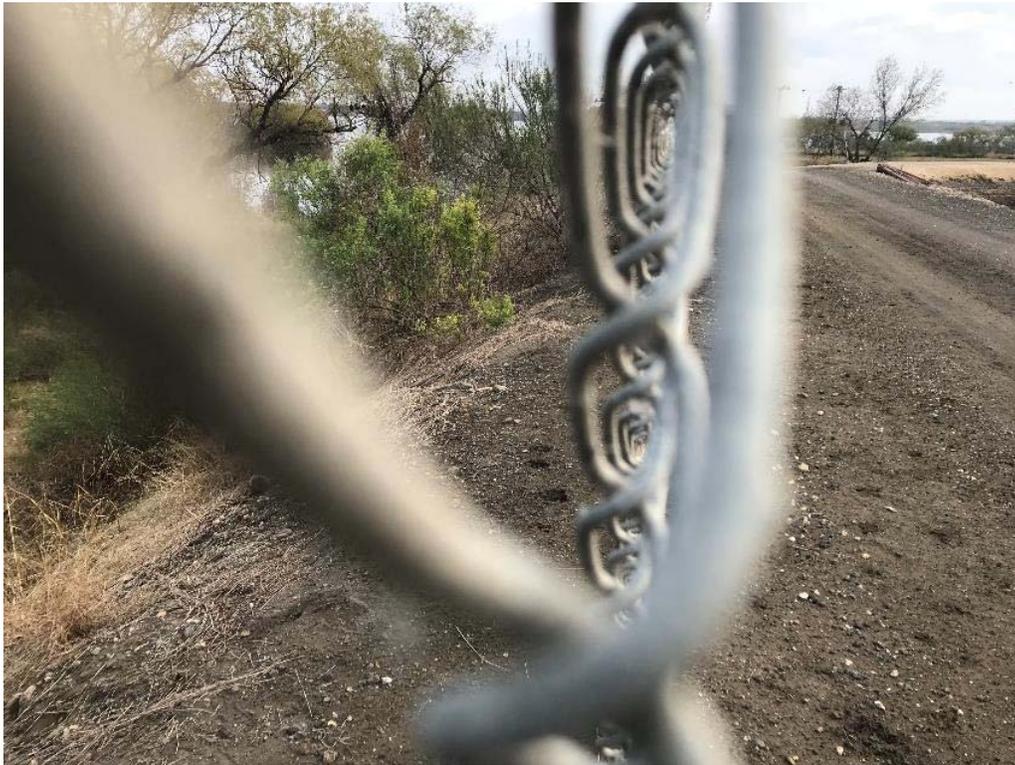
Grass along the western and eastern exterior embankment slopes was observed to be generally well maintained. The grass in an area of approximately 50 by 50 feet of the northwestern exterior embankment slope was observed to be damaged by wild hog activity, however, no erosion was observed in the area. Some woody plant growth was observed on the north exterior embankment slope. There is no apparent immediate impact to unit stability, however, the hog damaged area should be monitored for erosion and to confirm grass is restored and the woody plants should be removed from the north exterior embankment slope to facilitate inspection of the slope. No obstruction of or damage to outfall structures was observed.

**Photograph: 21** North Bottom Ash Pond – standing on northern berm – facing east. Woody plant growth noted on northern berm exterior side slope. Photo taken 12/18/18.

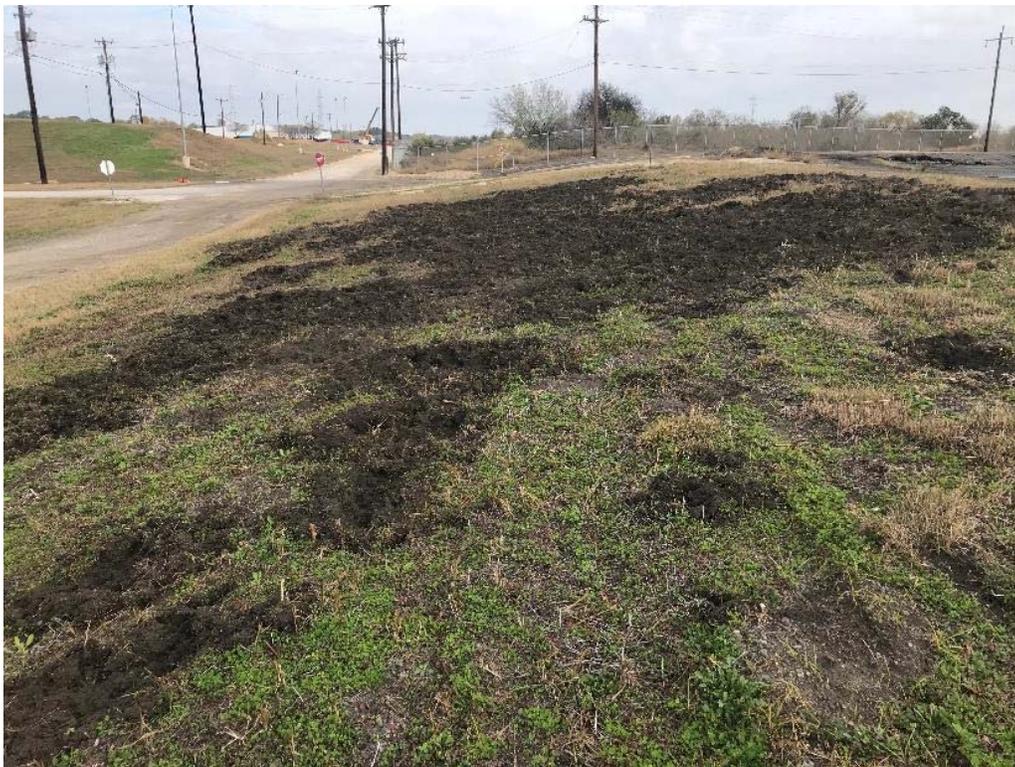
**Photograph: 22** North Bottom Ash Pond – standing on western berm – facing north. Surficial vegetation damage due to hog activity. Photo taken 12/18/18.

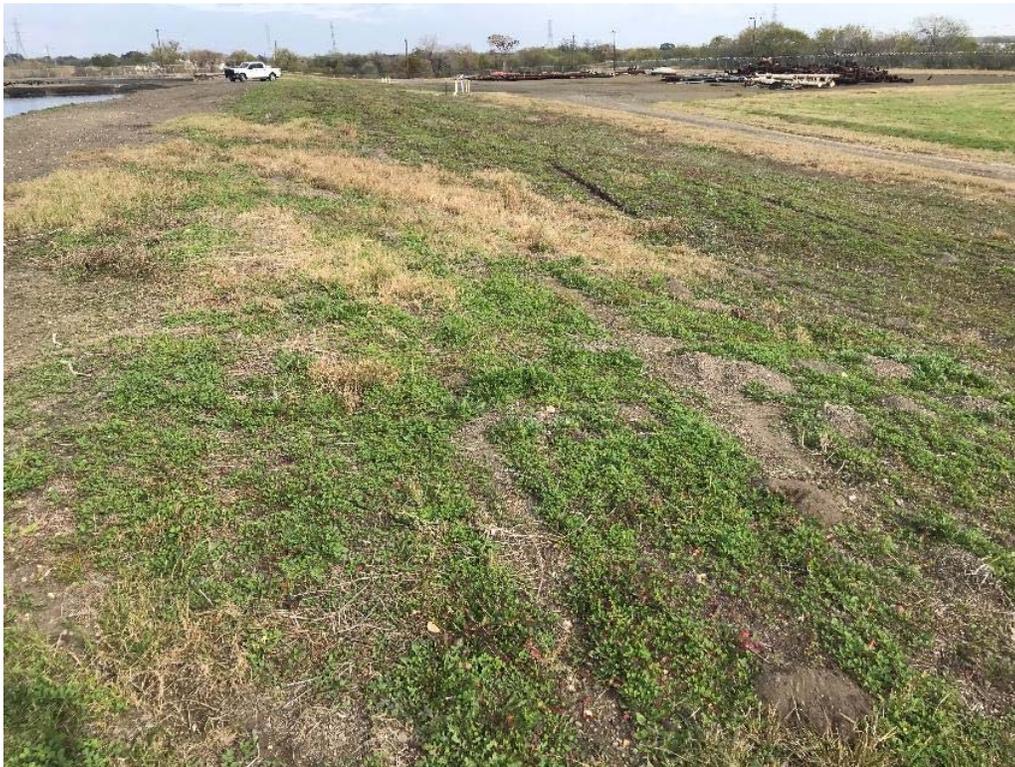
Grass along the external embankment slopes was observed to be generally well maintained. Some minor erosion was observed on interior and minor rutting was observed on the exterior embankment slopes of the South BAP. This erosion does not appear to impact unit stability. Obstruction of or damage to outfall structures could not be observed since the outfall structure was below the water surface at the time of the annual inspection.

**Photograph: 24** South Bottom Ash Pond – standing on eastern berm – facing north. Minor rutting due to vehicle traffic noted on eastern berm exterior side slope. Photo taken 12/18/18.

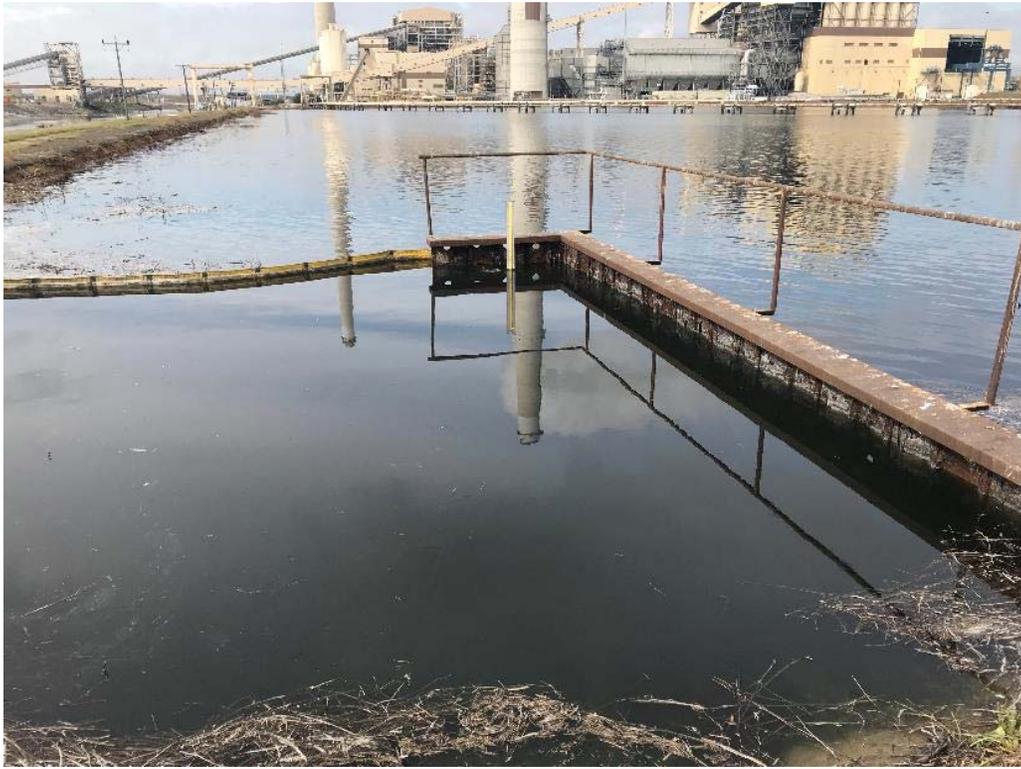
**Photograph: 25** South Bottom Ash Pond – standing on southeast corner – facing west. Outfall intake noted below water level. Photo taken 12/18/18.

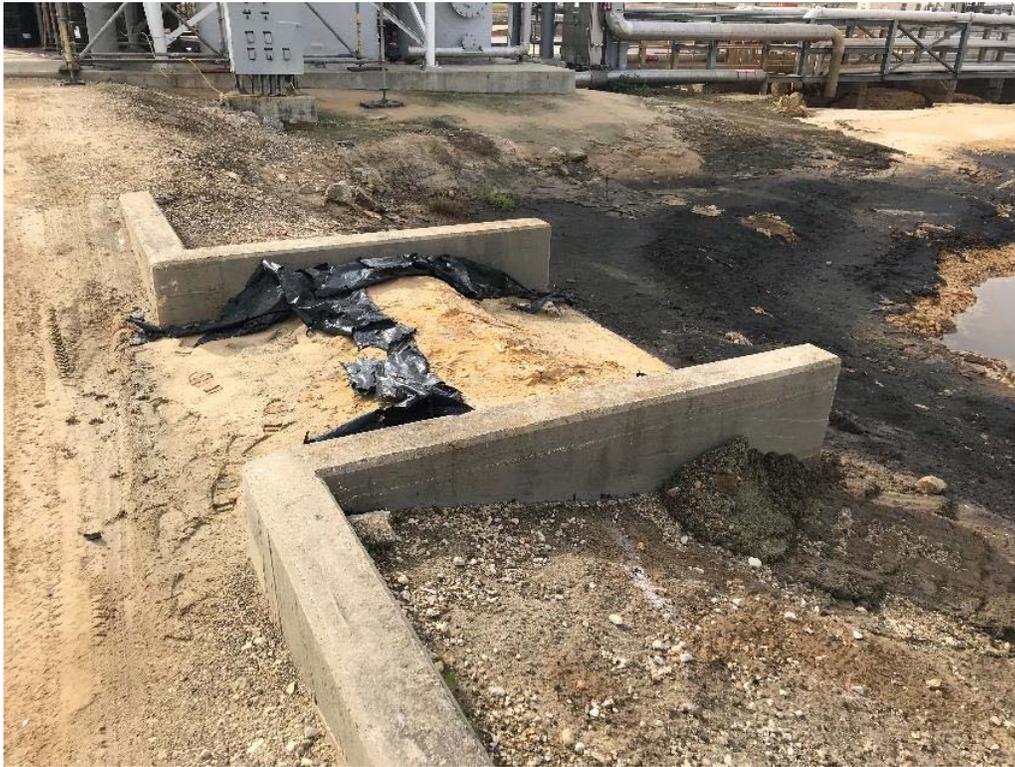
Grass along the external embankment slopes was observed to be generally well maintained. Spillways that flow to the South BAP appeared partially obstructed with sand and plastic sheeting.

**Photograph: 31** North SRH Pond – standing on eastern berm – facing southwest. Spillway structure. Photo taken 12/18/18.

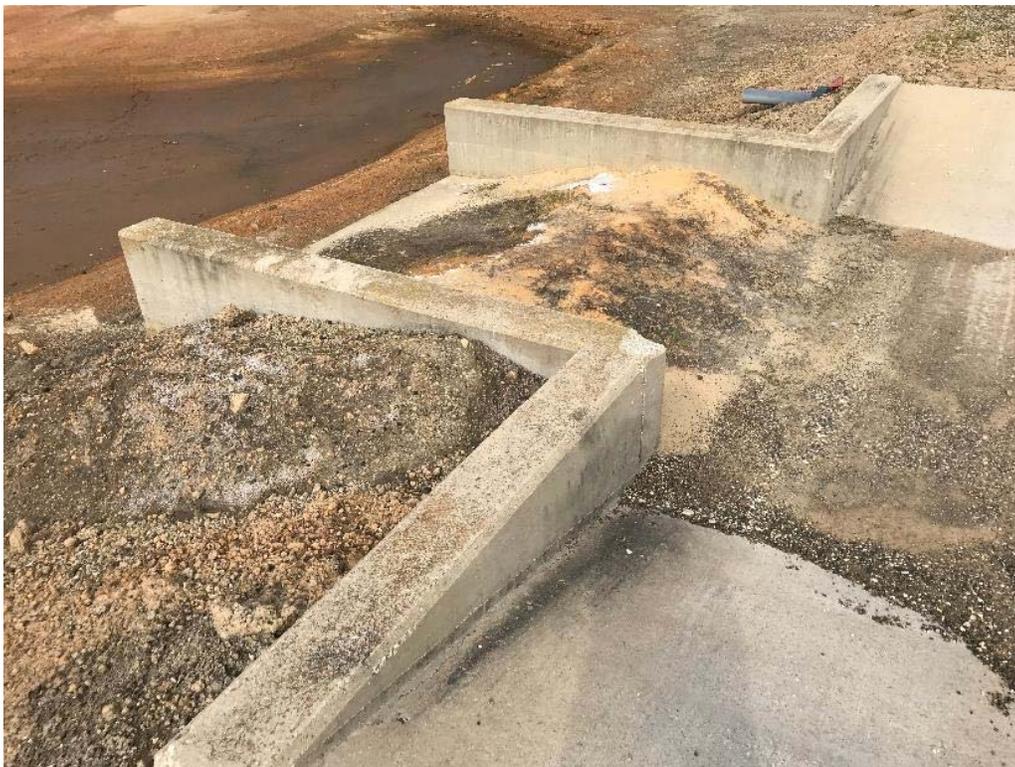
**Photograph:** 38 South SRH Pond – standing on the eastern berm – facing northwest. Spillway structure. Photo taken 12/18/18.

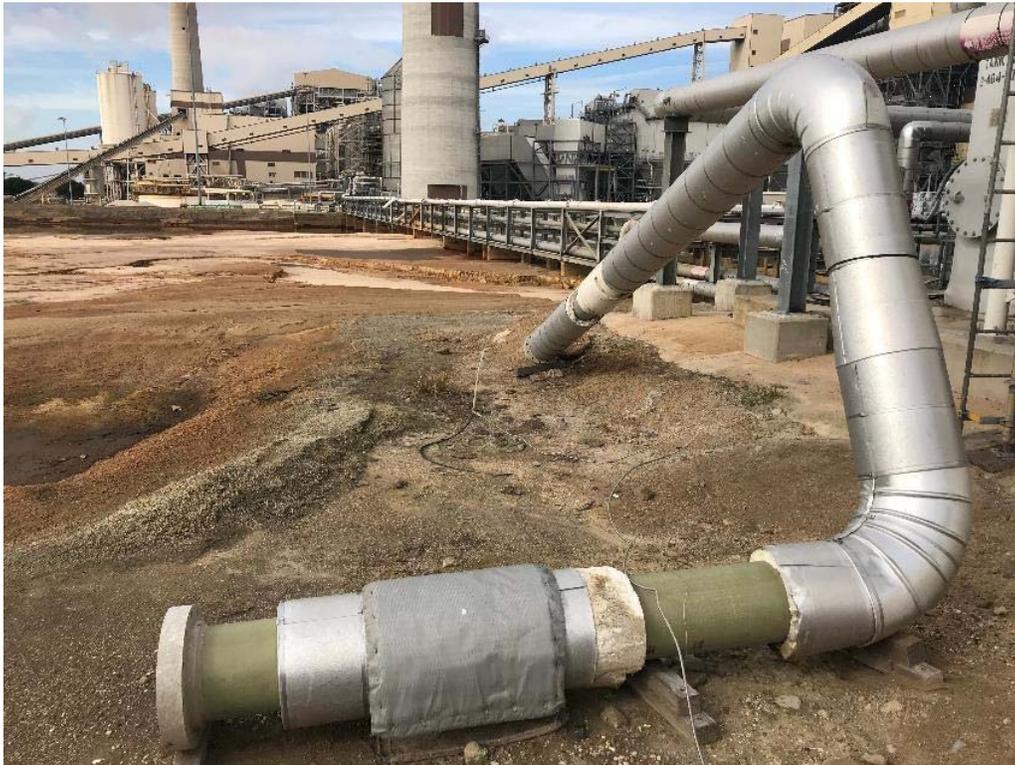
The SRH Ponds contained water at the time of the inspection. Only the North SRH Pond was in use during the inspection. The South SRH Pond appeared to be approximately 75% full with CCR solids and was not in use. The North SRH Pond appeared to have approximately 4 feet of freeboard. This corresponds to an approximate combined available capacity (including freeboard) of 9 acre-feet, with approximately 14 acre-feet of water and CCR contained.

**Photograph: 39** South SRH Pond – standing on the eastern berm – facing west. Substantially full of solids and not in use. Photo taken 12/18/18.
