## Texas Commission on Environmental Quality

### Registration Application for Coal Combustion Residuals (CCR) Waste Management

Facility Name: Calaveras Plant Site

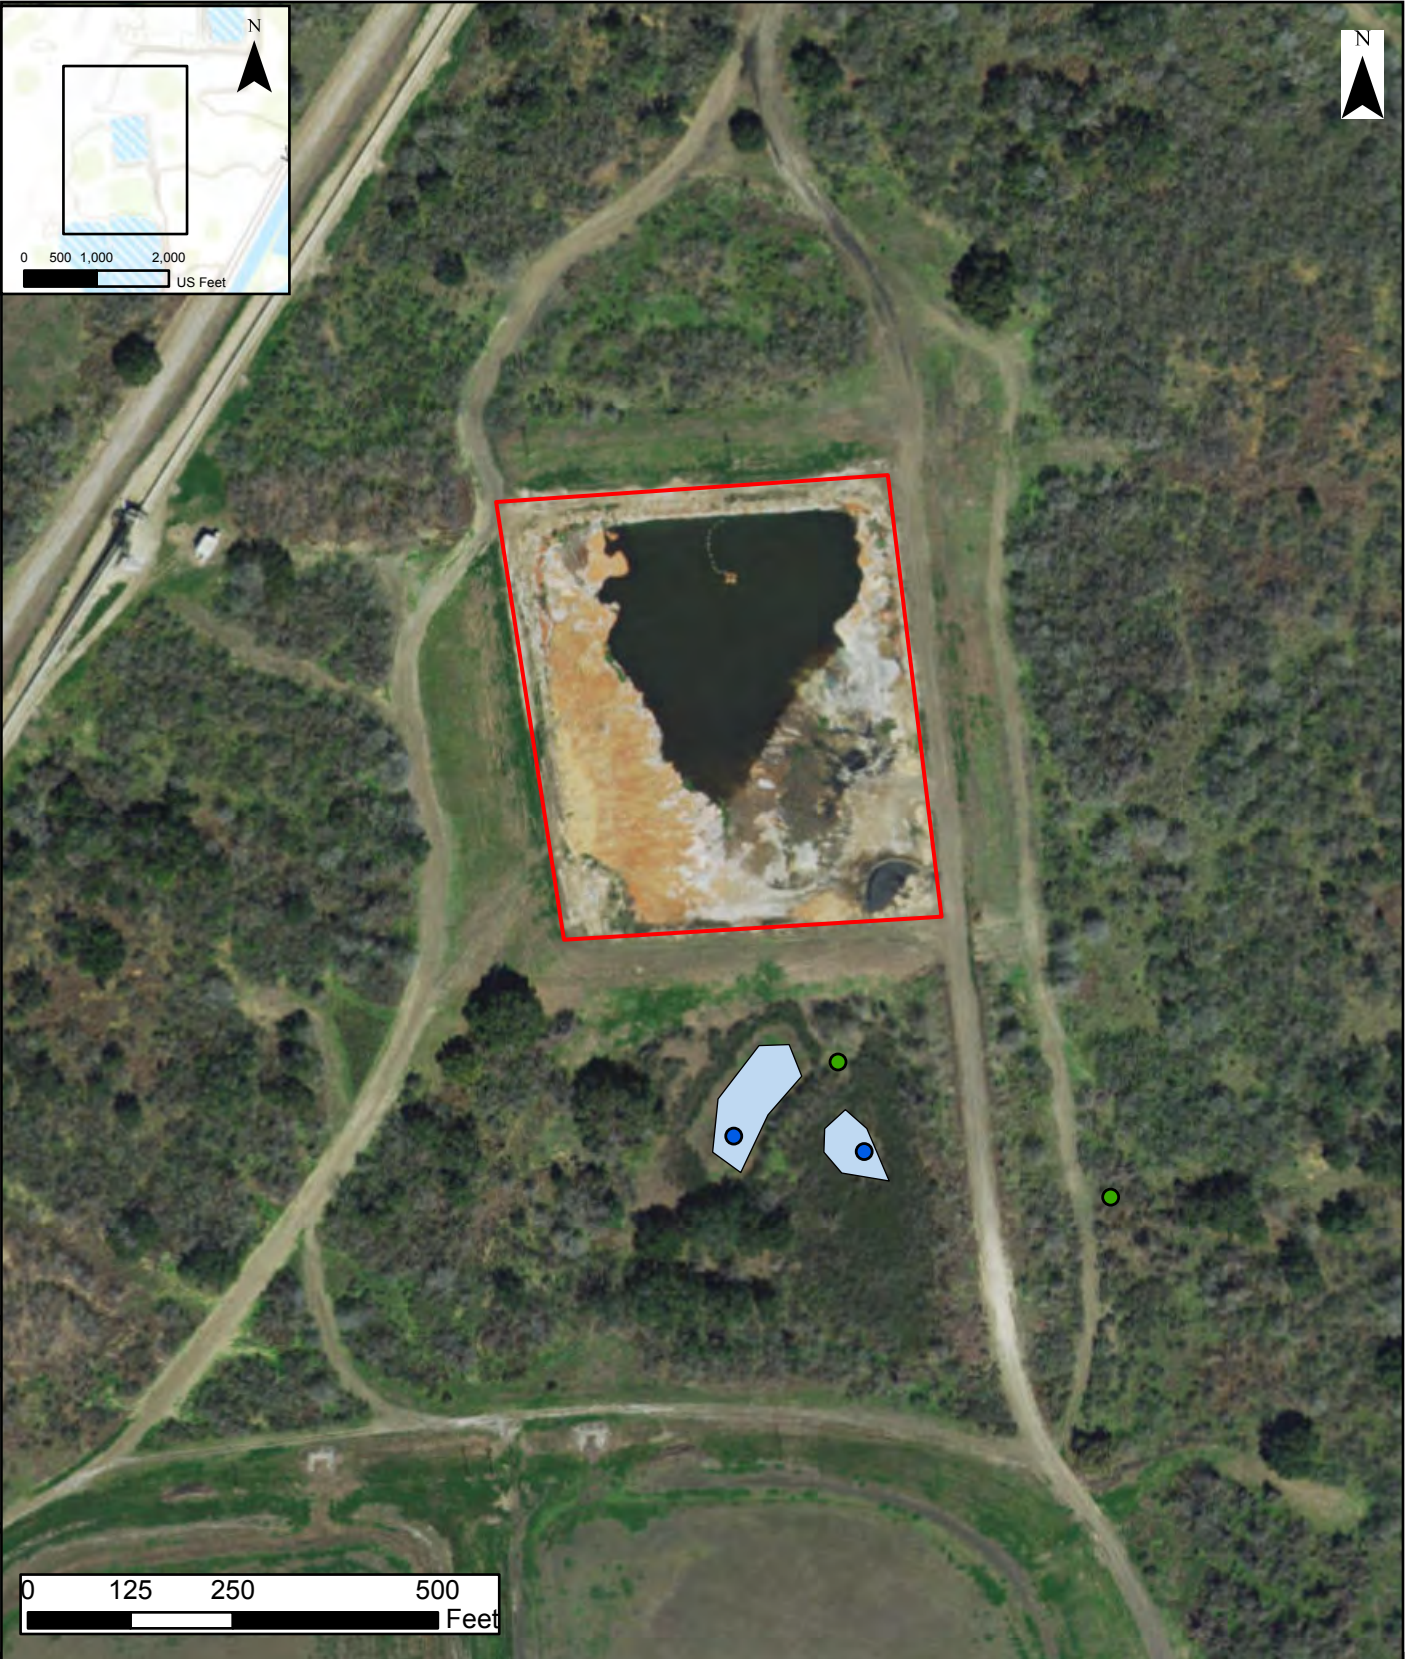
- Upland Point
- Wetland Point
- Wetland Area
- Unit Boundary

The site visit confirmed that the EP was not located in any wetlands or waterbodies. The wetland area mapped approximately 100 feet south of the buffer for the EP was observed to be two emergent wetlands within depressions resulting from excavation and berms. The wetlands appeared manmade and isolated; therefore they are expected to be non-jurisdictional.

The site visit confirmed that the BAPs were not located in any wetlands or waterbodies. A concrete-lined drainage ditch was observed approximately 50 feet south of the buffer for the South BAP. The drainage ditch is manmade and is a continuation of the non-jurisdictional drainage ditch described south of the SRH Pond. Although the east buffer of the BAPs is generally approximately 300 feet from Calaveras Lake, there is a cove located approximately 100 feet from the northeast corner of the North BAP. An approximately 6-foot fringe of wetland vegetation was observed along the edge of the water in the cove, but did not extend up towards the buffer of the North BAP.

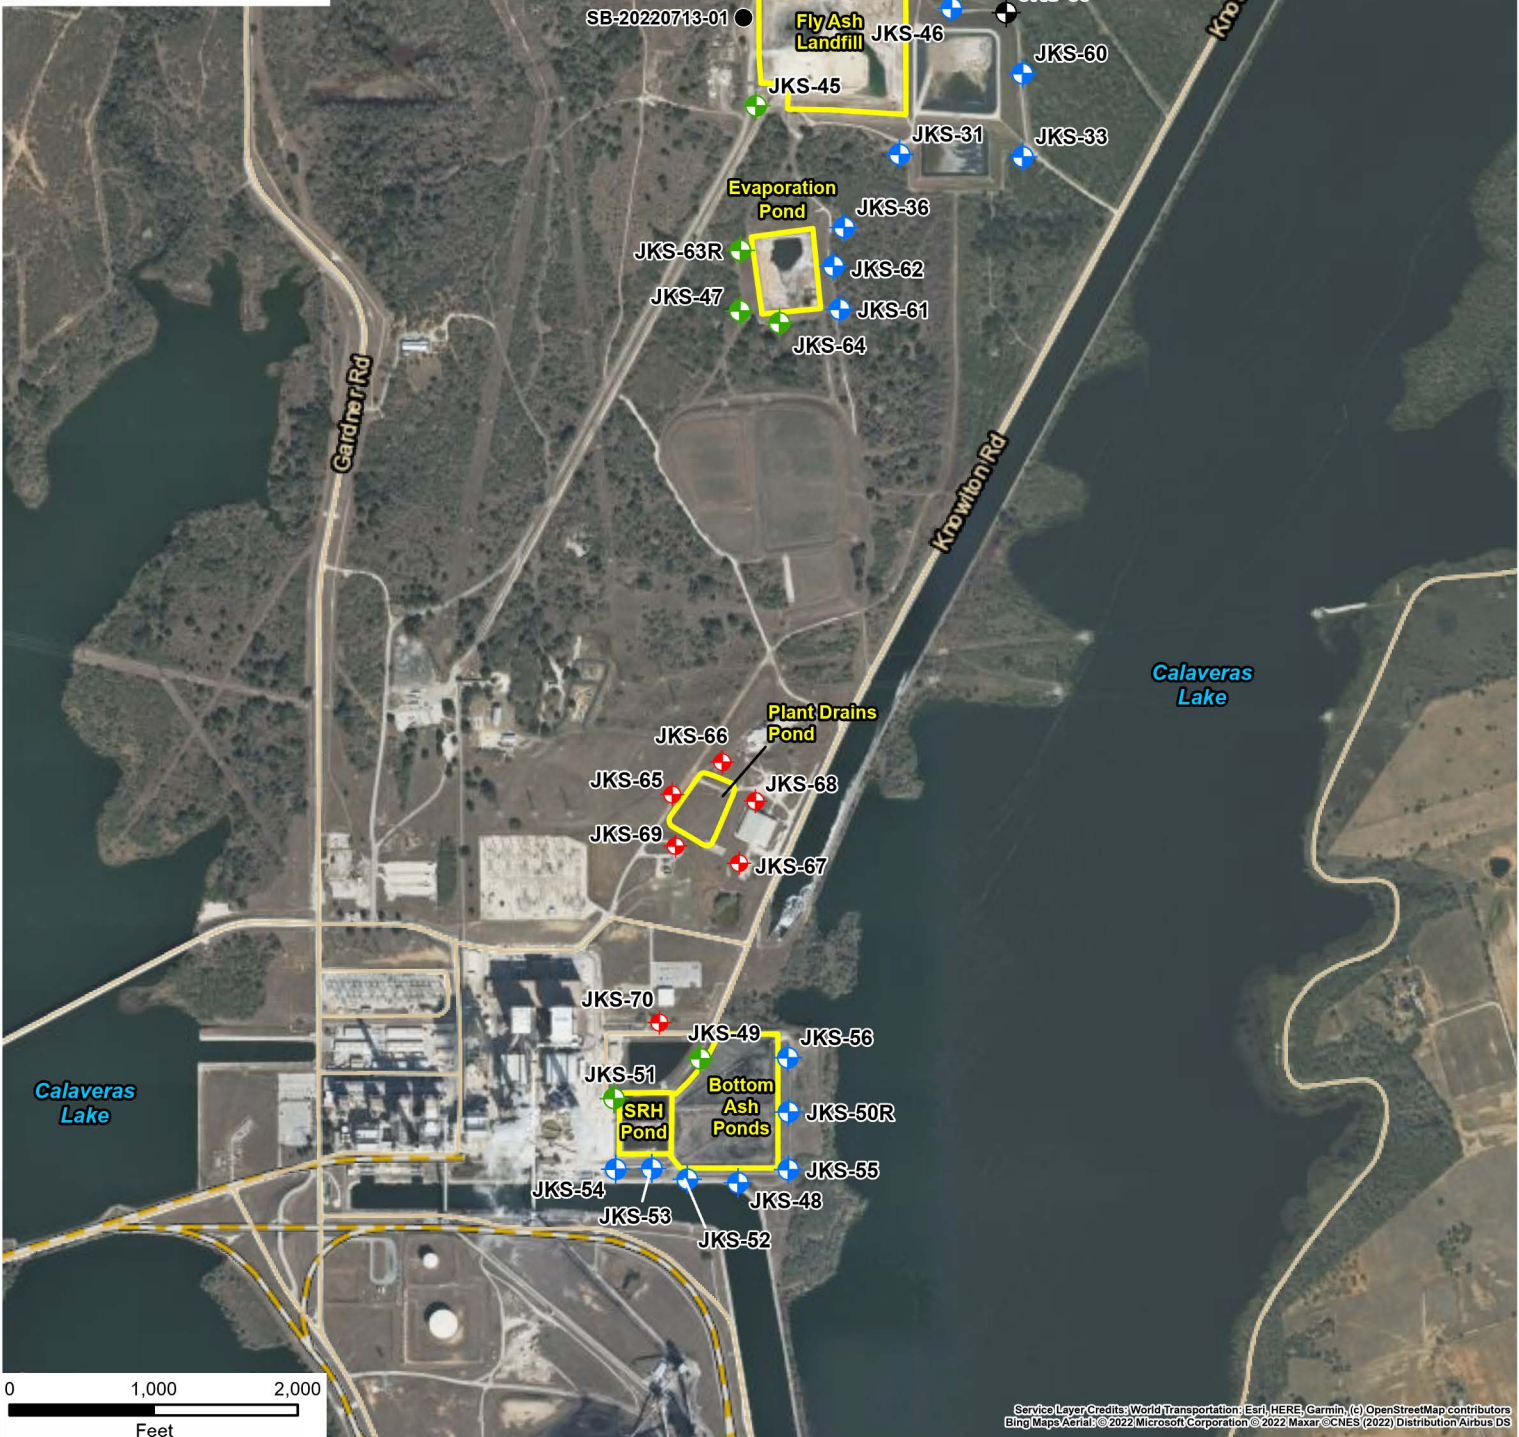
FIGURE 1  
CCR WELL NETWORK LOCATION MAP  
CPS Energy - Calaveras Power Station  
San Antonio, Texas

- Legend**
- ◆ Additional Monitor Well
  - ◆ Background Monitor Well
  - ◆ Downgradient Monitor Well
  - ◆ Groundwater Elevation Observation Well
  - Soil Boring
  - CCR Unit

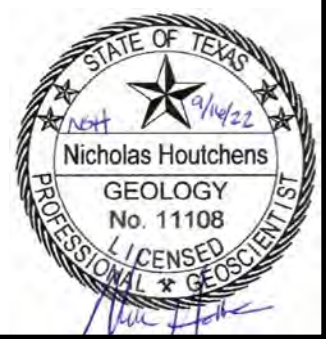
Elevation (Ft MSL)	Depth (Feet)	Graphic Log	Well Construction	Recovery (%)	Lab Sample Data	Description Interval (Feet)	Description/Soil Classification (Color, Texture, Structure)
60				100	JKS-45_60-62 USCS: Fat Clay (CH) AL: 75 / 26 / 49 -200 Sieve: 86.4 k: 1.82x10 <sup>-8</sup>		Cohesive sample (Shelby tube) collected from 60'-62' bgs.  Boring terminated at 62' bgs.
465							
65							
460							
70							
455							
75							
450							
80

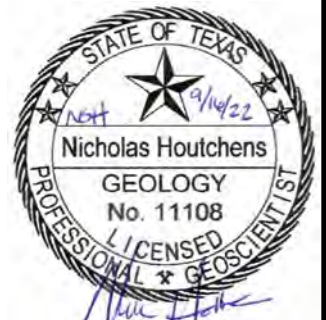
Elevation (Ft MSL)	Depth (Feet)	Graphic Log	Well Construction	Recovery (%)	Lab Sample Data	Description Interval (Feet)	Description/Soil Classification (Color, Texture, Structure)
475	20	[Dotted pattern]	[Well casing]	75	No Samples Collected	25-30	At 20' bgs: Color change to brownish tan with orange band (2" thick) at 20.25' bgs. At 21.5' bgs: Color change to tannish grey with yellowish orange band (2" thick). At 22.5' bgs: Color change to tan stratified with pinkish orange and orange.  CLAY: Dark greyish brown; damp to dry; very stiff; high to very high plasticity (fat); fractures along planar surfaces; Light grey and yellowish orange silt lenses throughout.
470	25	[Diagonal lines]	[Well casing]	100			At 29.75' bgs: Dark grey silt lenses; some very small gypsum crystals. Boring terminated at 30' bgs.
465	30						
460	35						
40

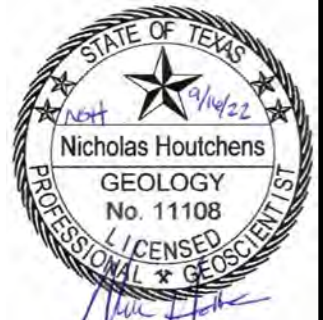
Elevation (Ft MSL)	Depth (Feet)	Graphic Log	Well Construction	Recovery (%)	Lab Sample Data	Description Interval (Feet)	Description/Soil Classification (Color, Texture, Structure)
470	40	[Dotted pattern]	[Hatched pattern]	75	No Samples Collected		At 40' bgs: Clayey sand lens (2" thick). At 40.5' bgs: Occasional pinkish brown silt stringers to 41' bgs. At 41.5' bgs: Abundant yellowish orange silt stringers to 42.5' bgs.
465	45	[Dotted pattern]	[Hatched pattern]	100			At 41.5' bgs: Orange and brown laminated silt stringers to 43' bgs.  At 44' bgs: Medium-grained; no silt content.  At 46' bgs: Orangish brown silt layer (1/2" thick). At 46.5' bgs: Color change to greyish tan; fine to medium-grained with decreasing grain size with depth.
460	50						Boring terminated at 48' bgs.
455	55						
60

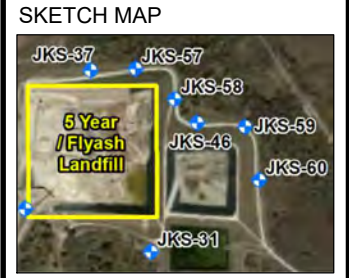
# JKS-57 DRILLING LOG

Proj. No. 0366643 Boring/Well ID JKS-57 Date Drilled 2016-09-07  
 Project Ground Water Investigation - Phase II Owner CPS Energy  
 Location Calaveras Power Station - San Antonio Boring T.D. 27.50' Boring Diam. 0.00"  
 N. Coord. 13668235.72' E. Coord. 2187486.38' Surface Elevation 503.83' Ft. MSL Datum  
 Screen: Type Sch. 40 PVC Diam. 2.00" Length 15.00' Slot Size 0.01"  
 Casing: Type Sch. 40 PVC Diam. 2.00" Length 12.00' Sump Length 0'  
 Top of Casing Elevation 506.91' Stickup 3.08'  
 Depth to Water: 1. Ft. btoc 20.07 ( 2016-05-21 ) 2. Ft. \_\_\_\_\_ ( \_\_\_\_\_ )  
 Drilling Company Strata Core Services, LLC Driller Ryan Spaust  
 Drilling Method Hollow-Stem Auger Log By Andrew Henry

Elevation (Ft MSL)	Depth (Feet)	Graphic Log	Well Construction	Recovery (%)	Lab Sample Data	Description Interval (Feet)	Description/Soil Classification (Color, Texture, Structure)
480	20			100			At 20-21' bgs: Mostly sand with yellow and trace iron-oxide staining.  At 21-21.5' bgs: 2" thick layer of reddish brown, hard-packed sand; 4" thick layer of tan, very fine grained, loose sand. At 21.5-25' bgs: Mostly dark gray clay; At 22.5' bgs: Reddish brown coloration;  At 24-25' bgs: Color is brownish gray with redox stippling.  25-25.5 SAND: Gray; fine grained; dry; medium dense; low plasticity. 25.5-27 At 25.5' bgs: Very thin (1/8" thick) brownish red coloration. INTERBEDDED CLAY AND SAND: Brownish gray clay interbedded with fine grained sand; dense; hard-packed. 27-27.5 At 26.6' bgs: Thin, tan, dry, very fine grained, sand.  SAND: Highly cemented; reddish brown nodules present.  Refusal encountered at 27.5' bgs.

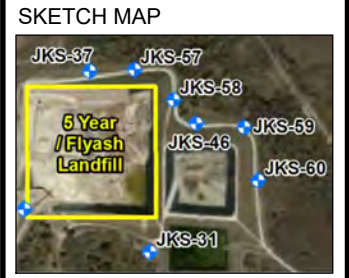
JKS-59  
DRILLING LOG

Proj. No. 0366643 Boring/Well ID JKS-59 Date Drilled 2016-09-07  
 Project Ground Water Investigation - Phase II Owner CPS Energy  
 Location Calaveras Power Station - San Antonio Boring T.D. 27.00' Boring Diam. 8.25"  
 N. Coord. 13667779.88' E. Coord. 2188352.07' Surface Elevation 493.53' Ft. MSL Datum  
 Screen: Type Sch. 40 PVC Diam. 2.00" Length 15.00' Slot Size 0.01"  
 Casing: Type Sch. 40 PVC Diam. 2.00" Length 12.00' Sump Length 0'  
 Top of Casing Elevation 496.45' Stickup 2.92'  
 Depth to Water: 1. Ft. btoc 15.49 ( 2016-05-21 ) 2. Ft. \_\_\_\_\_ ( \_\_\_\_\_ )  
 Drilling Company Strata Core Services, LLC Driller Ryan Spaust  
 Drilling Method Hollow-Stem Auger Log By Andrew Henry

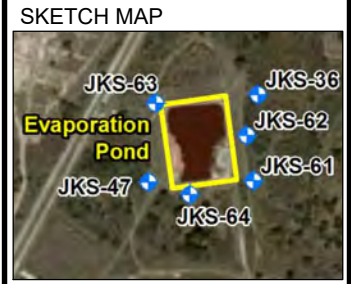
## JKS-63 DRILLING LOG

Proj. No. 0366643 Boring/Well ID JKS-63 Date Drilled 2016-09-08  
 Project Ground Water Investigation - Phase II Owner CPS Energy  
 Location Calaveras Power Station - San Antonio Boring T.D. 50.00' Boring Diam. 8.25"  
 N. Coord. 13666230.86' E. Coord. 2186553.38' Surface Elevation 523.55' Ft. MSL Datum  
 Screen: Type Sch. 40 PVC Diam. 2.00" Length 20.00' Slot Size 0.01"  
 Casing: Type Sch. 40 PVC Diam. 2.00" Length 30.00' Sump Length 0'  
 Top of Casing Elevation 526.86' Stickup 3.31'  
 Depth to Water: 1. Ft. btoc 44.70 ( 2016-05-21 ) 2. Ft. \_\_\_\_\_ ( \_\_\_\_\_ )  
 Drilling Company Strata Core Services, LLC Driller Ryan Spaust  
 Drilling Method Hollow-Stem Auger Log By Andrew Henry

Elevation (Ft MSL)	Depth (Feet)	Graphic Log	Well Construction	Recovery (%)	Lab Sample Data	Description Interval (Feet)	Description/Soil Classification (Color, Texture, Structure)
40							
480				80			
45							At 45' bgs: Moisture content increases to saturated; trace iron-oxide staining.
475				80			
50							Boring terminated at 50' bgs.
470							
55							
465							
60

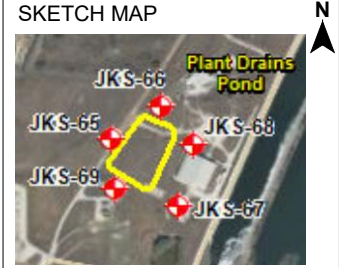
**JKS-67  
DRILLING LOG**

Proj. No. 0503422 Boring/Well ID JKS-67 Date Drilled 2020-08-18  
 Project Plant Drains Pond CCR Unit Owner CPS Energy  
 Location Calaveras Power Station Boring T.D. 25.00' Boring Diam. 8.25"  
 N. Coord. 13664200.80 E. Coord. 2186869.58 Surface Elevation 500.48' Ft. MSL Datum  
 Screen: Type Sch. 40 PVC Diam. 2.00" Length 15.00' Slot Size 0.01"  
 Casing: Type Sch. 40 PVC Diam. 2.00" Length 20.00' Sump Length 0.00'  
 Top of Casing Elevation 503.29' Stickup 2.81'  
 Depth to Water: 1. Ft. 12.00' (SB Installation) 2. Ft. \_\_\_\_\_ (\_\_\_\_\_)  
 Drilling Company Vortex Drilling Partners, LP Driller James E. Neal  
 Drilling Method Hollow-Stem Auger Log By Nick Houtchens

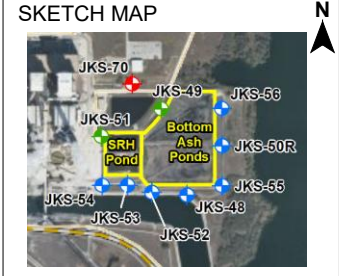
**JKS-70  
DRILLING LOG**

Proj. No. 0636109 Boring/Well ID JKS-70 Date Drilled 2022-07-12  
 Project 2022 Well Installation Owner CPS Energy  
 Location Calaveras Power Station Boring T.D. 27.00' Boring Diam. 7.25"  
 N. Coord. 13663092.09 E. Coord. 2186316.21 Surface Elevation 493.51' Ft. MSL Datum  
 Screen: Type Sch. 40 PVC Diam. 2.00" Length 15.00' Slot Size 0.01"  
 Casing: Type Sch. 40 PVC Diam. 2.00" Length 12.00' Sump Length 0.00'  
 Top of Casing Elevation 496.29' Stickup 2.78'  
 Depth to Water: 1. Ft. 15.00' ( Installation ) 2. Ft. \_\_\_\_\_ ( \_\_\_\_\_ )  
 Drilling Company Envirotech Drilling Services, LLC Driller Juan Martinez  
 Drilling Method Hollow-Stem Auger Log By Nick Houtchens

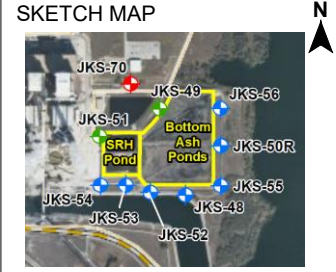
**JKS-70  
DRILLING LOG**

Proj. No. 0636109 Boring/Well ID JKS-70 Date Drilled 2022-07-12  
 Project 2022 Well Installation Owner CPS Energy  
 Location Calaveras Power Station Boring T.D. 27.00' Boring Diam. 7.25"  
 N. Coord. 13663092.09 E. Coord. 2186316.21 Surface Elevation 493.51' Ft. MSL Datum  
 Screen: Type Sch. 40 PVC Diam. 2.00" Length 15.00' Slot Size 0.01"  
 Casing: Type Sch. 40 PVC Diam. 2.00" Length 12.00' Sump Length 0.00'  
 Top of Casing Elevation 496.29' Stickup 2.78'  
 Depth to Water: 1. Ft. 15.00' ( Installation ) 2. Ft. \_\_\_\_\_ ( \_\_\_\_\_ )  
 Drilling Company Envirotech Drilling Services, LLC Driller Juan Martinez  
 Drilling Method Hollow-Stem Auger Log By Nick Houtchens

Elevation (Ft MSL)	Depth (Feet)	Graphic Log	Well Construction	Lab Sample Data	Description Interval (Feet)	Description/Soil Classification (Color, Texture, Structure)
473.51	20				20.8-22.0 22.0-27.0	At 20.4' bgs: Abundant orange silt stringers. SILTY CLAYEY SAND: Brown, wet, loose, very fine grained, sub-angular, abundant dark brown silt stringers, no odor. SAND: Light greyish brown, wet, very dense, very fine grained, well sorted, sub-angular, trace dark brown silt stringers, no odor.
468.51	25					At 25.0' bgs: Saturated.
466.51						At 27.0' bgs: Drilling refusal (possible bedrock).
	30					
	35					
	40

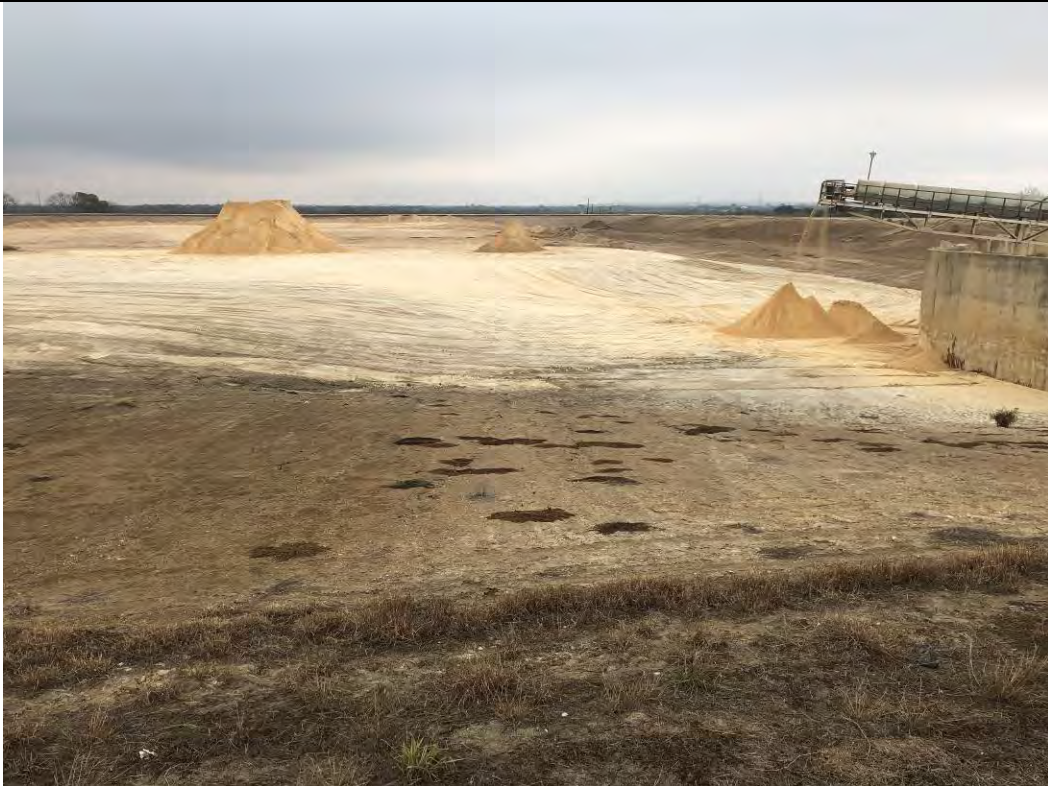
**Photograph: 1** Fly Ash Landfill – standing on west berm – facing east. Radial stacker located in southwest corner of landfill. Photo taken 12/15/2020.

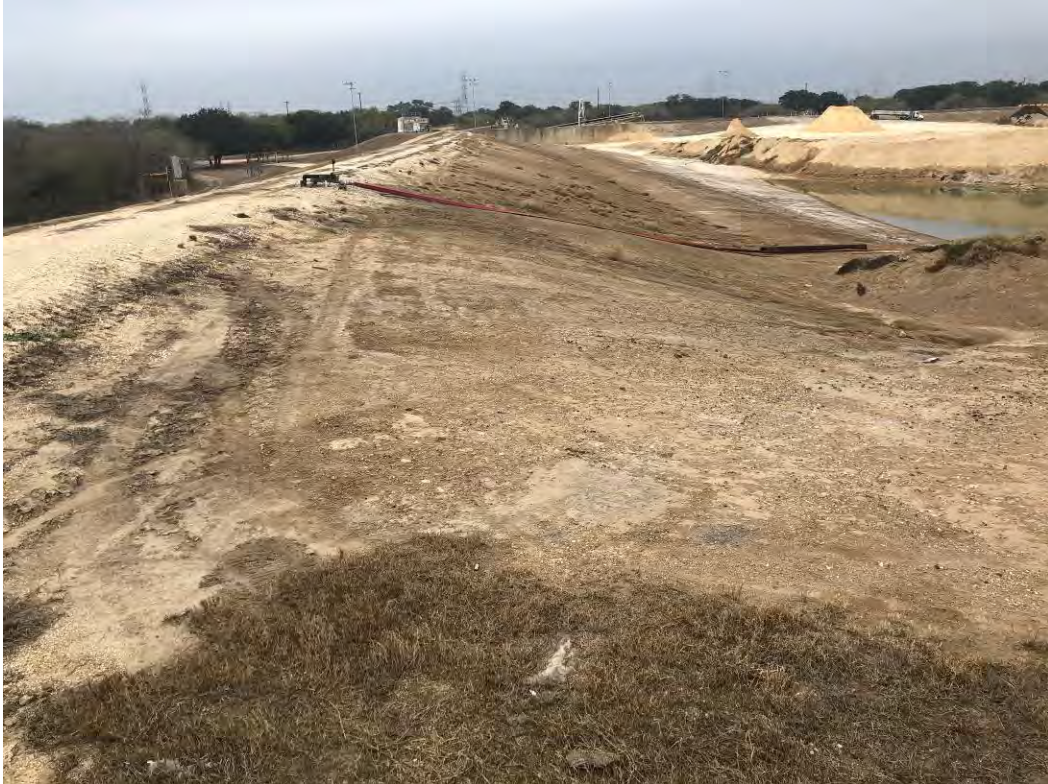
**Photograph: 5** Fly Ash Landfill – standing on southeast corner – facing west. Radial stacker located in southwest corner and stormwater discharge piping in southeast corner of landfill. Photo taken 12/15/2020.

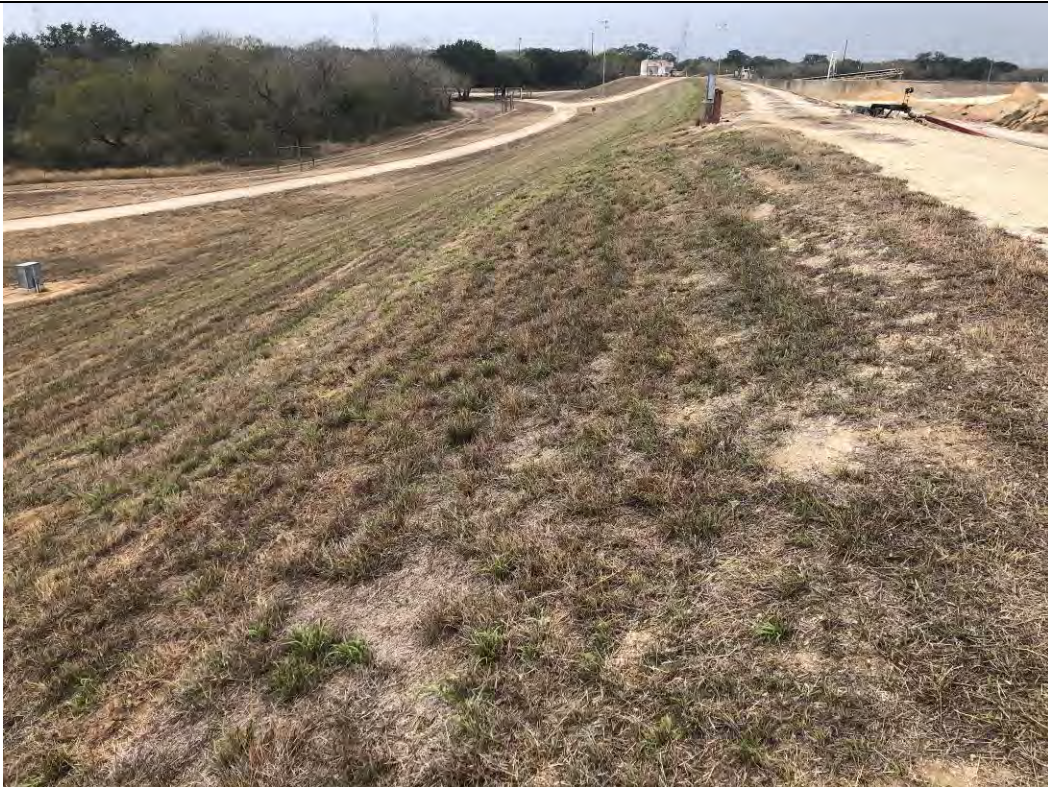
**Photograph: 6** Fly Ash Landfill – standing on southeast corner – facing west. Radial stacker located in southwest corner and stormwater discharge piping in southeast corner of landfill. Photo taken 12/15/2020.

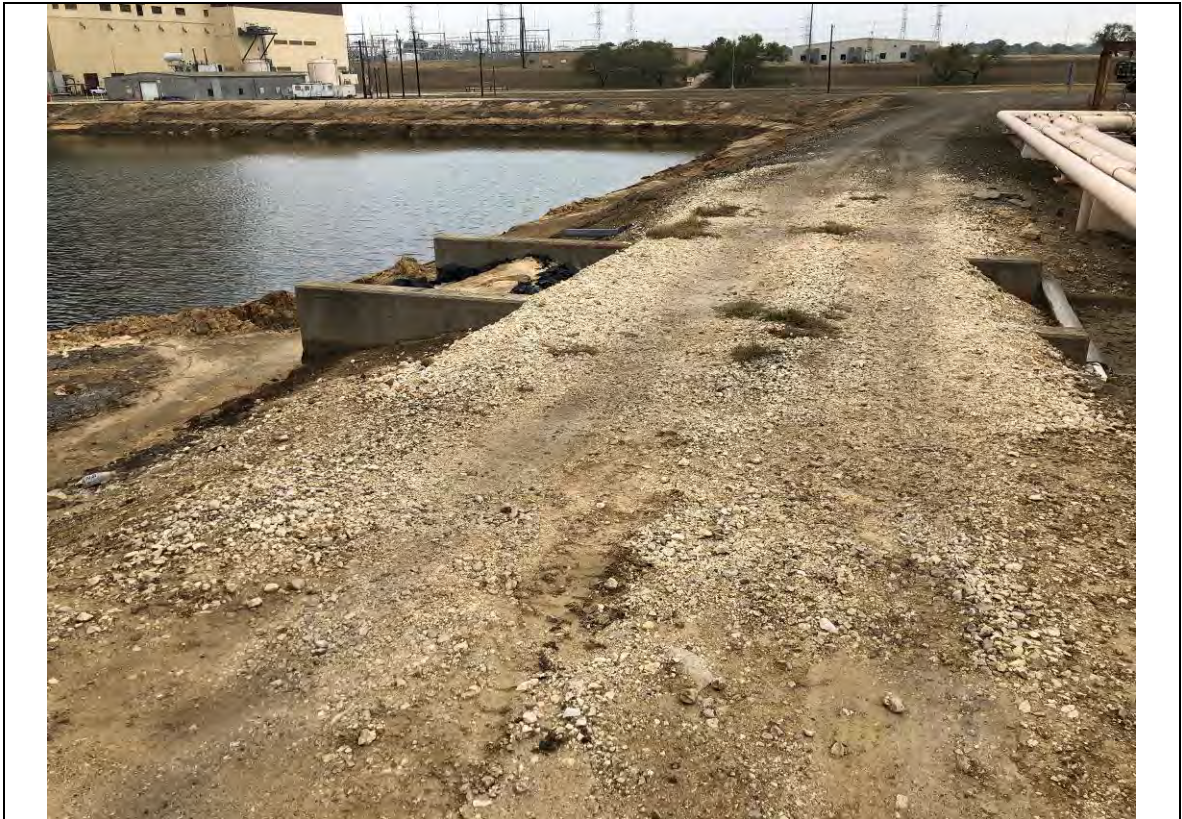
**Photograph: 29** North SRH Pond – standing on southeast corner – facing north. Spillway structure. Photo taken 12/15/2020.

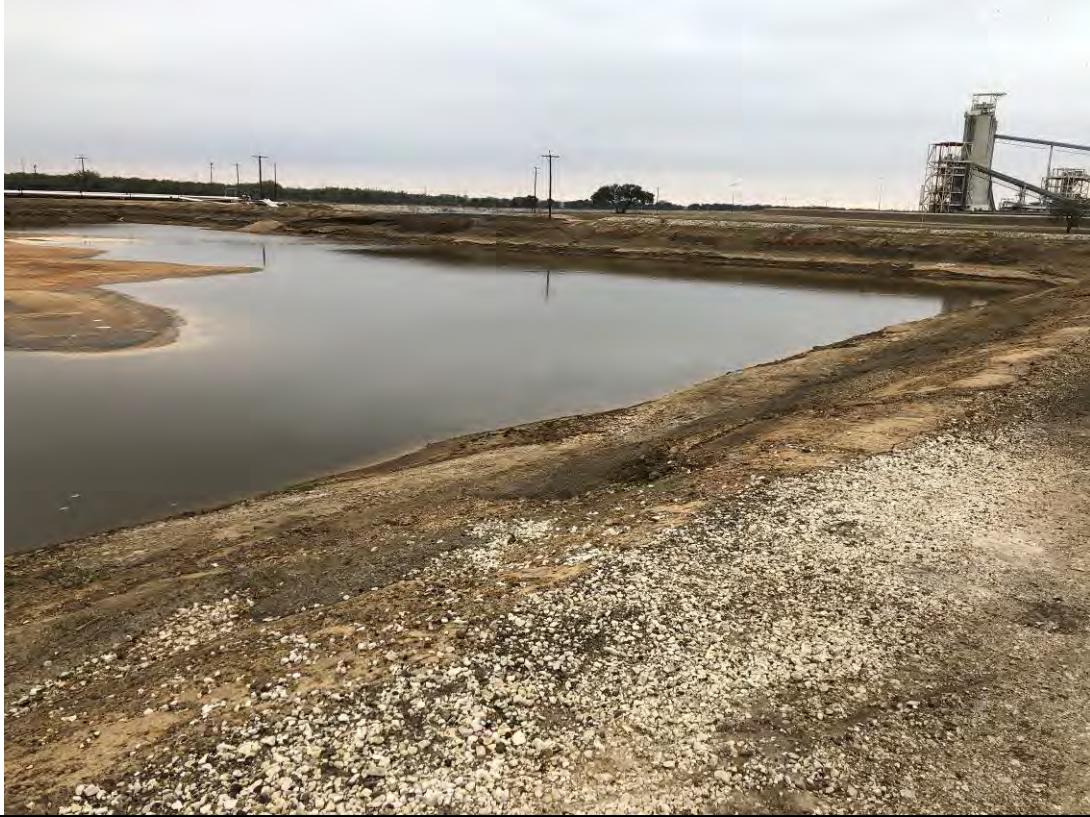
**Photograph: 31** South SRH Pond – standing on the northwest corner – facing southeast. Photo taken 12/15/2020.

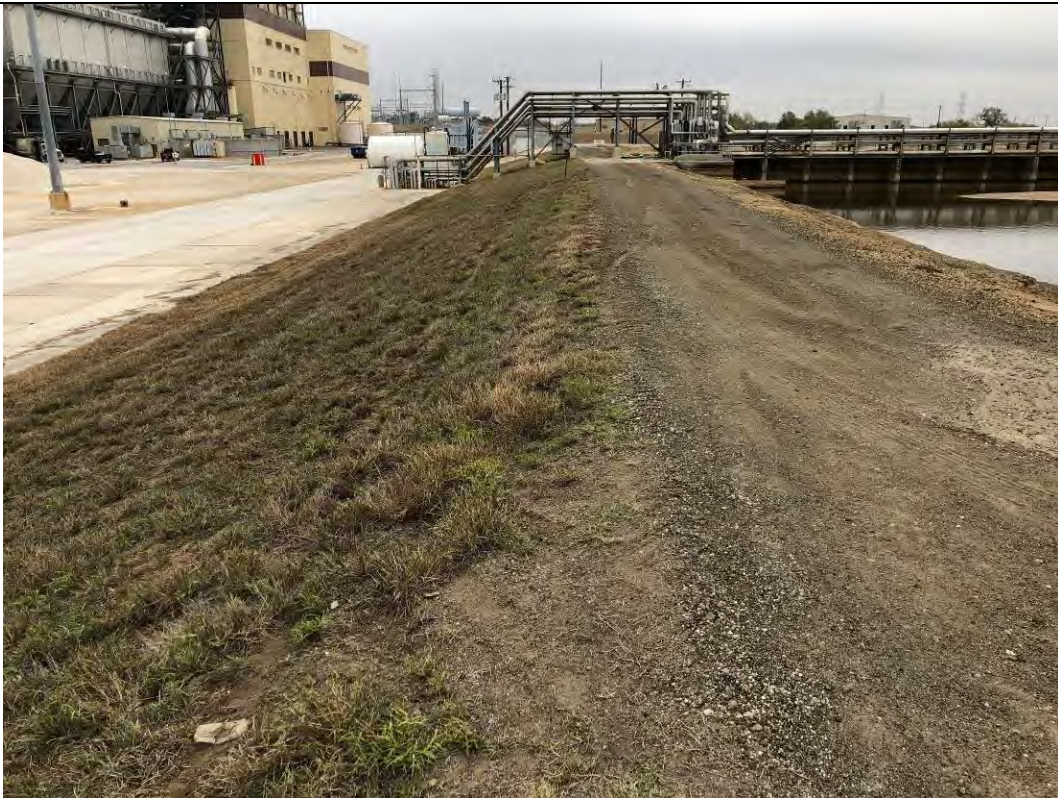
**Photograph: 32** South SRH Pond – standing on the southwest corner – facing north. Photo taken 12/15/2020.

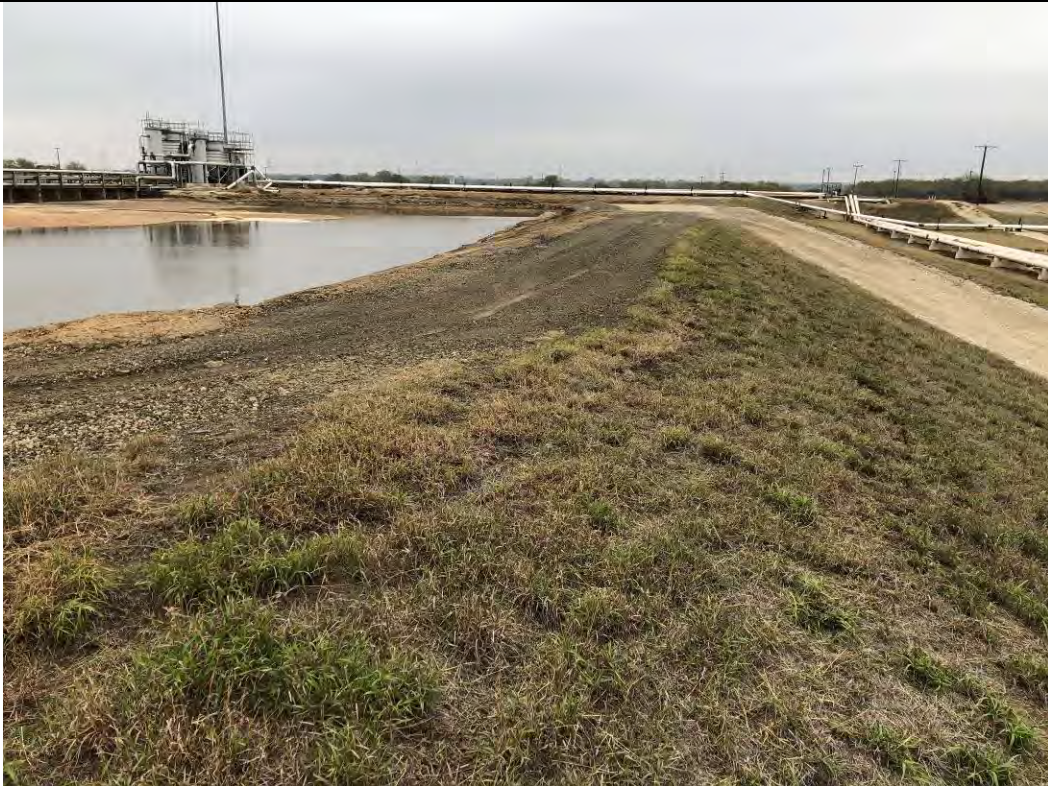
**Photograph: 33** South SRH Pond – standing on the southwest corner – facing east. Photo taken 12/15/2020.

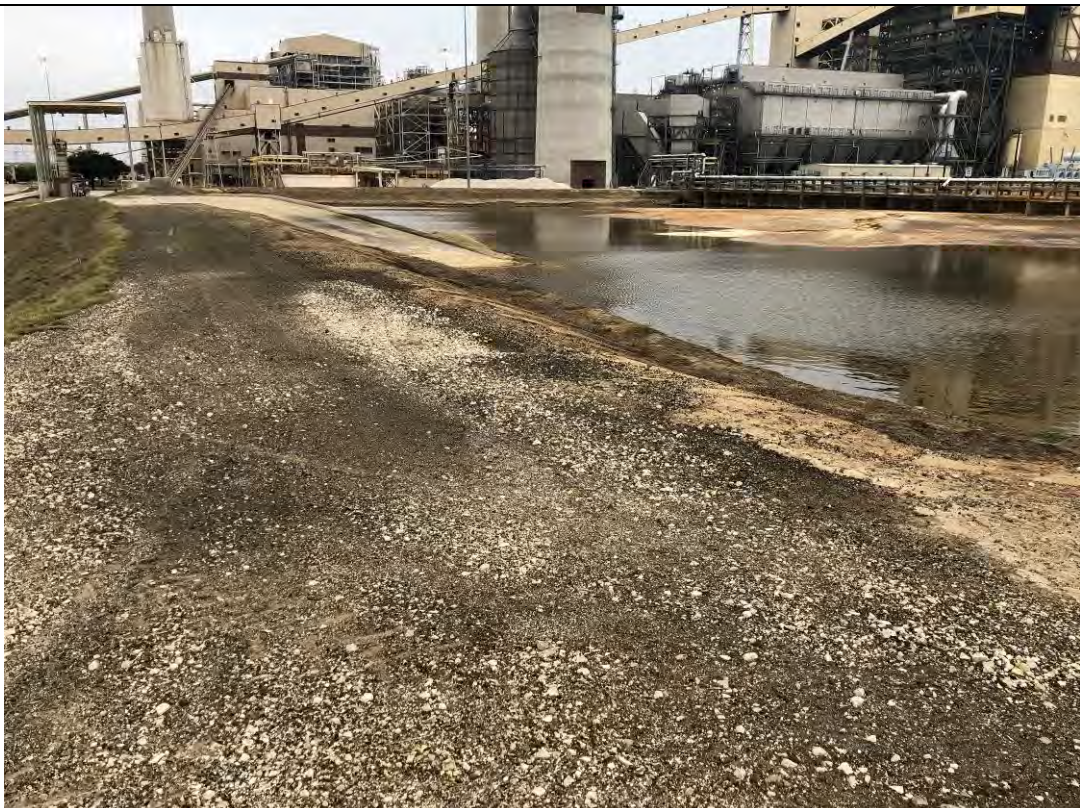
**Photograph: 34** South SRH Pond – standing on the southeast corner – facing west. Photo taken 12/15/2020.

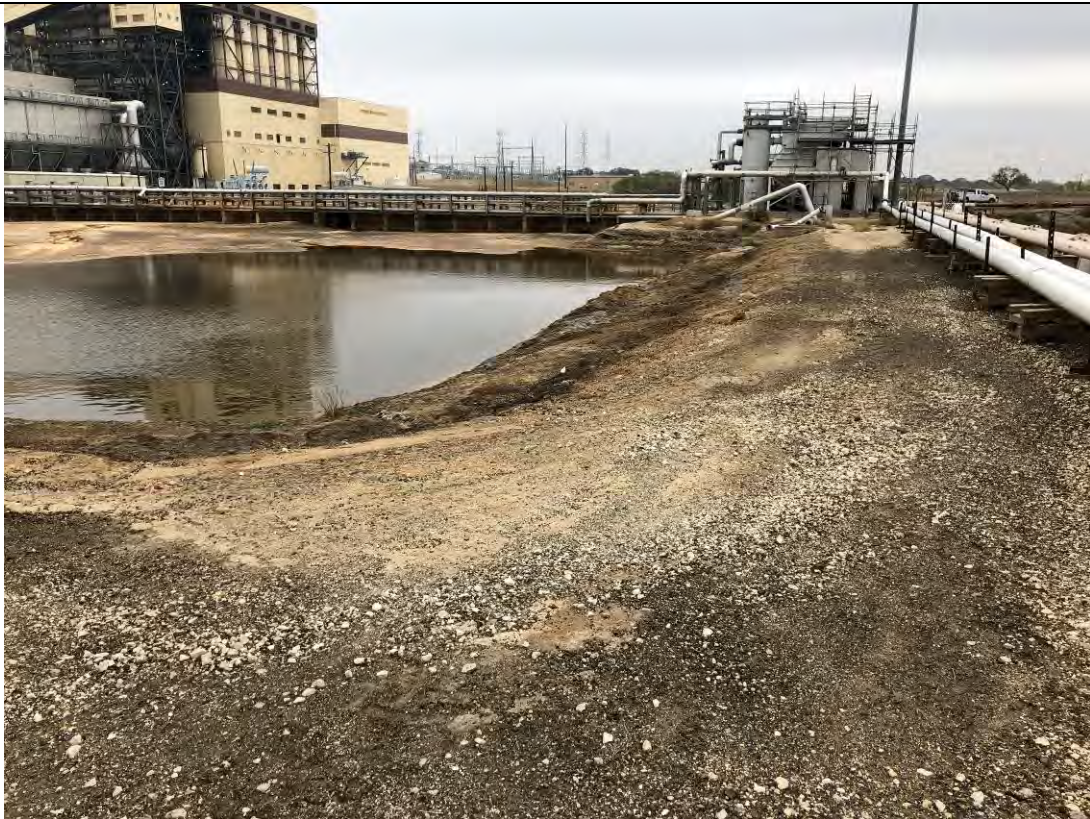
**Photograph: 35** South SRH Pond – standing on northwest corner – facing south. Photo taken 12/15/2020.

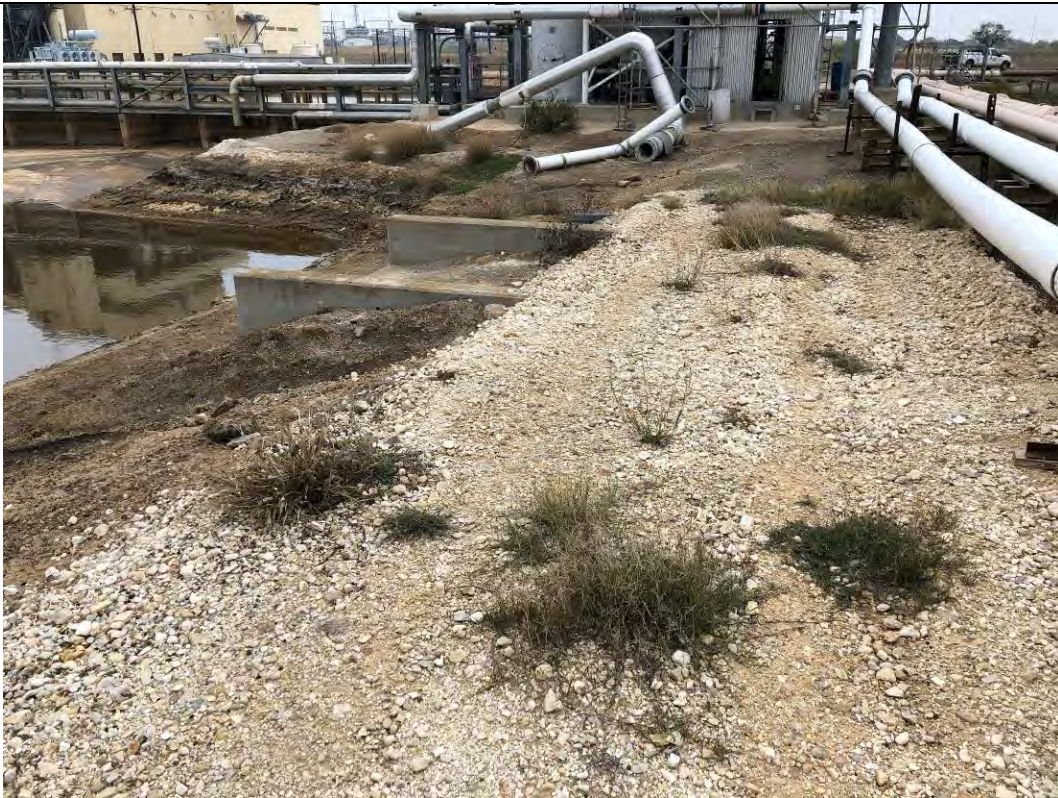
**Photograph: 36** South SRH Pond – standing on east corner – facing north. Spillway structure. Photo taken 12/15/2020.

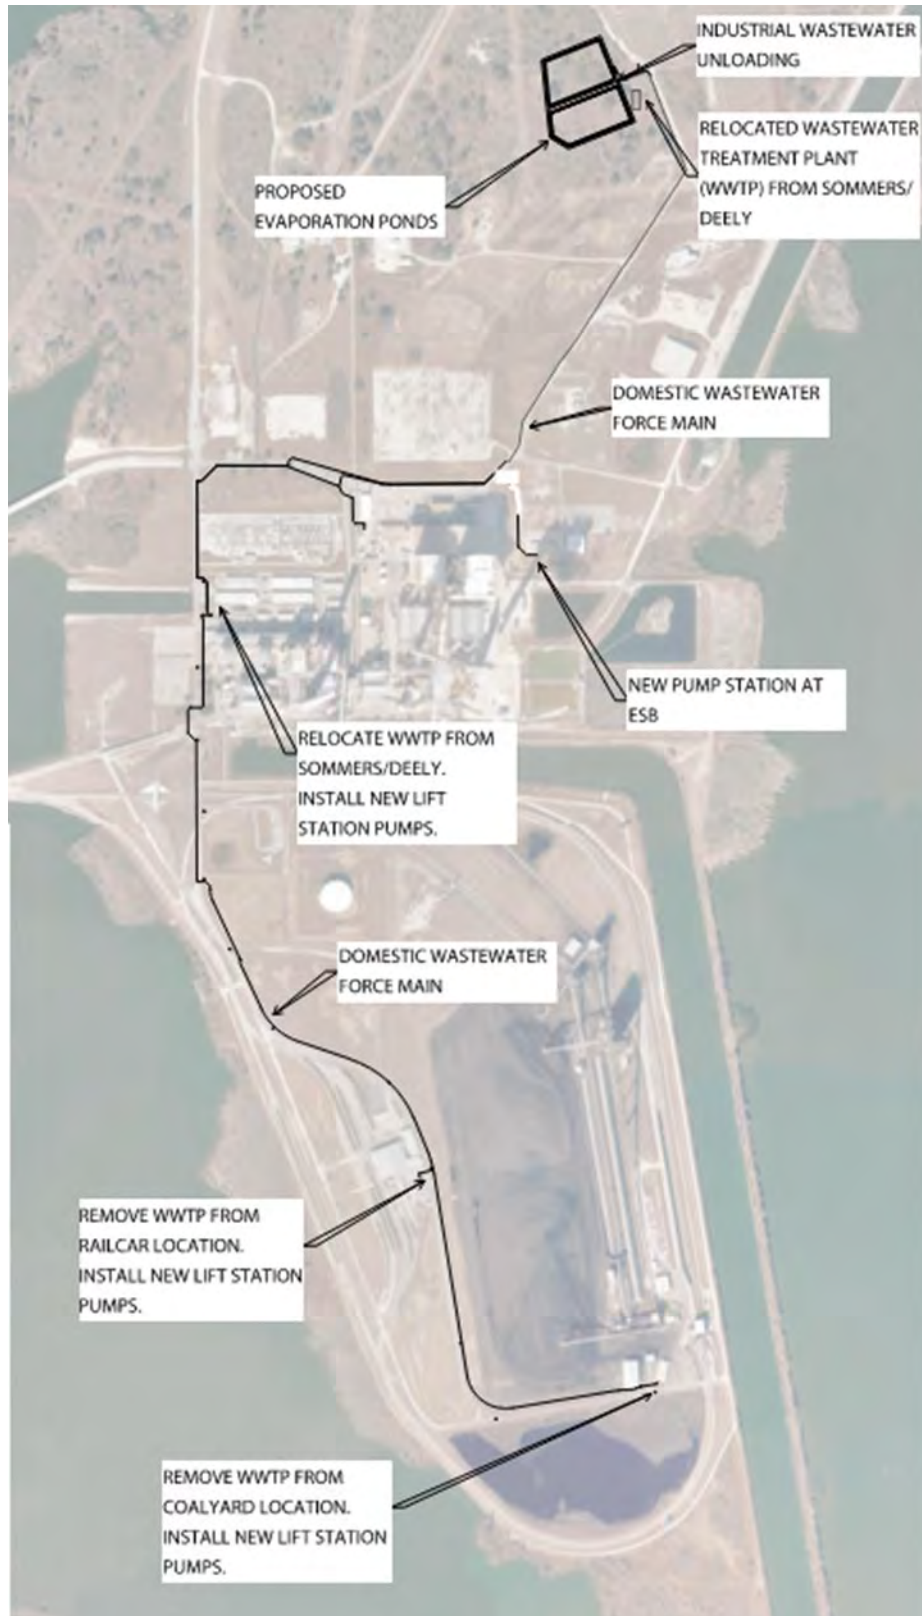
### Exhibit 3.4: Proposed Site Plan

- Construction of the new EP to store and treat domestic wastewater and industrial wastestreams. The preliminary footprint is approximately 6.5 acres and consists of two cells to assist with pond maintenance. The new EP will be constructed with a liner system that will be compliant with State requirements.
- Redirection of the existing industrial wastestreams to the new EP.
- Commencement of closure of the existing EP.
- Consolidation of domestic wastewater flows from the four existing WWTPs. A PFD of the proposed improvements for the domestic waste is shown as Exhibit 3-3. New pumps will be provided at each existing WWTP for pumping from the various units to the Sommers/Deely WWTP. A preliminary force main alignment is shown on Exhibit 3-4; however, the Sommers/Deely WWTP will be relocated to be adjacent to the new EP.
- Direction of WWTP flows to the new EP.

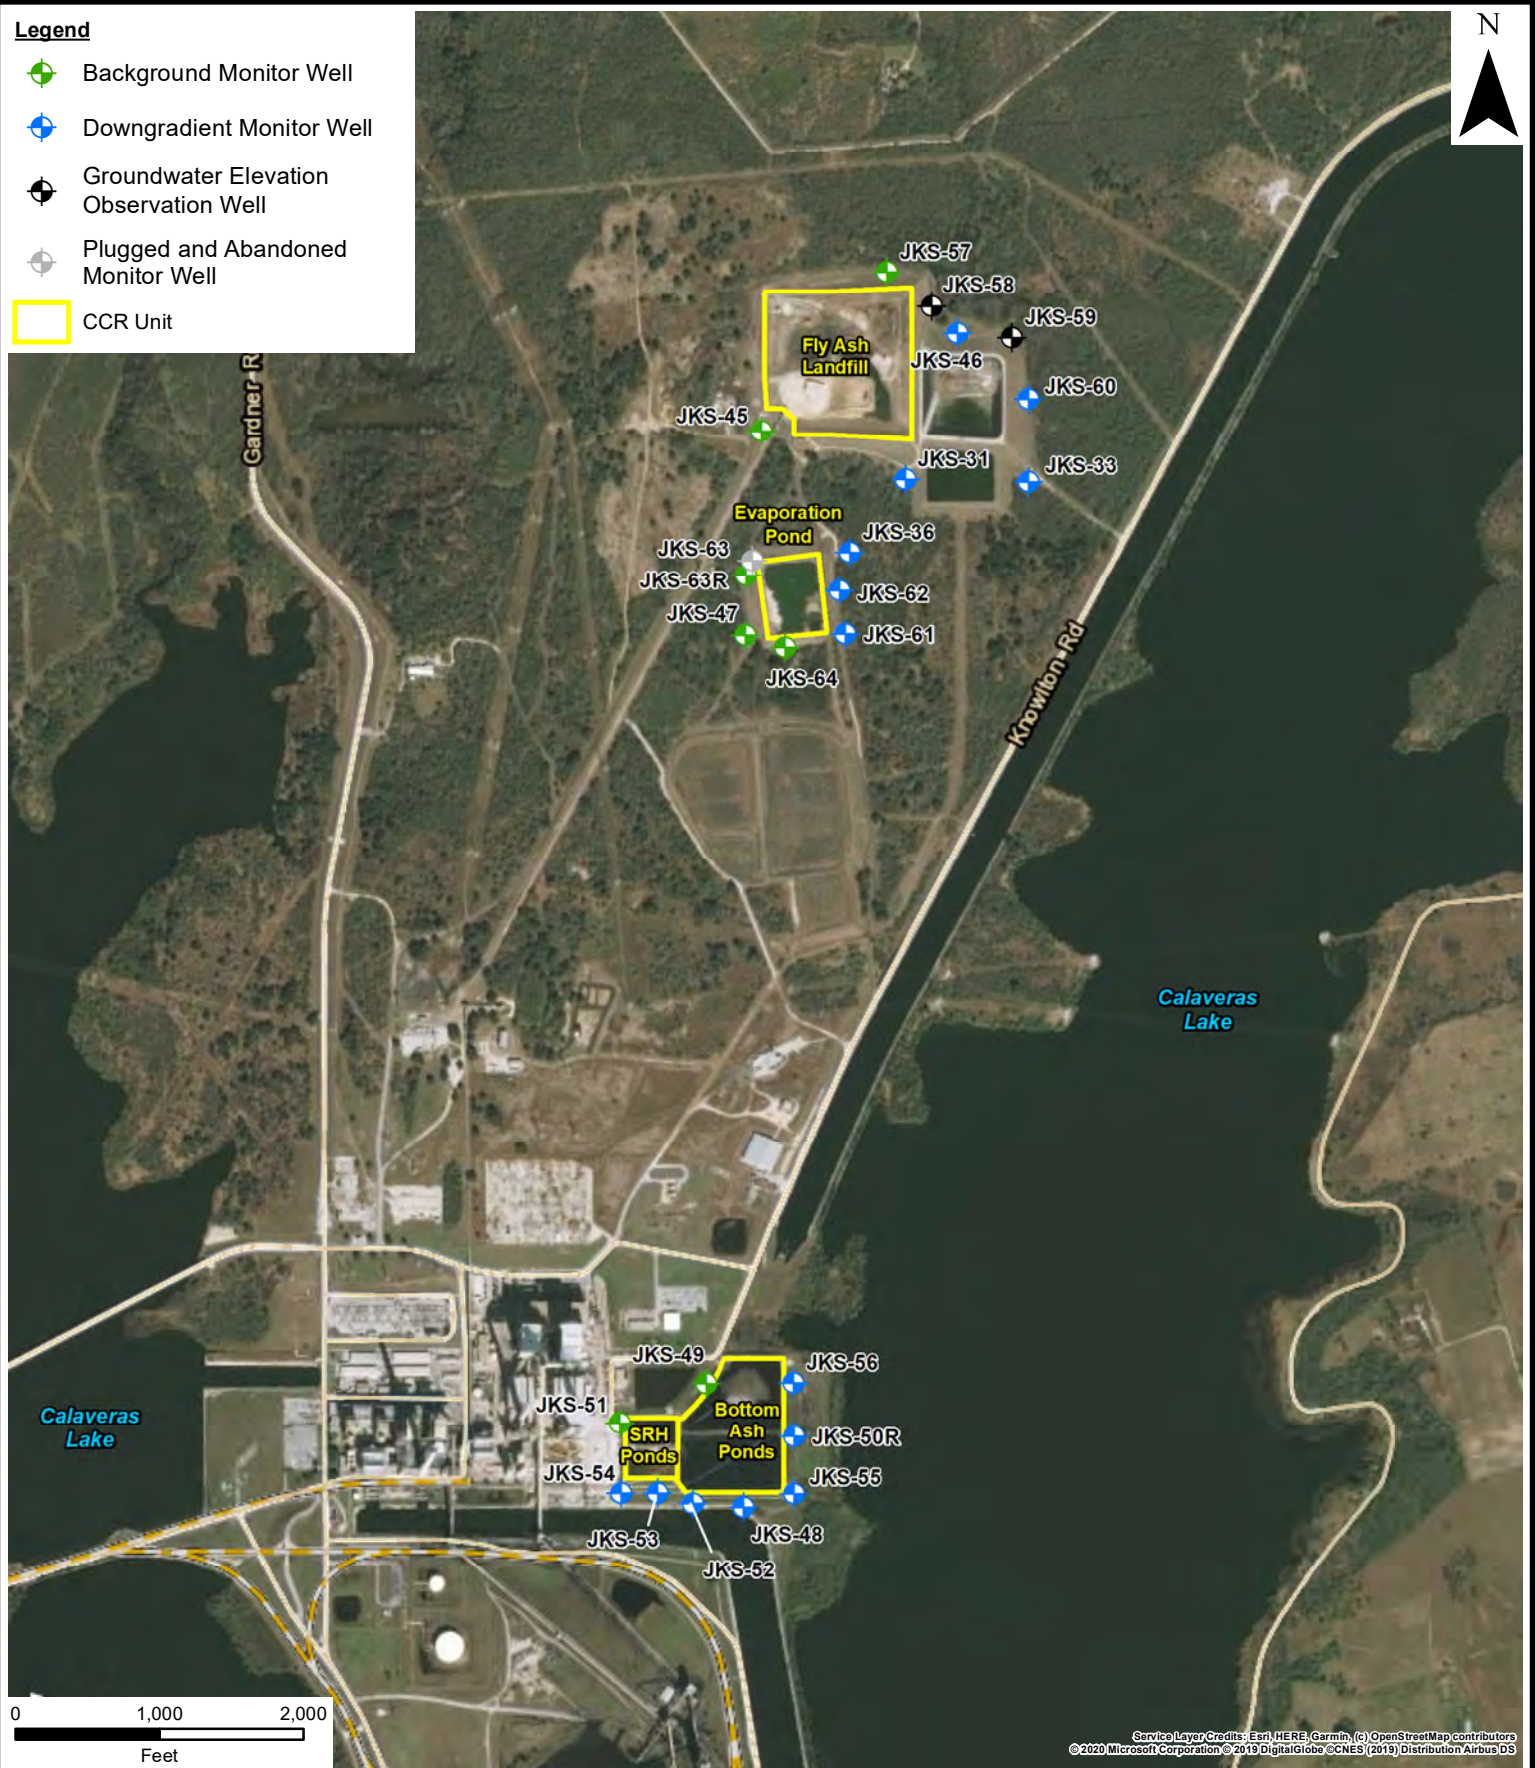
FIGURE 1  
CCR WELL NETWORK LOCATION MAP  
CPS Energy - Calaveras Power Station  
San Antonio, Texas
