## Texas Commission on Environmental Quality

### Registration Application for Coal Combustion Residuals (CCR) Waste Management

Facility Name: Calaveras Plant Site

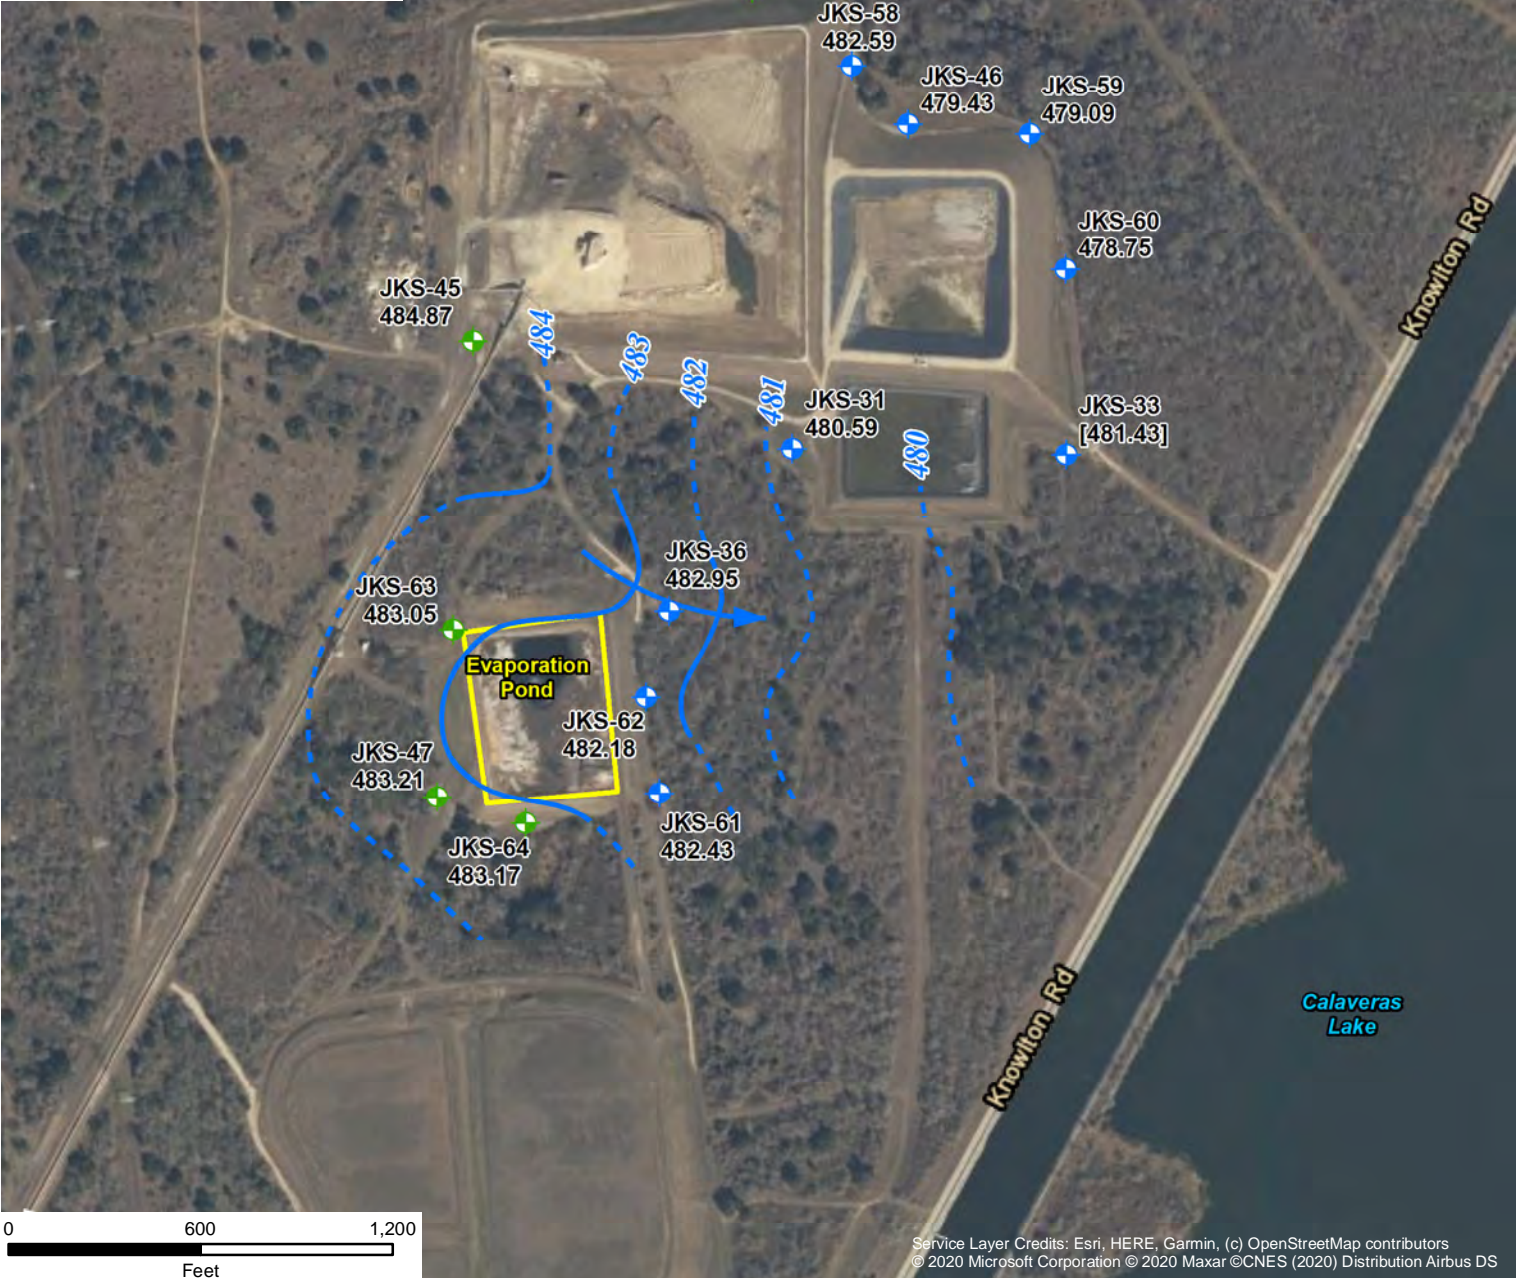
POTENTIOMETRIC SURFACE MAP -  
APRIL 2018  
Evaporation Pond CCR Unit  
CPS Energy - Calaveras Power Station  
San Antonio, Texas

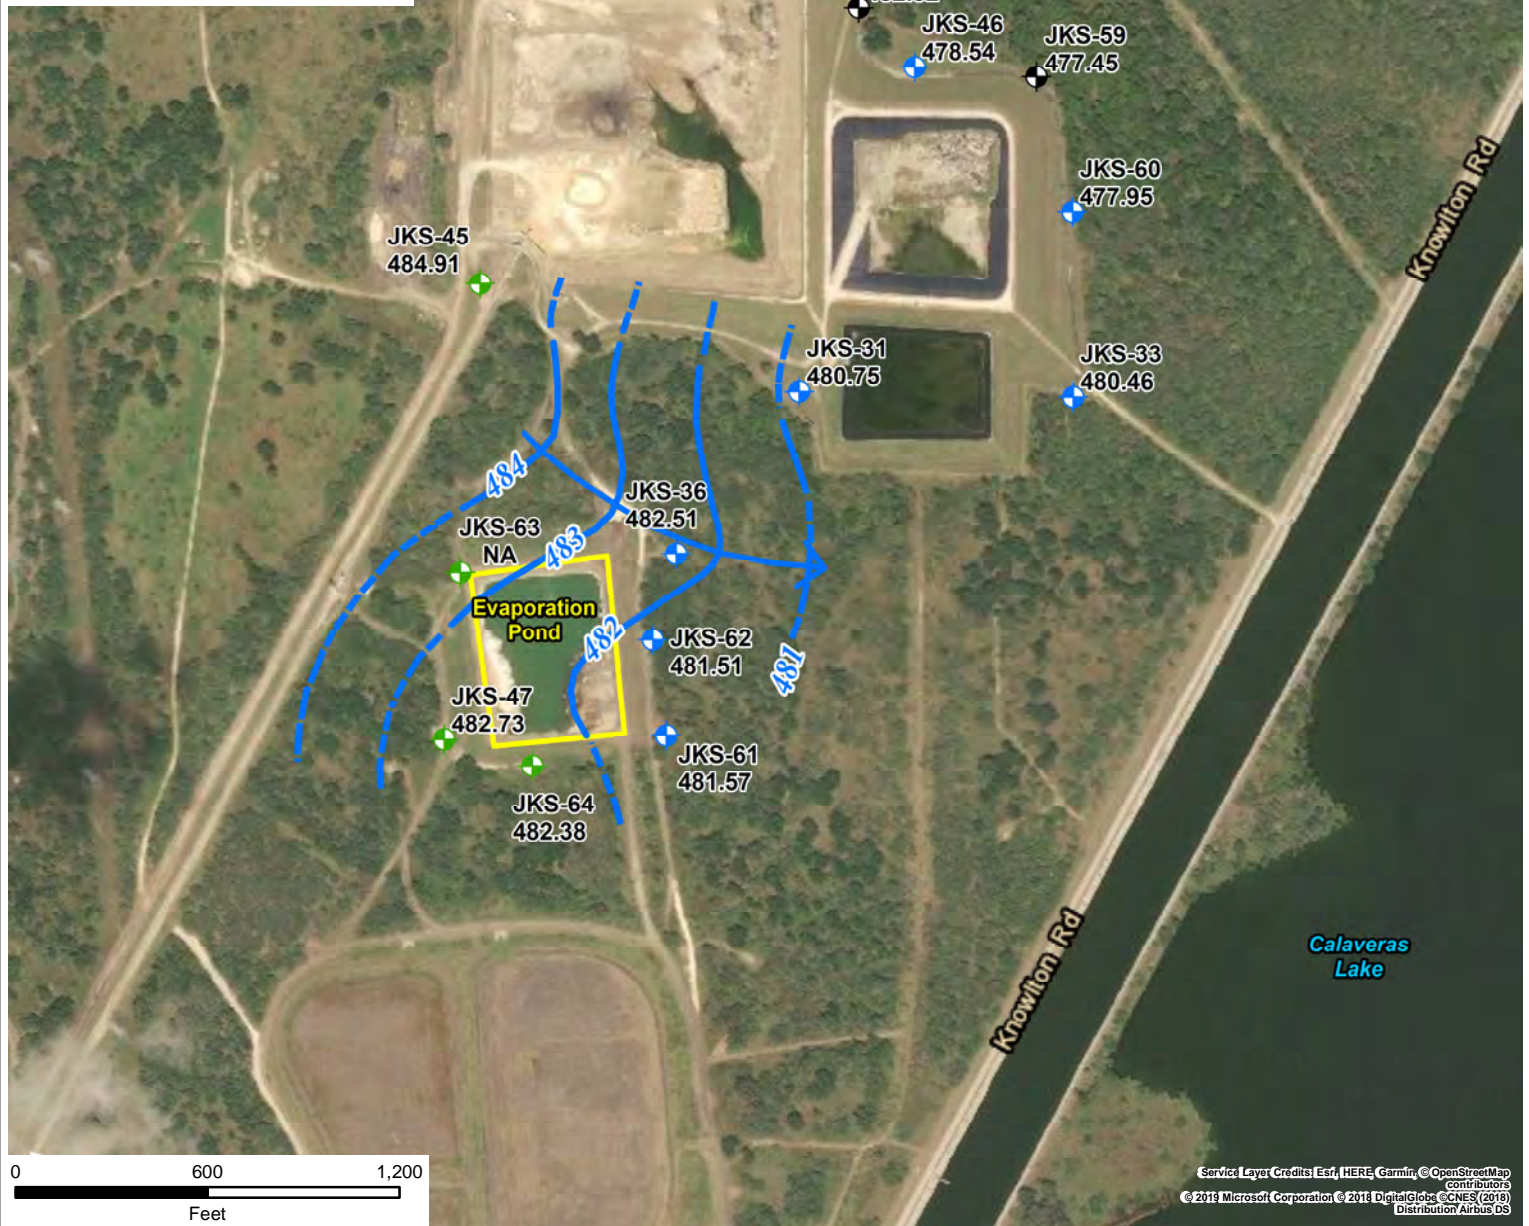
POTENTIOMETRIC SURFACE MAP -  
 OCTOBER 2018  
 Evaporation Pond CCR Unit  
 CPS Energy - Calaveras Power Station  
 San Antonio, Texas

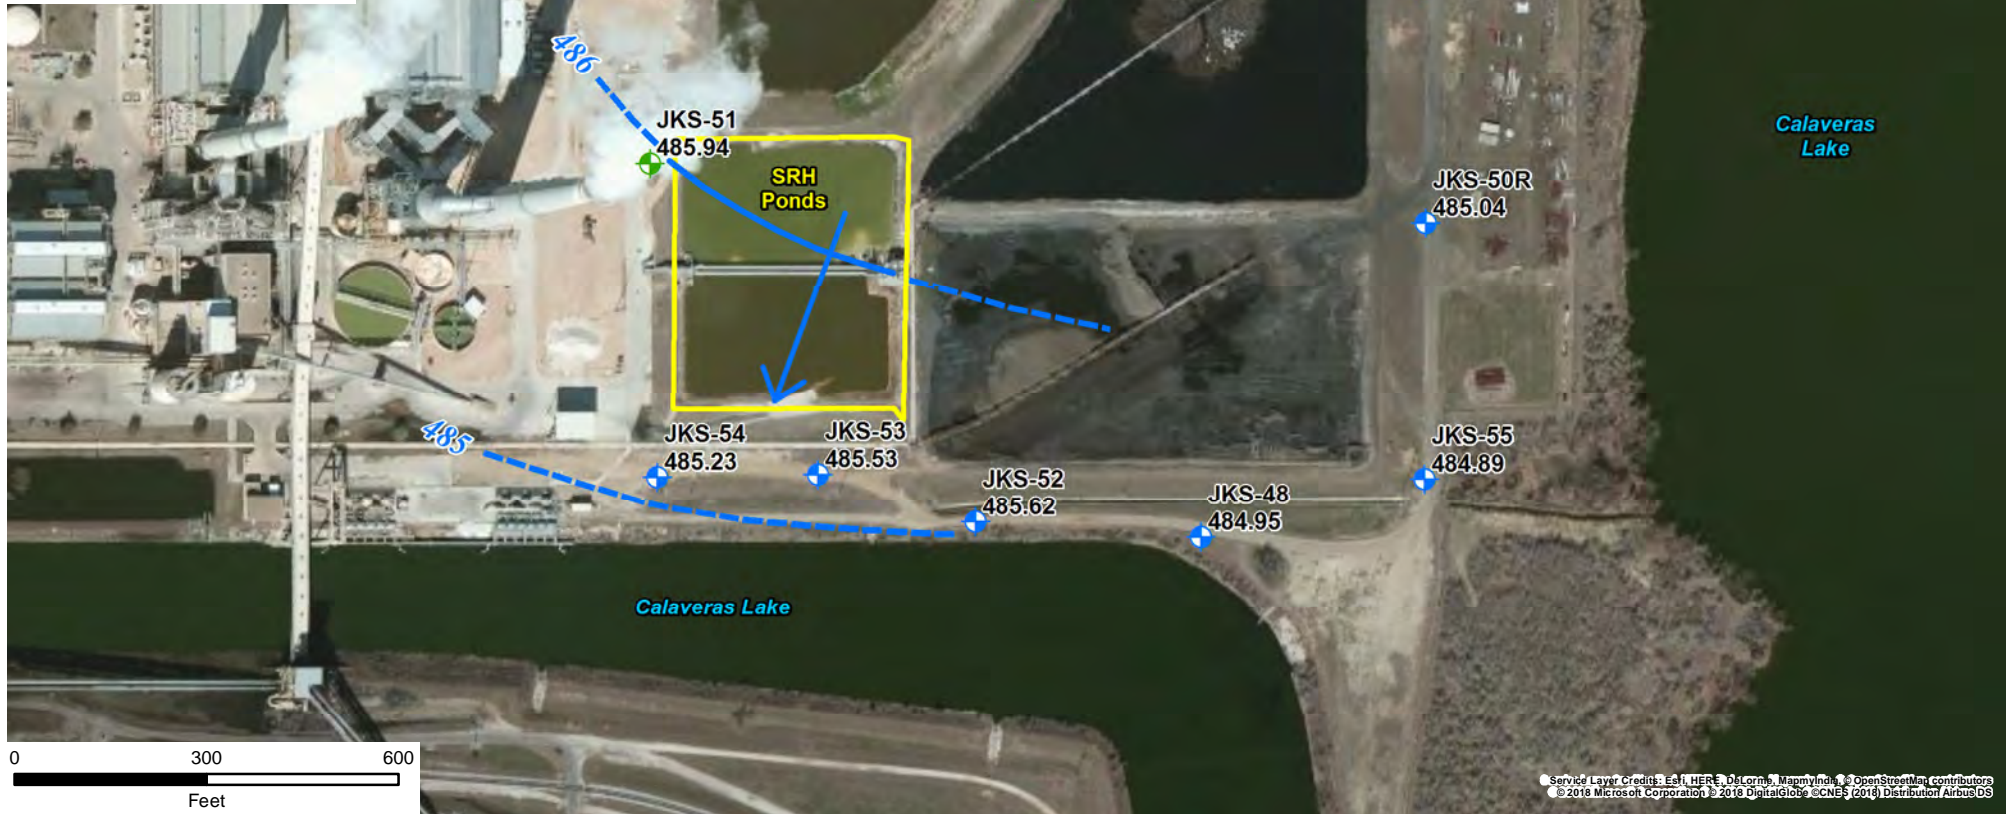
POTENTIOMETRIC SURFACE MAP -  
 OCTOBER 2017  
 SRH Pond CCR Unit  
 CPS Energy - Calaveras Power Station  
 San Antonio, Texas

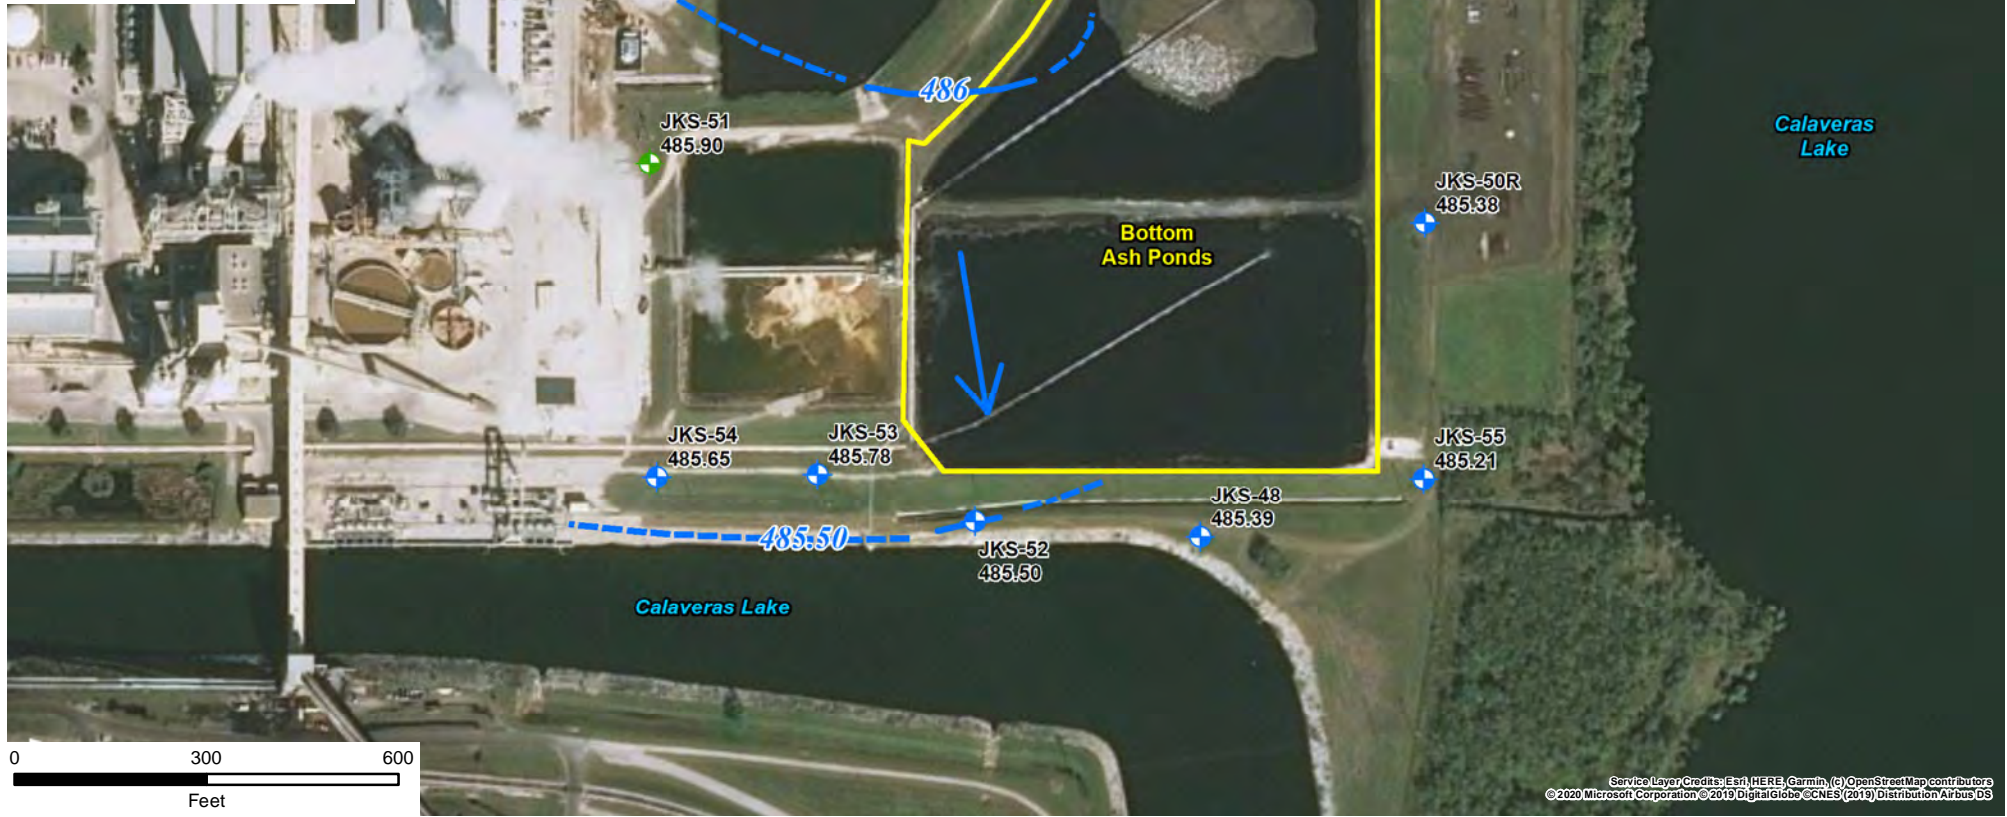
- Legend**
-   Background Monitor Well
  -   Downgradient Monitor Well
  -   CCR Unit
  -   Potentiometric Surface Contour Line (Feet, Mean Sea Level)
  -   Groundwater Flow Direction
  - 485.90** Potentiometric Surface Elevation (Feet, Mean Sea Level)

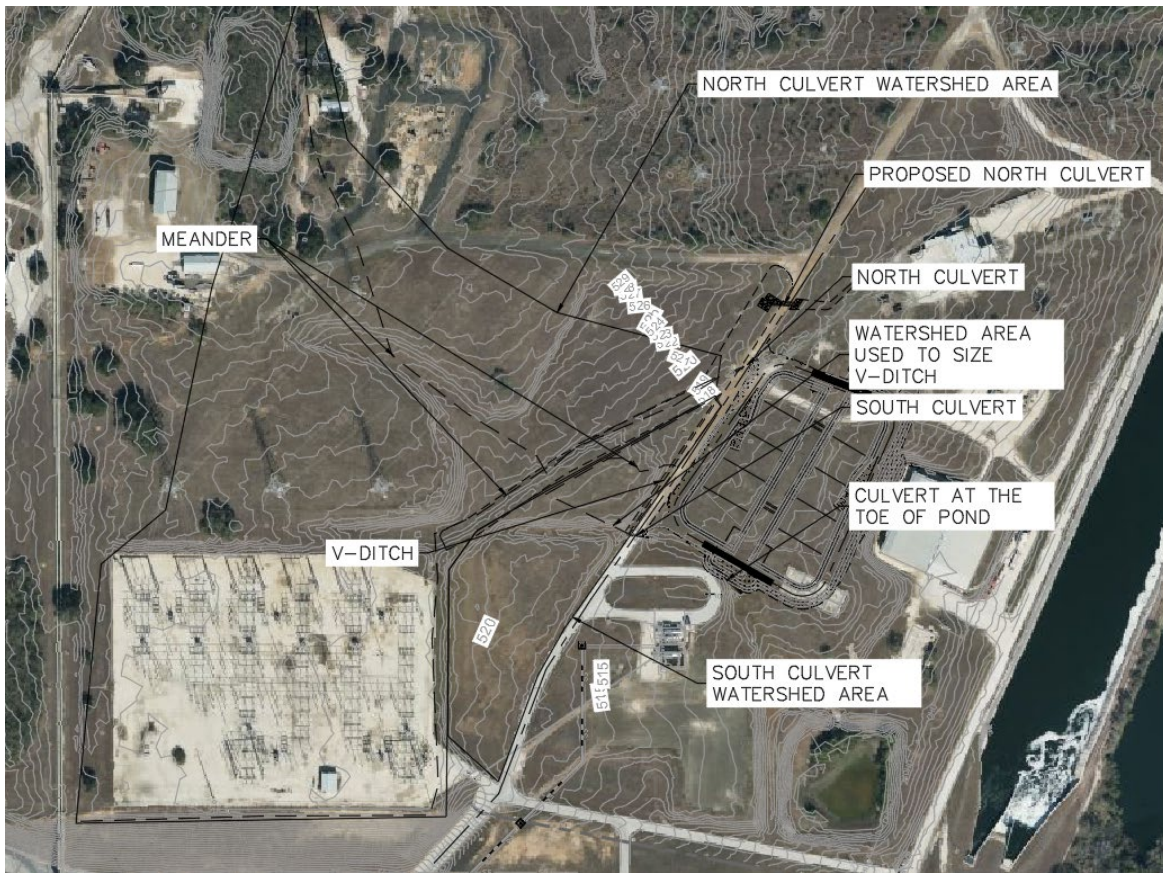
The area west of the pond consists of the North Culvert and South Culvert Watersheds with areas of 30.2 acres and 4.5 acres, respectively. The area tributary to the v-ditch within the South Culvert Watershed is 1.15 acres. The runoff coefficient is a weighted average of sandy soil (substation) with average slope ( $C=0.1-0.15$ ) and cultivated land ( $C=0.2-0.5$ ). The weighted average runoff coefficient used for this study is  $C=0.3$ .
