ASSESSMENT OF DAM SAFETY OF COAL COMBUSTION SURFACE IMPOUNDMENTS FINAL REPORT

**CPS Energy
J.T. Deely Power Plant
San Antonio, Texas**

Prepared for
*U.S. Environmental
Protection Agency
Washington, D.C.*

February 2014
Revised May 2014
Revised June 2014

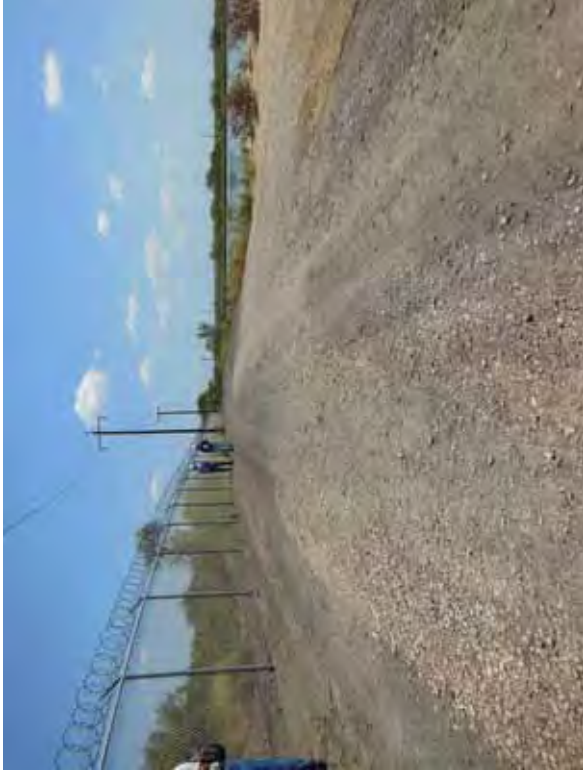
The crest of the North Bottom Ash Pond appeared to be in satisfactory condition (Photographs 1, 10, 29, and 42). The crest was approximately 15 feet wide at all embankments except the north embankment where the crest measured approximately 30 feet wide. The crest of the embankments consists of compacted granular soils and gravel and is exposed to minimal vehicle traffic. An area of erosion near a fence post was observed at the north embankment crest (Photographs 5 and 52). Wood support poles for overhead powerlines are located in the crest of the north embankment (Photograph 1). No depressions or evidence of settlement were observed on the crest.

Photo 1: NP - North Embankment crest, looking east.

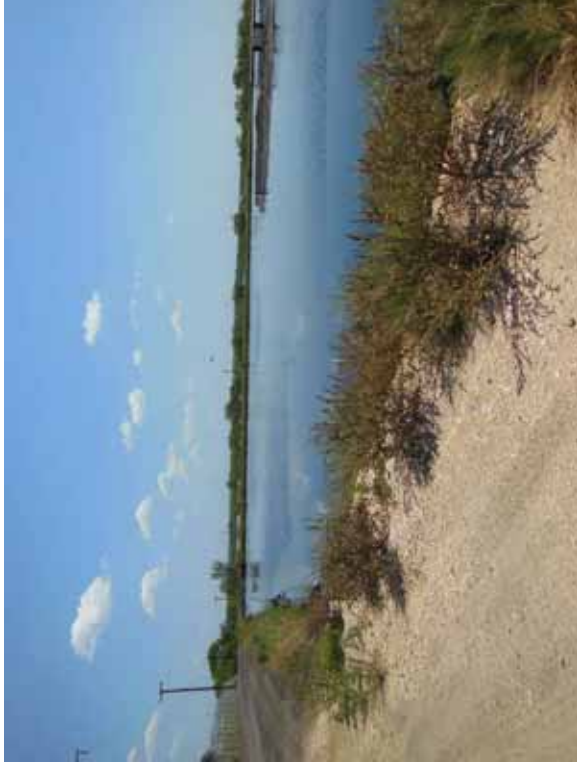
Photo 2: NP - North embankment interior slope, looking east.

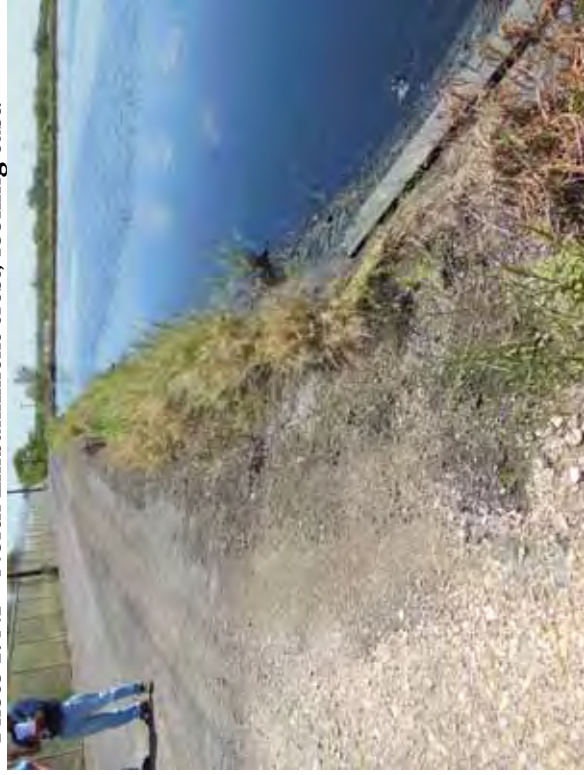
Due to the water level in the North Bottom Ash Pond during the assessment, only the upper 2 feet of the interior slopes were visible (Photographs 3, 12, 27, and 40). Based on construction drawings, the interior slopes were constructed at 2H:1V. The interior slopes were measured at approximately 3H:1V near the top of the embankment and included a layer of ash material (Photograph 28). Small areas of erosion into ash were observed on the interior slope at the east, south, and west embankments (Photographs 17, 23, 38, and 43) and an area of loose ash was observed on the east embankment interior slope (Photograph 14). Vegetation covered some portions of the interior slopes that were visible (Photographs 6, 12, 32, and 35). Visible portions of interior slopes did not include riprap or other armoring.

Photo 3: NP - North embankment interior slope, looking east.

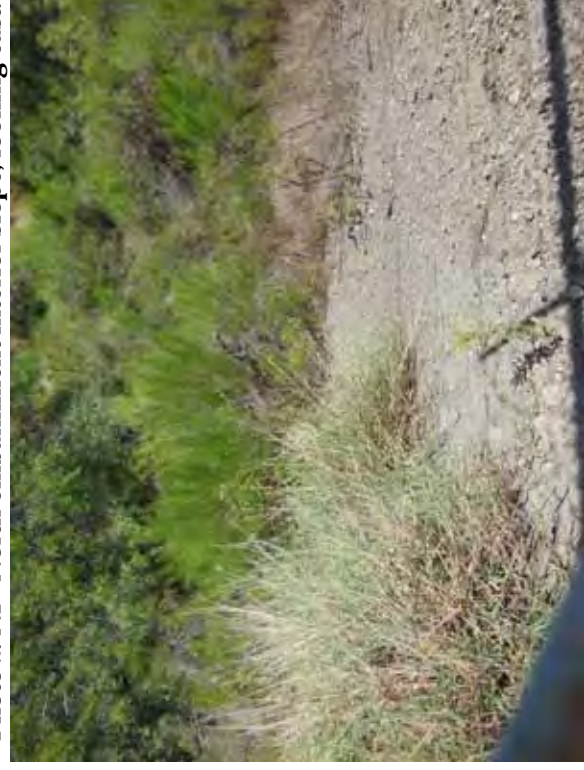
Photo 4: NP - North embankment exterior slope, looking north.

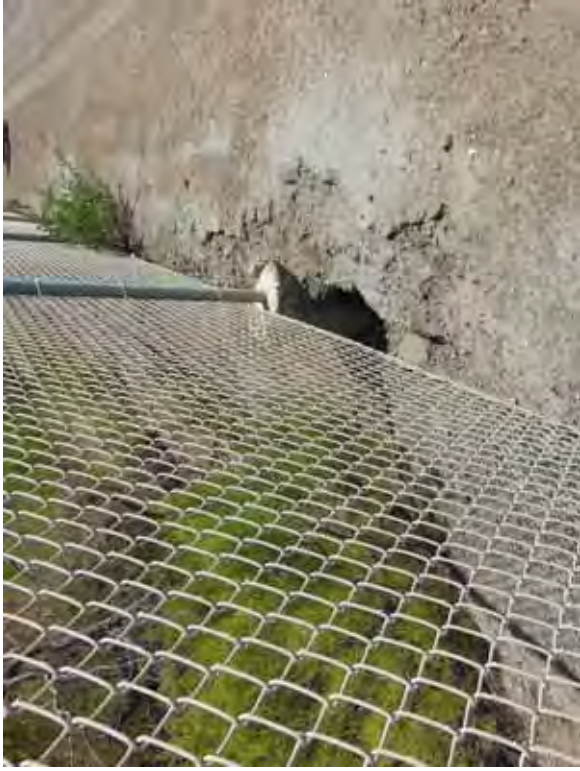
**Photo 5: NP - North embankment exterior slope, looking northeast.
Note erosion near fence post.**

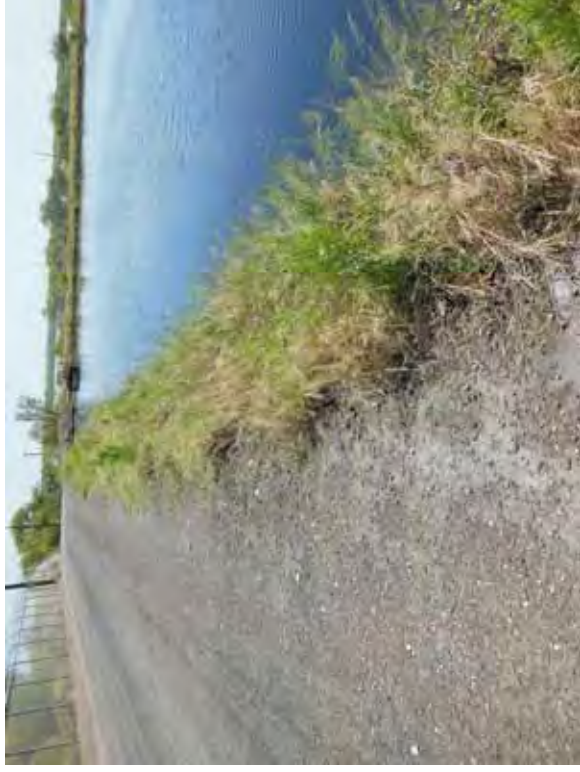
Photo 6: NP - North embankment interior slope, looking east.

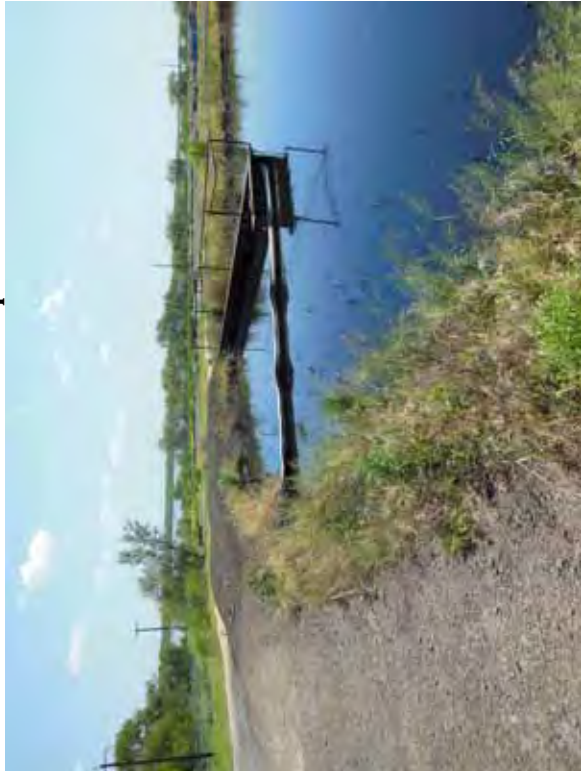
Photo 7: NP - Outlet structure at northeast corner, looking east.

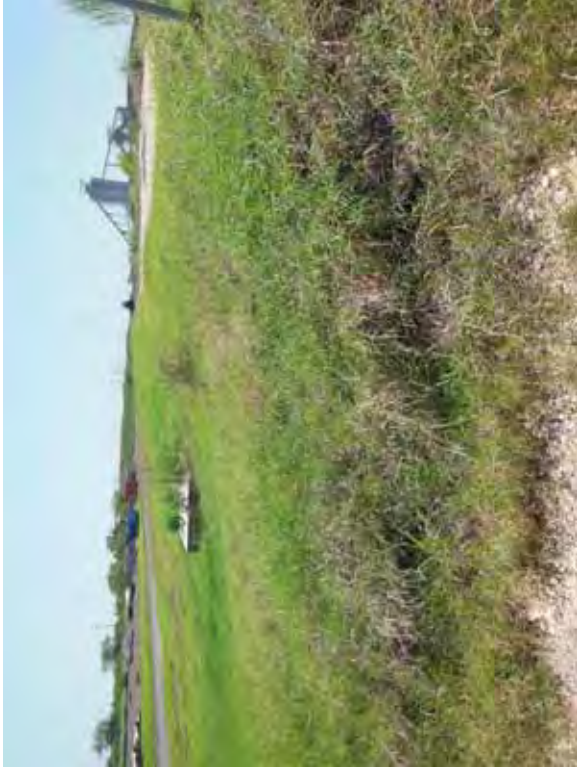
Photo 9: NP - East embankment exterior slope, looking south.

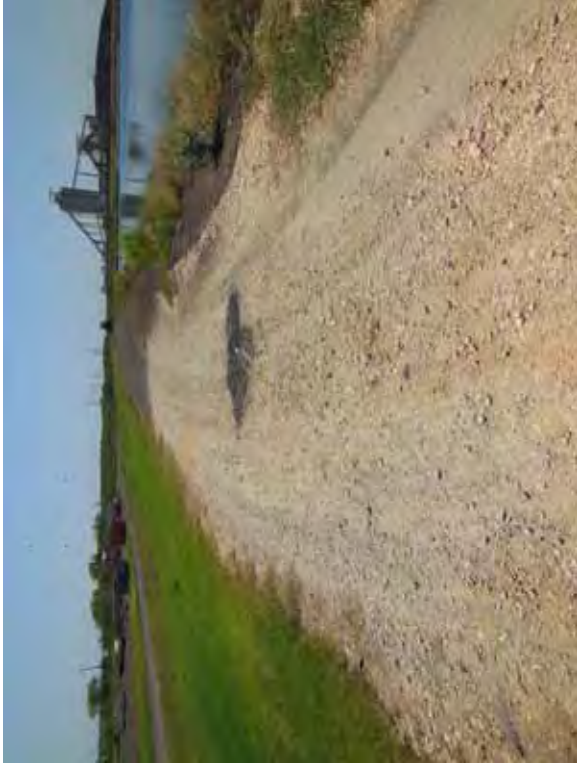
Photo 10: NP - East embankment crest, looking south.

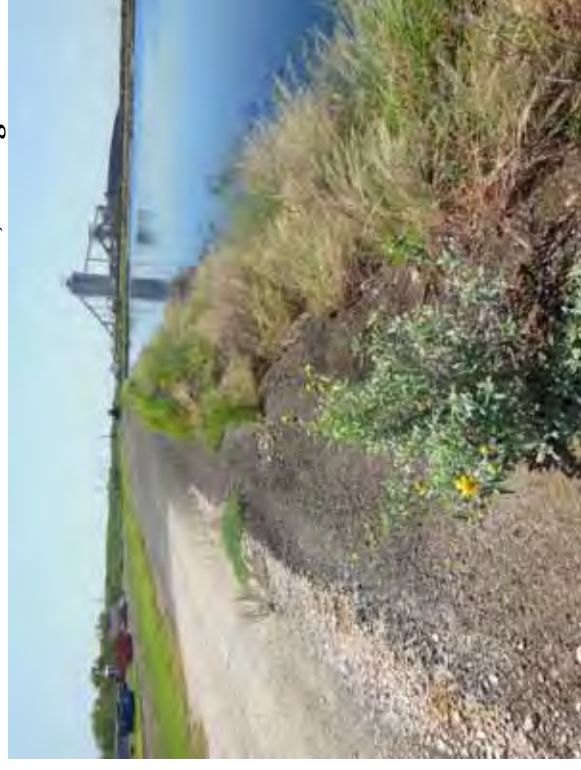
Photo 12: NP - East interior slope, looking south.

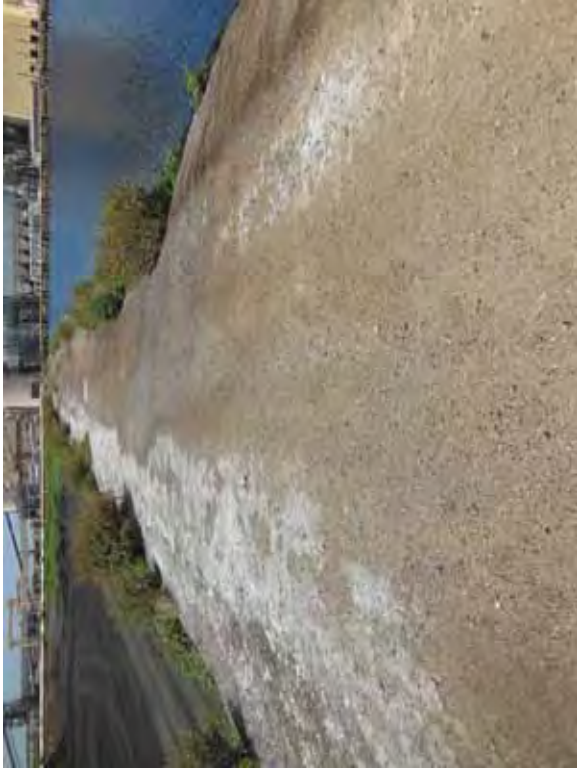
The crest of the South Bottom Ash Pond appeared to be in satisfactory condition (Photographs 29, 56, 65, and 73). All embankment crests were approximately 15 feet wide and consists of compacted granular soils and gravel and is exposed to minimal vehicle traffic. A clarifier structure associated with the adjacent SRH Pond was located on the west embankment crest (Photograph 78). The west embankment crest included two spillways connecting the SRH and South Bottom Ash Ponds (Photographs 75, 76, 77, 79, 80, and 81). No depressions or evidence of settlement were observed on the crest.

Photo 29: NP/SP - Common embankment crest, looking west.

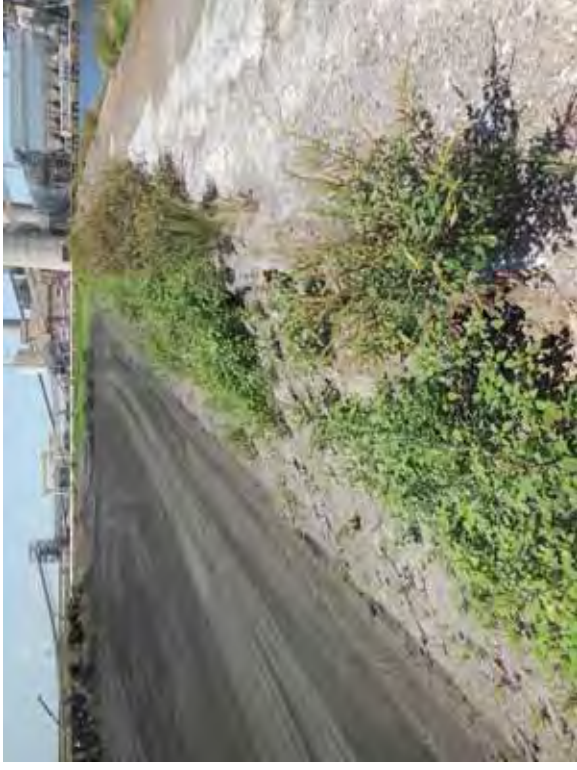
Exterior slopes of the North Bottom Ash Pond appear to be in fair condition (Photographs 15, 30, 39, and 49). Due to the terrain and vegetation on the exterior slope of the north embankment, the slope was only visible from the embankment crest (Photograph 50). A few small trees and brush less than 8 inches in diameter were observed on the exterior slope of the north embankment (Photographs 47 and 48). The exterior slopes of the west and east embankments are approximately 3H:1V and covered in grassy vegetation approximately 3 inches tall (Photographs 16 and 39). The south embankment is shared with the South Bottom Ash Pond and is covered in ash material with sparse vegetation consisting primarily of grass and brush, approximately 2 feet high. Some areas of minor erosion into the ash material (Photographs 24, 25, and 26) were observed. The #1 Stormwater Runoff Pond is located at the west embankment exterior toe and the SRH Pond is located at the exterior toe of the southwest corner (Photograph 37).

Interior slopes appeared to be in fair condition (Photographs 30, 59, 66, and 70). Based on construction drawings, the interior slopes were constructed at 2H:1V. The north embankment is shared with the North Bottom Ash Pond and is covered in ash material (Photograph 22). Vegetation is sparse, consisting primarily of grass and brush, approximately 2 feet high (Photographs 24, 25, 26, 59, 64, 70, and 84). Some areas of minor erosion into the ash material (Photographs 24, 25, and 26) were observed. A stockpile of CCW was observed on the east embankment interior slope (Photograph 57). Visible portions of interior slopes were not protected by riprap or other armoring.

Photo 30: NP/SP - Common embankment south slope, looking west.

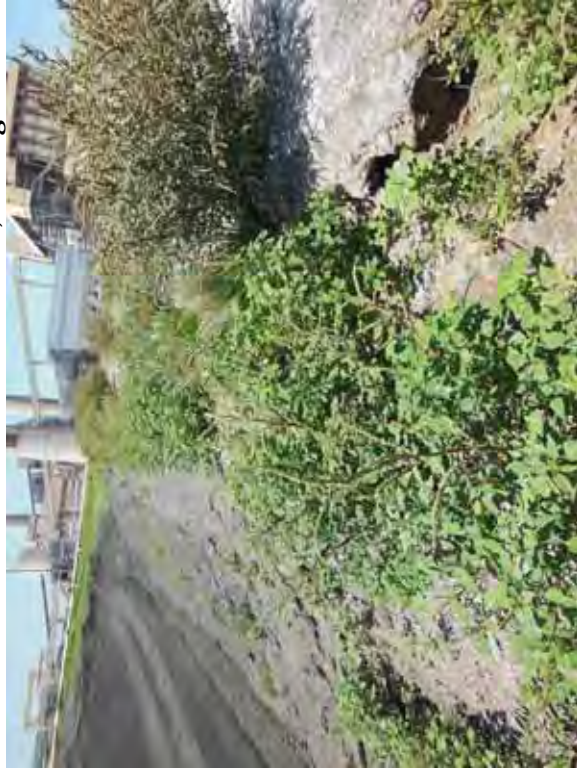
Photo 31: NP/SP - Common embankment south slope, looking west.

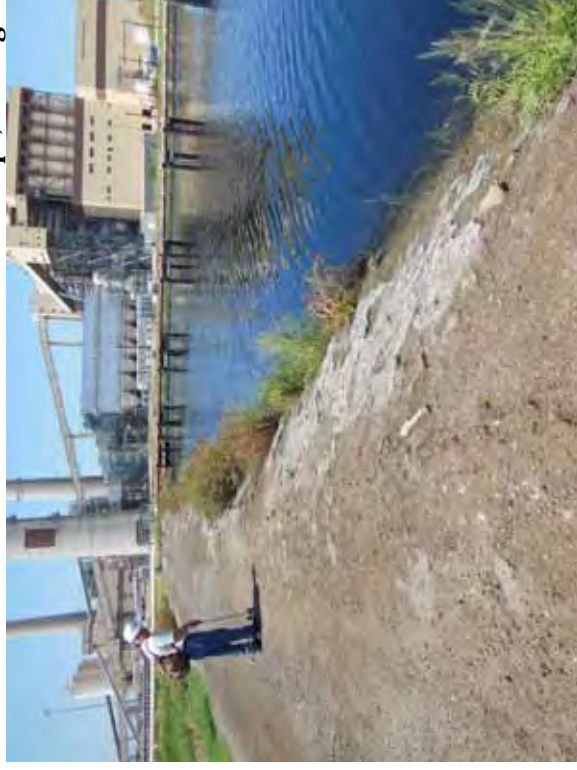
Photo 32: NP/SP - Common embankment north slope, looking west.

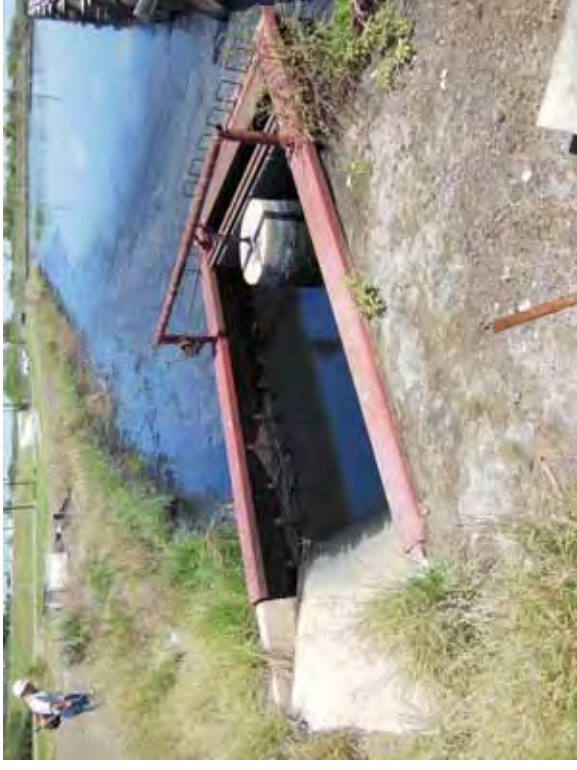
The outlet structure located near the interior slope of the northeast corner consists of a 12-inch-diameter welded steel vertical outlet pipe and a 12-inch-diameter welded steel drain pipe. The outlet pipes are partially surrounded by a steel sheet pile wall containing an opening, with a floating sorbent boom (Photographs 7 and 11). The outlet pipes discharge liquids from the North Bottom Ash Pond to outfalls at the Plant intake canal (Photographs 85, 86, 87, and 88). A 24-inch-diameter welded steel outlet pipe at the interior slope near the southwest corner returns liquids from the pond to the Plant (Photograph 34).

Photo 34: NP - 24-inch-diameter Plant return outlet, looking north.

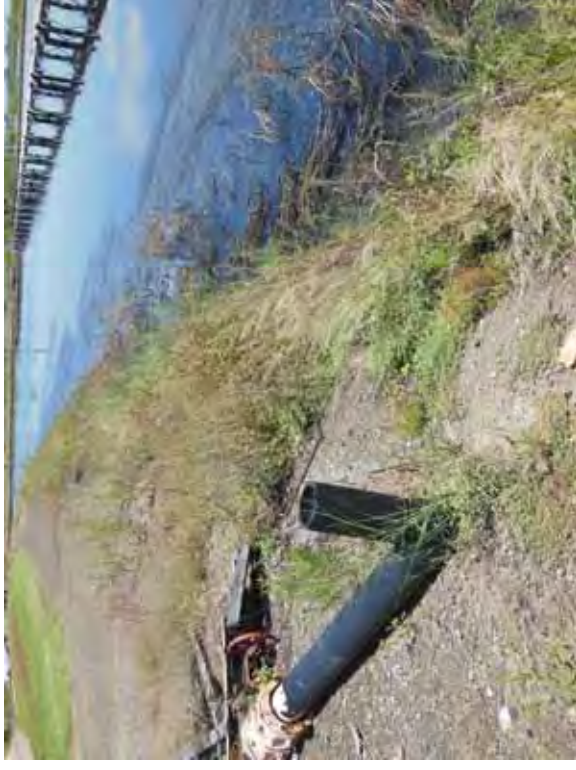
Photo 36: NP - North embankment interior slope, looking northeast.

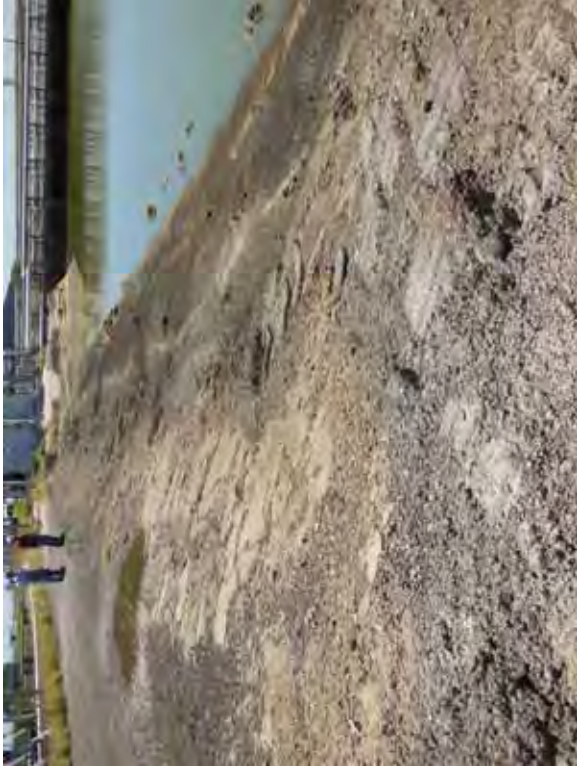
Photo 37: NP - West embankment exterior slope, looking south.

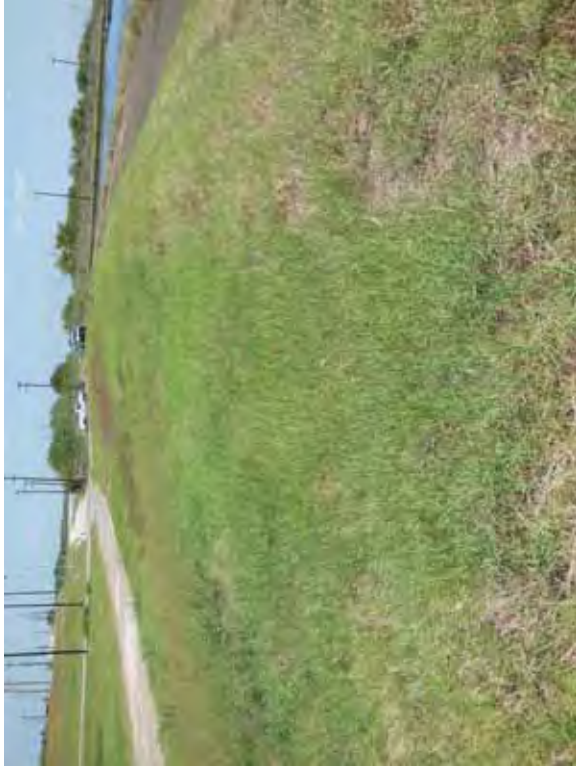
Photo 39: NP - West embankment exterior slope, looking northeast.

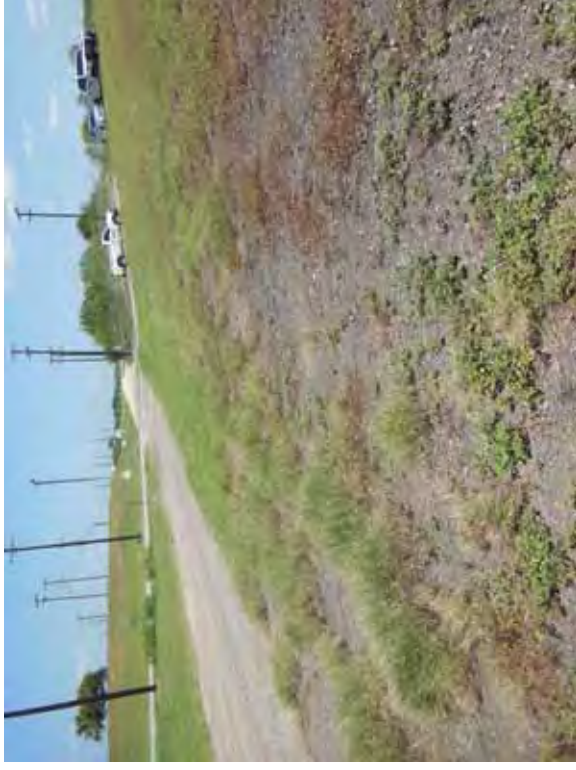
Photo 44: NP - West embankment exterior slope, looking north.

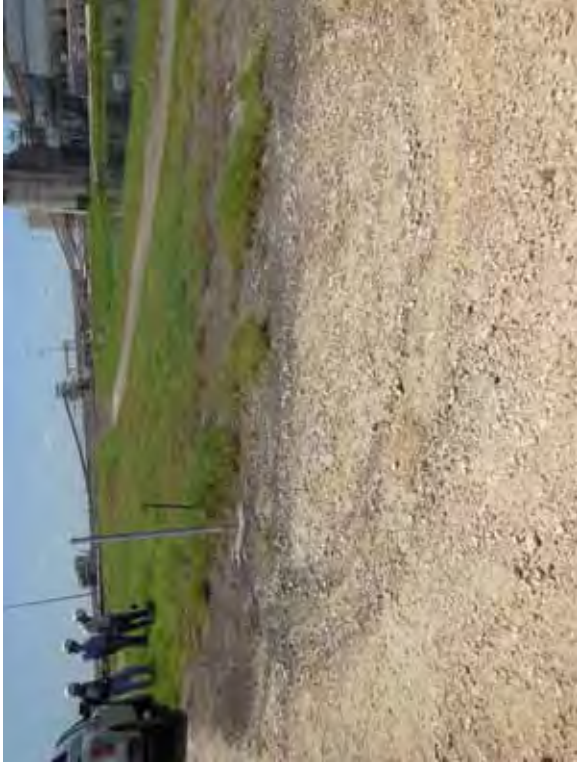
Photo 46: NP - Northwest corner exterior slope, looking south.

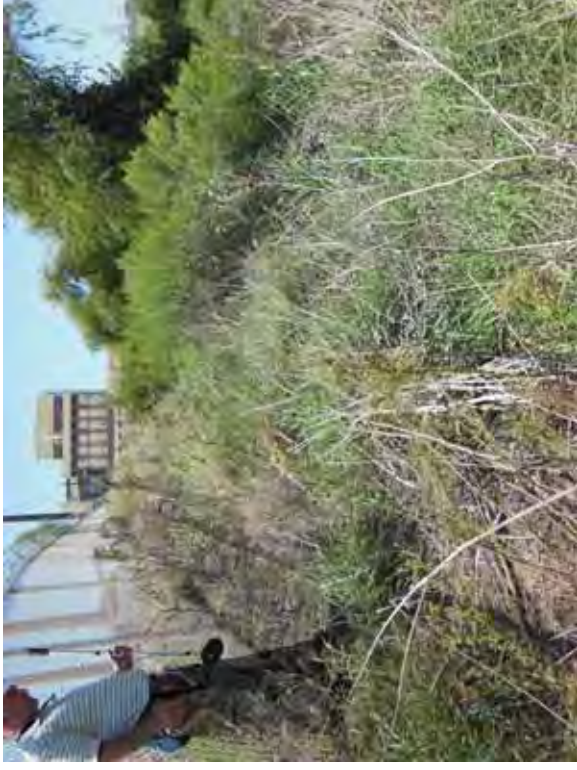
Photo 48: NP - North embankment exterior slope, looking west.

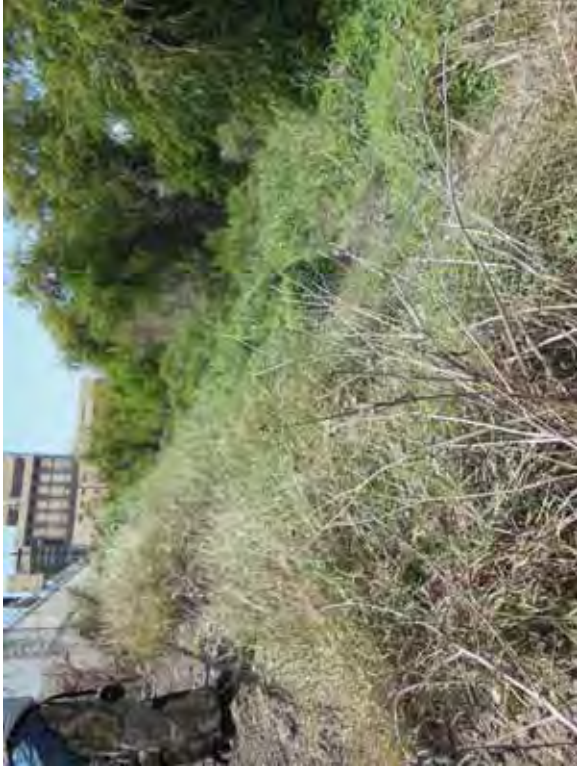
Photo 49: NP - North embankment exterior slope, looking west.

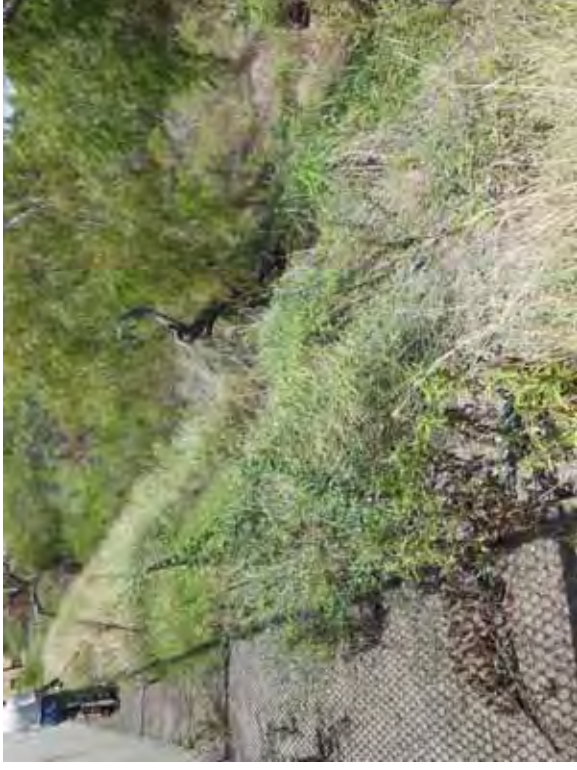
Photo 50: NP - North embankment exterior slope, looking west.

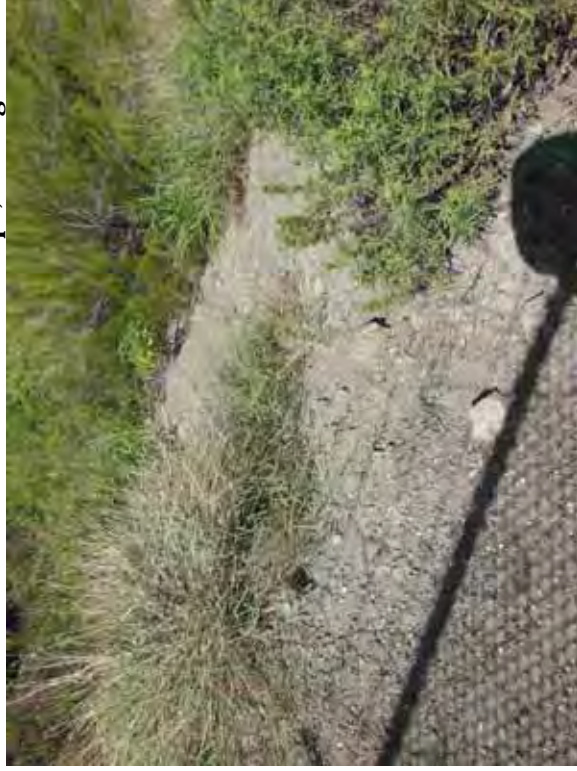
Photo 51: NP - Erosion on north embankment exterior slope, looking north.

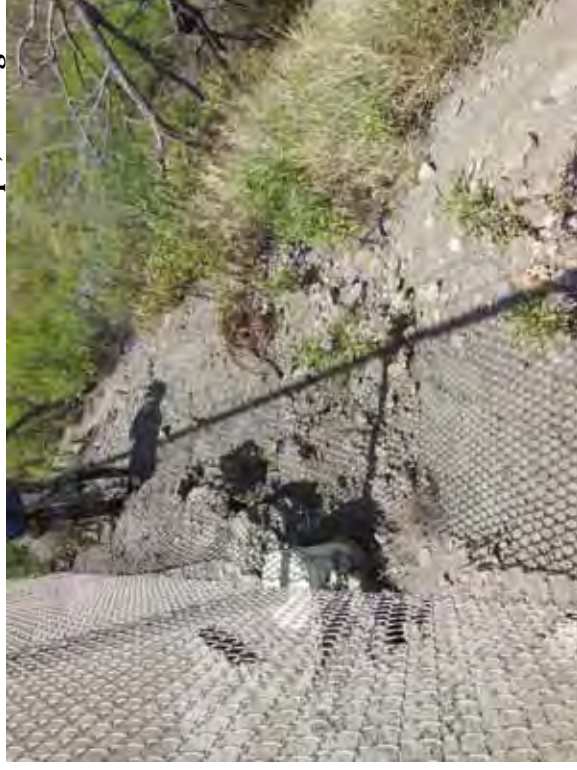
Photo 52: NP - Erosion at fence post on north embankment exterior slope.

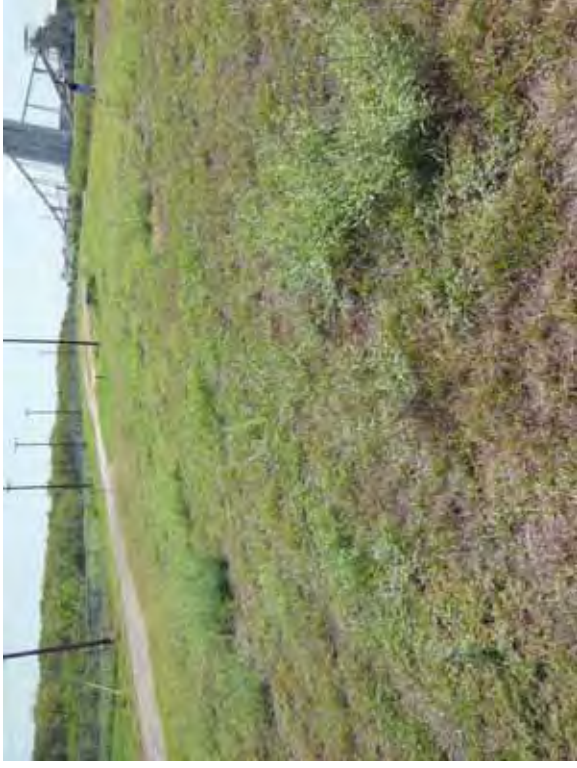
Exterior slopes of the South Bottom Ash Pond appear to be in fair condition (Photographs 27, 58, 62, and 74). The exterior slopes of the east and south embankments are approximately 3H:1V and covered in grassy vegetation approximately 3 inches tall (Photograph 63). The north embankment exterior slope is shared with the North Bottom Ash Pond and is covered in ash material with sparse vegetation consisting of grass and brush, approximately 2 feet high. Some areas of minor erosion were observed on the exterior slope, in the ash material (Photograph 23). The SRH Pond is located at the west embankment exterior slope and is covered with ash and other granular material (Photographs 74, 81, and 82). A drainage ditch is located at the south embankment exterior toe (Photograph 67).

Photo 58: SP - East embankment exterior slope, looking south.

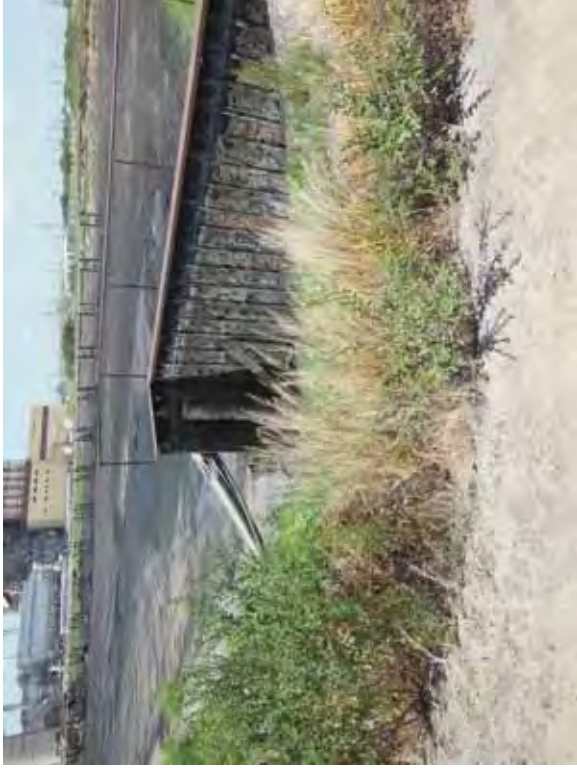
The outlet structure near the interior slope of at the southeast corner consists of a 12-inch-diameter welded steel vertical outlet pipe and a 12-inch-diameter steel drain pipe. The outlet pipes are partially surrounded by a steel sheet pile wall containing an opening, with a floating sorbent boom, for flow to the outlet pipes (Photograph 61). The outlet pipes discharge liquids from the South Bottom Ash Pond to outfalls at the Plant intake canal (Photographs 85, 86, 87, and 89). A 24-inch-diameter welded steel outlet pipe at the interior slope near the northwest corner returns liquids from the pond to the Plant (Photograph 83).

Photo 61: SP – Outlet structure at southeast corner interior slope, looking northwest.

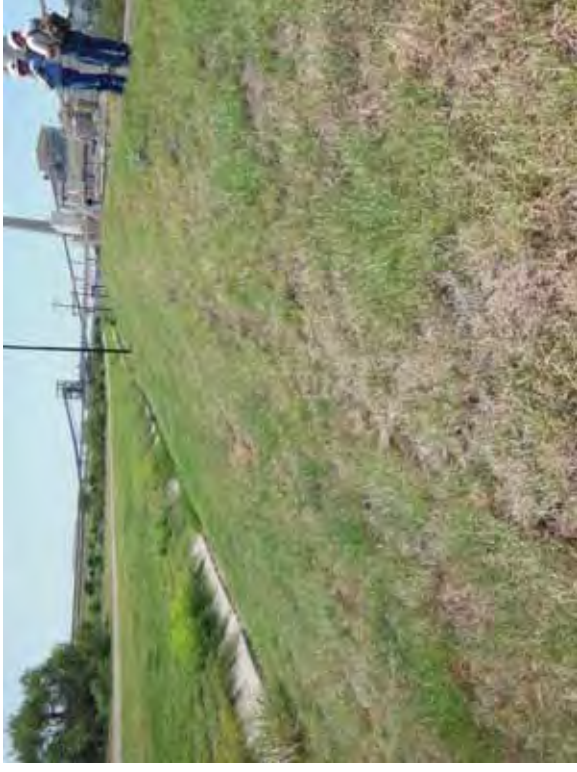
Photo 62: SP - South embankment exterior slope, looking west.

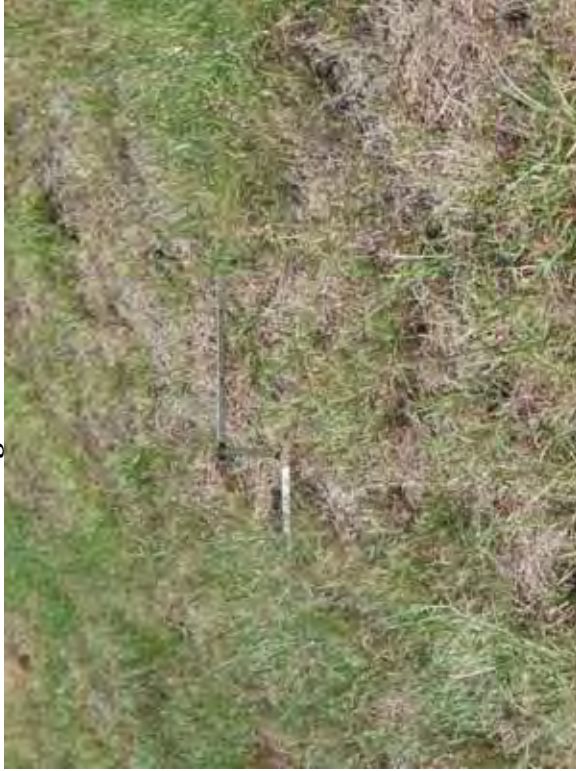
Photo 63: SP – Approximately 3H:1V side slope at south embankment exterior slope.

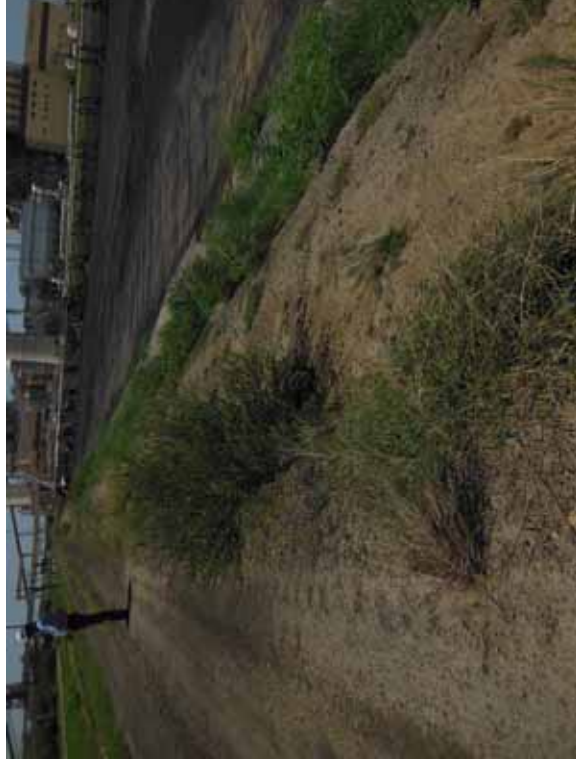
Photo 64: SP - South embankment interior slope, looking west.

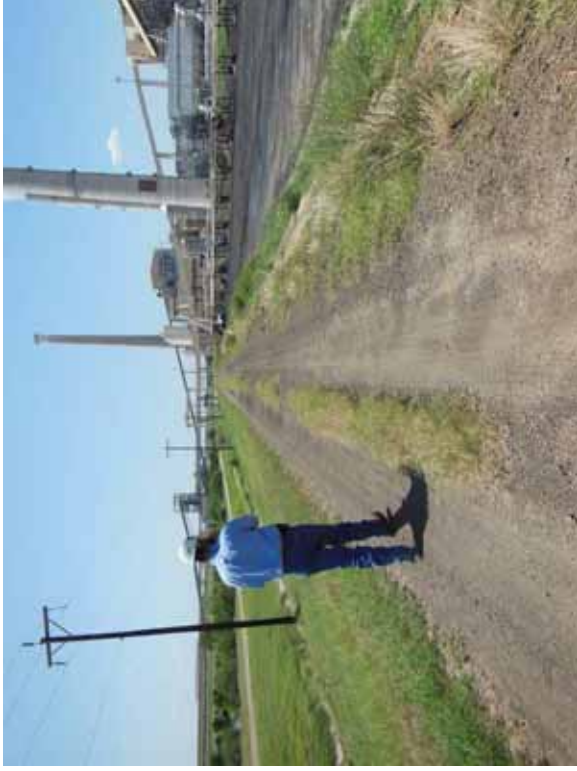
Photo 65: SP - South embankment crest, looking west.

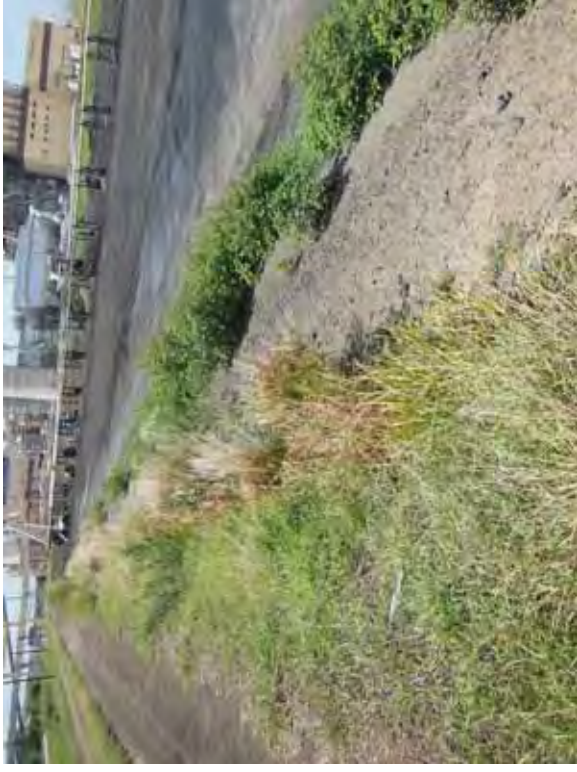
Photo 66: SP - South embankment interior slope, looking west.

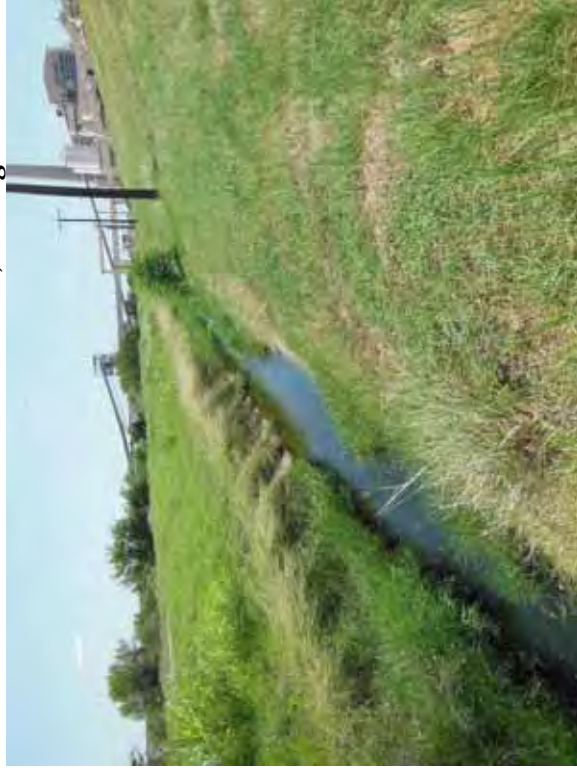
Photo 67: SP - Drainage ditch at south embankment exterior toe, looking west.

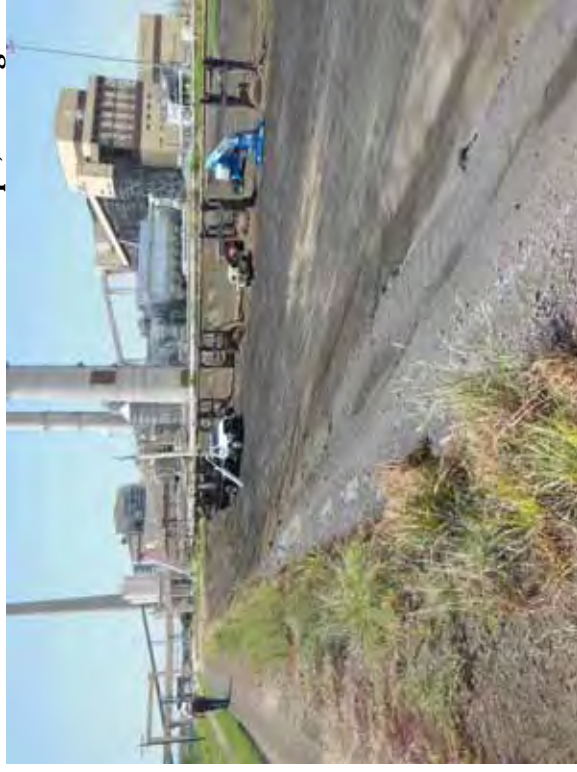
Three inlet pipes discharge liquids near the center of the South Bottom Ash Pond; two 12-inch-diameter welded steel and one 8-inch-diameter welded steel pipe (Photograph 71). The piping was being replaced during the site assessment (Photograph 68).

Photo 68: SP - South embankment exterior slope, looking west. Note equipment working in pond to replace inlet piping.

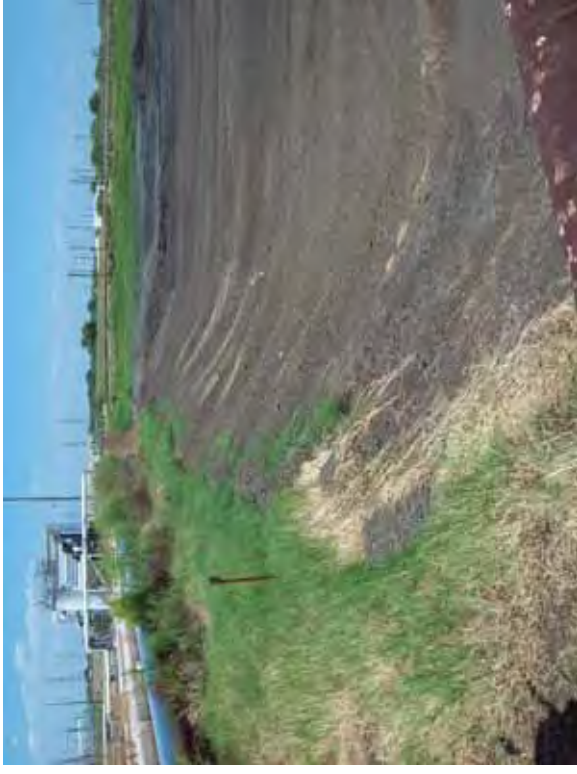
Photo 70: SP - West embankment interior slope, looking north.

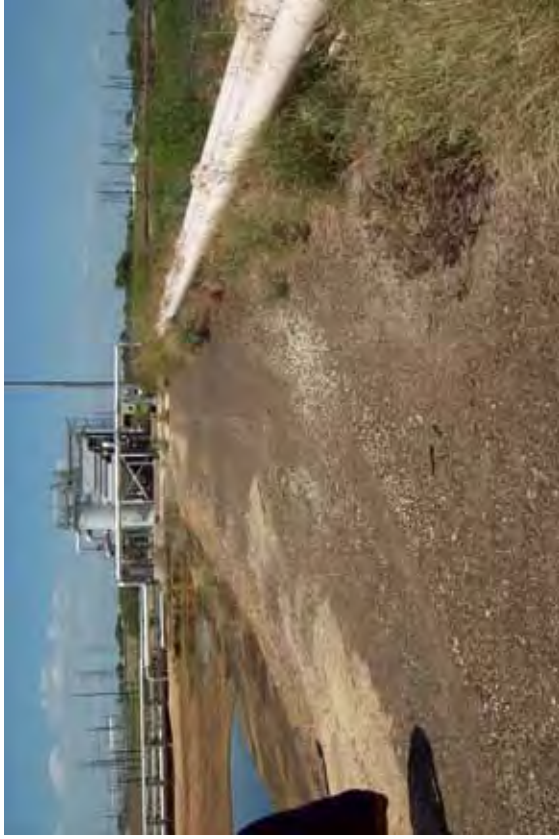
Photo 73: SP - West embankment crest, looking north.

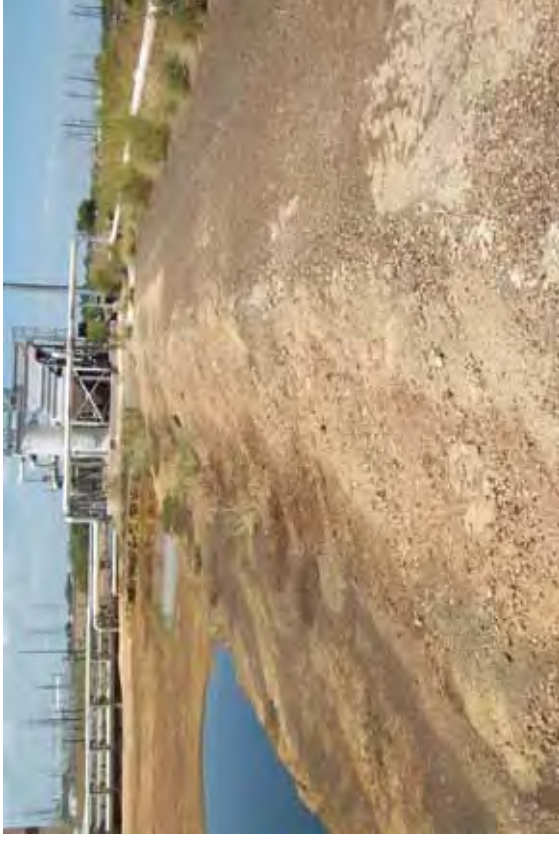
Photo 74: SP - West embankment exterior slope, looking north.

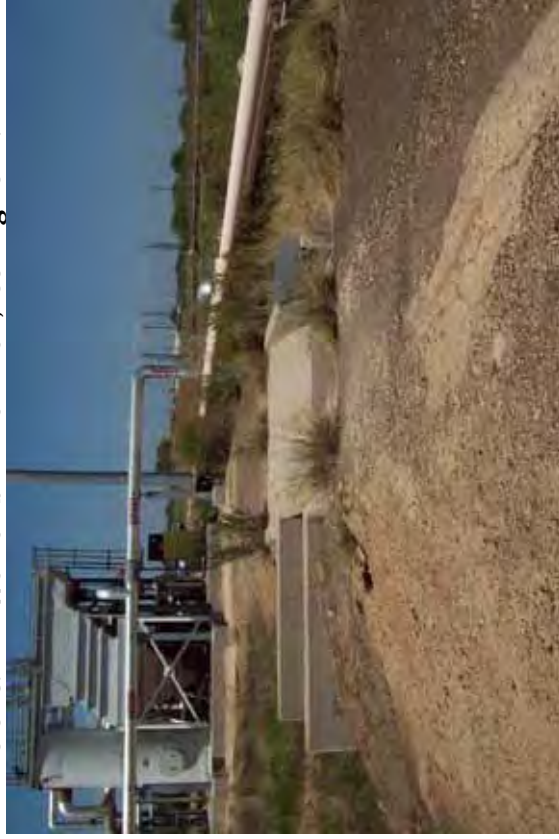
Photo 75: SP - Spillway between SRH Pond and South Bottom Ash Pond at west embankment crest, looking north.

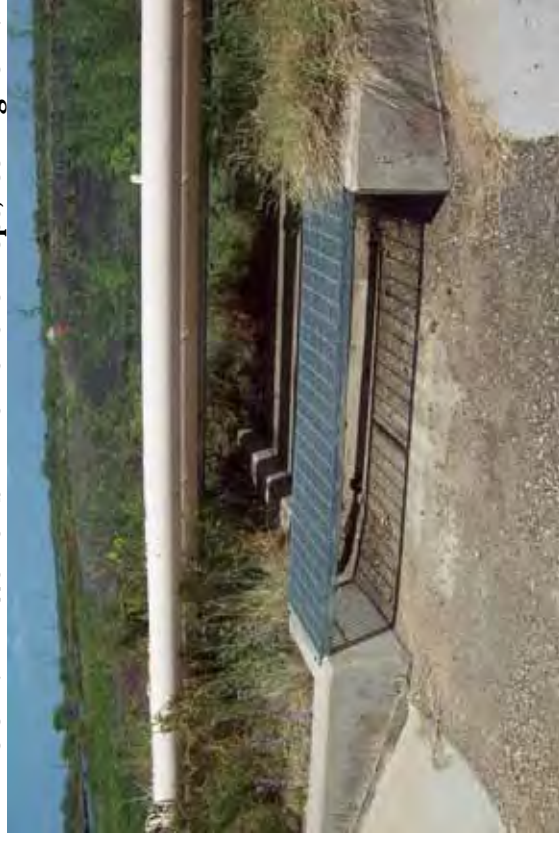
Photo 76: SP - Spillway between SRH Pond and South Bottom Ash Pond at west embankment interior slope, looking east.

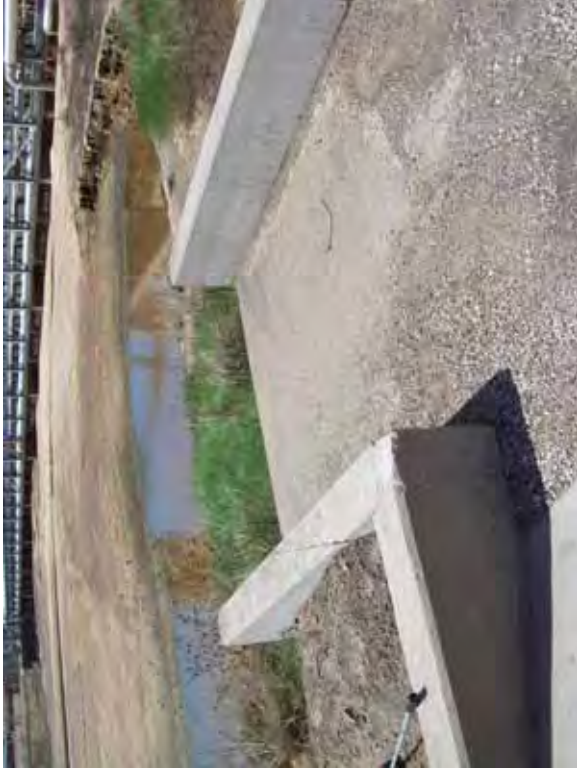
Photo 77: SP - Spillway between SRH Pond and South Bottom Ash Pond at west embankment exterior slope, looking west.

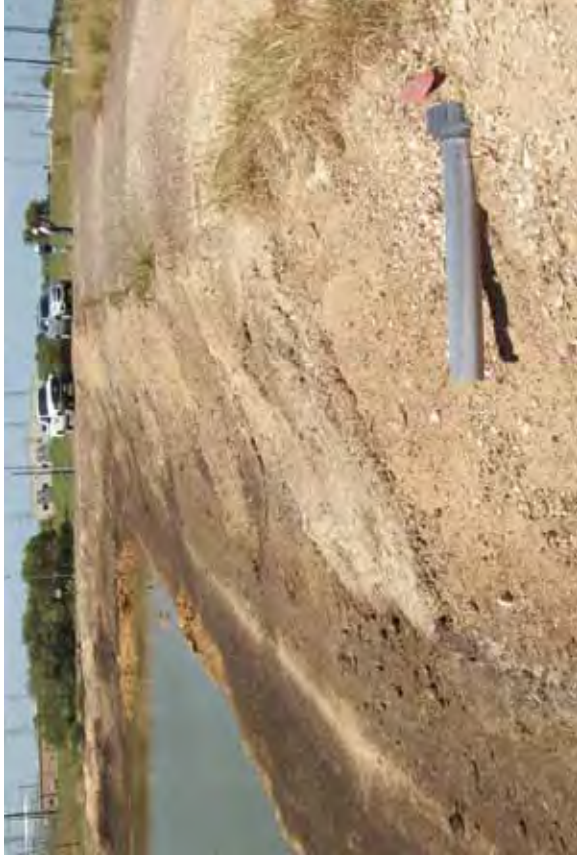
Photo 82: SP - West embankment exterior slope, looking north.

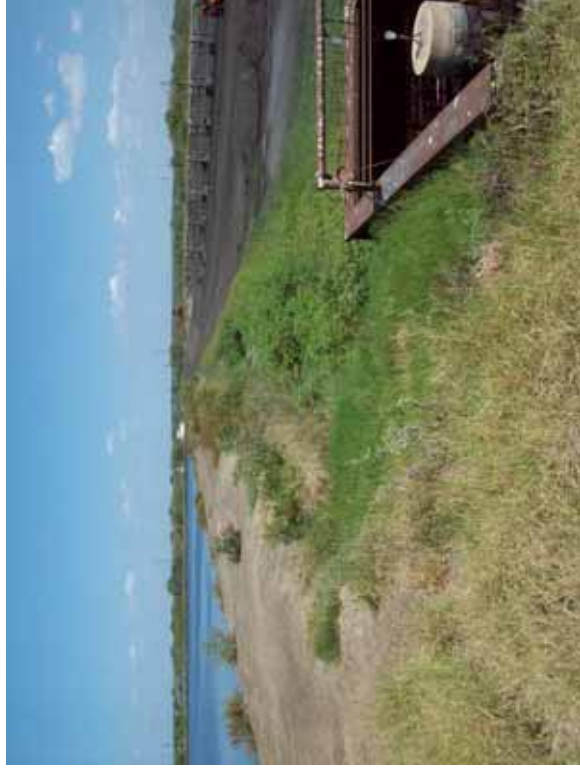
Photo 84: NP/SP - Common embankment south slope, looking east.

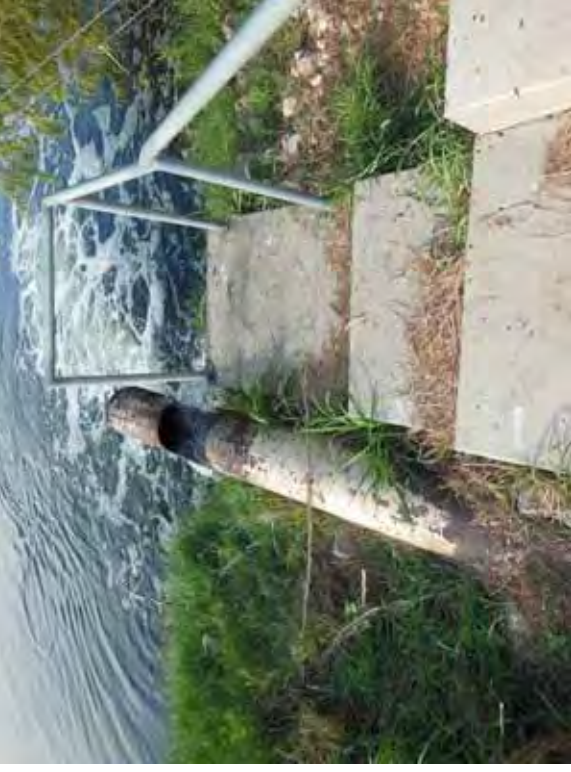
Photo 86: NP/SP - 12-inch-diameter piping at outfall 103C.

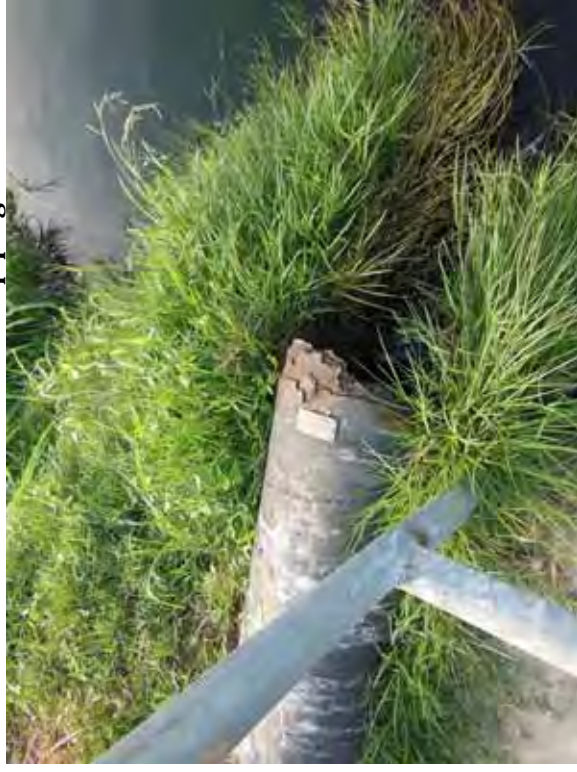
Photo 88: NP - 12-inch-diameter piping at outfall 103A.

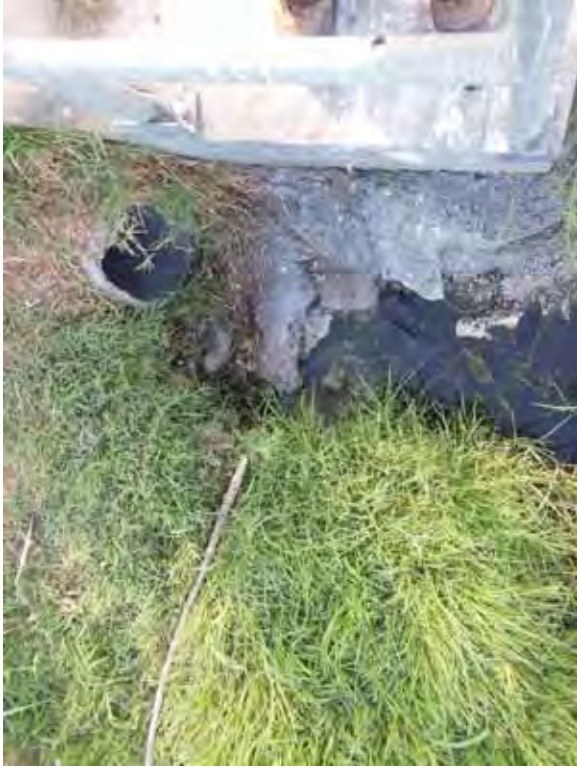
Photo 89: SP – 12-inch-diameter piping at outfall 103B.
