ASSESSMENT OF DAM SAFETY OF COAL COMBUSTION SURFACE IMPOUNDMENTS FINAL REPORT

**CPS Energy
J.T. Deely Power Plant
San Antonio, Texas**

Prepared for
*U.S. Environmental
Protection Agency
Washington, D.C.*

February 2014
Revised May 2014
Revised June 2014

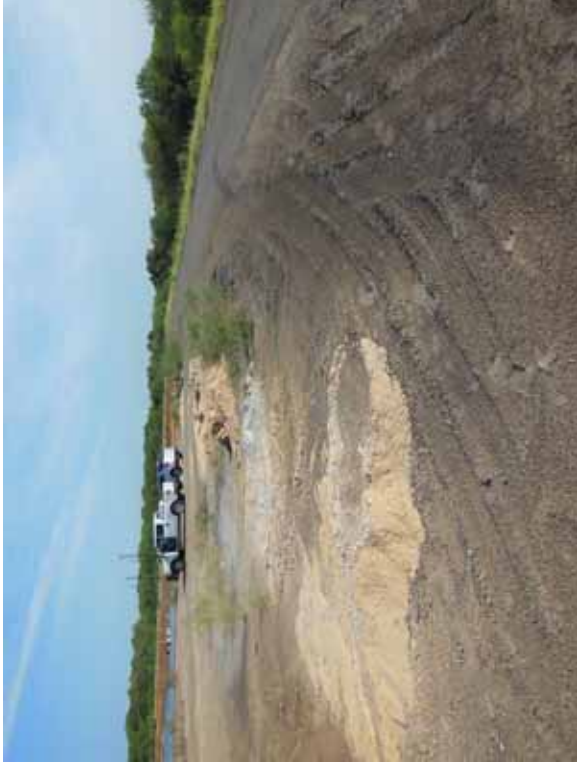
Due to the level of solids and water in the Evaporation Pond during the assessment, only the upper 0.5 to 2 feet of the interior slopes were visible (Photographs 91, 101, 102, 106, and 115). Vegetation covered some portions of the west and south embankment interior slopes (Photographs 111, 115, and 120). Ash and other solid material extend up to the crest near the southeast corner interior slope and on the east embankment interior slope (Photographs 91 and 122). Visible portions of interior slopes did not include riprap or other armoring.

Photo 91: East embankment interior slope, looking north.

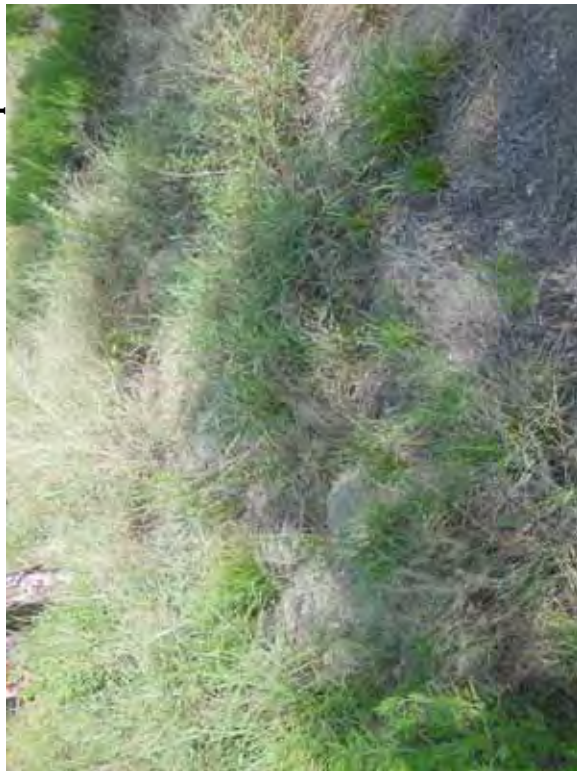
Photo 96: Loose soils near east embankment exterior toe.

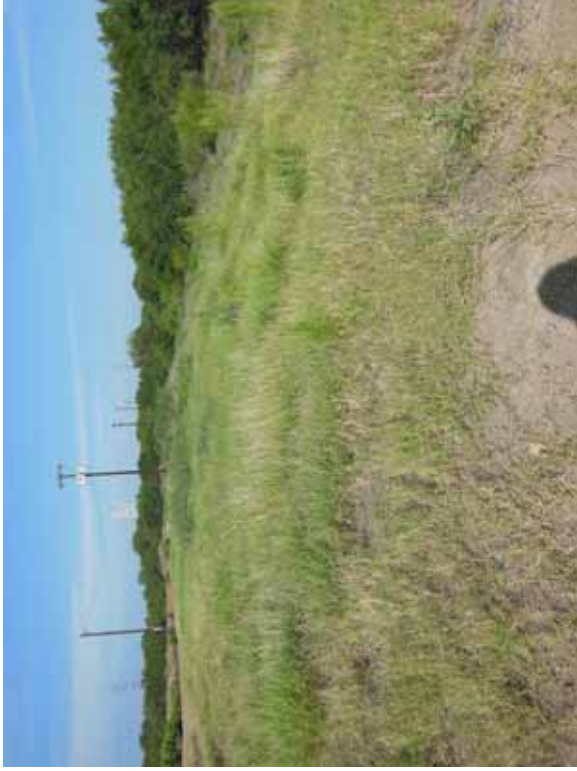
The exterior slopes appear to be in satisfactory condition and are covered in grassy vegetation approximately 2 feet high and a few small trees and bushes with diameters less than 6 inches in diameter (Photographs 93, 98, 109, and 119). Areas of loose soil were observed at the east embankment exterior slope (Photographs 92, 94, and 96) and an animal burrow was observed in the west embankment exterior slope (Photograph 110). An area of exposed soil was observed at the south embankment exterior slope (Photograph 117). Based on construction drawings, the exterior slopes are 3H:1V at all embankments, though slopes measured in the field ranged from 3H:1V to 4H:1V (Photographs 97 and 118). Trees up to 12 inches in diameter were located at the toe of all embankments (Photographs 95, 105, 112, and 119).

Photo 98: North embankment exterior slope, looking west.

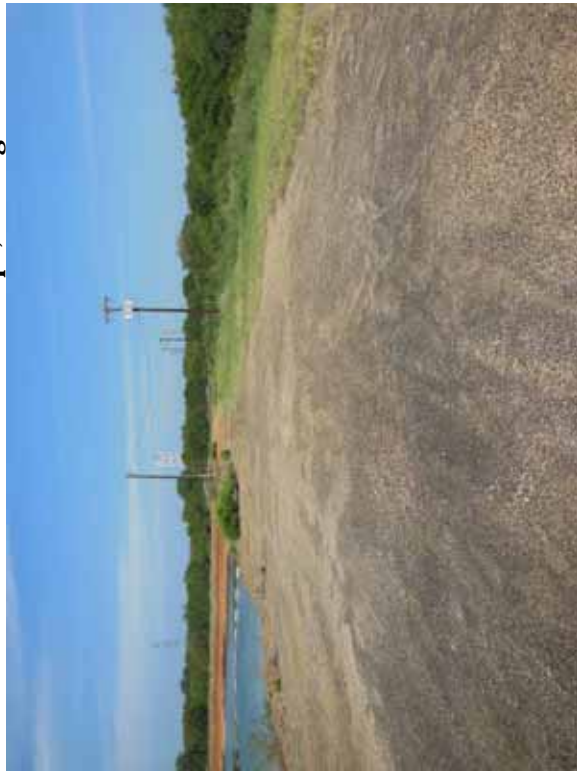
The embankment crest of the Evaporation Pond appeared to be in satisfactory condition (Photographs 90, 100, 108, and 114). The crest was approximately 15 feet wide at all embankments except the north embankment where the crest measured approximately 50 feet wide. The crest of the embankment consists of a compacted gravel drive and grass. The surface is exposed to minimal vehicle traffic. No depressions or evidence of settlement were observed on the crest.

Photo 100: North embankment crest, looking west.

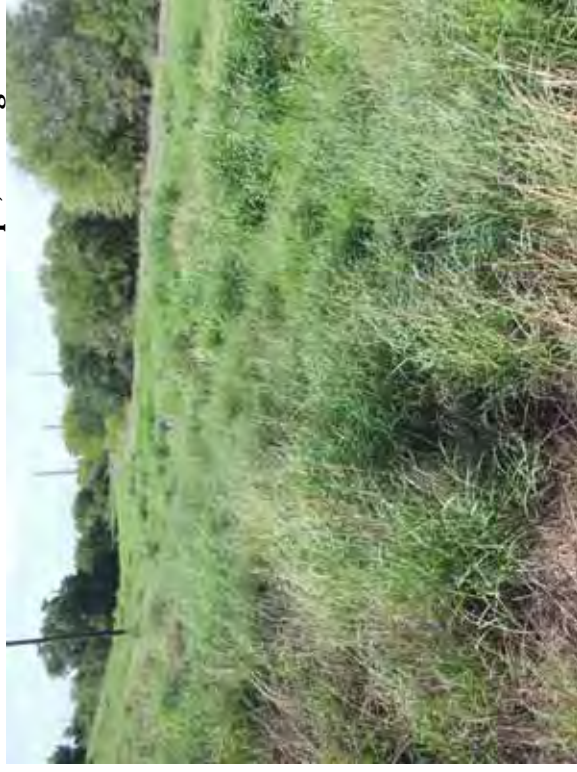
Photo 109: West embankment exterior slope, looking southwest.

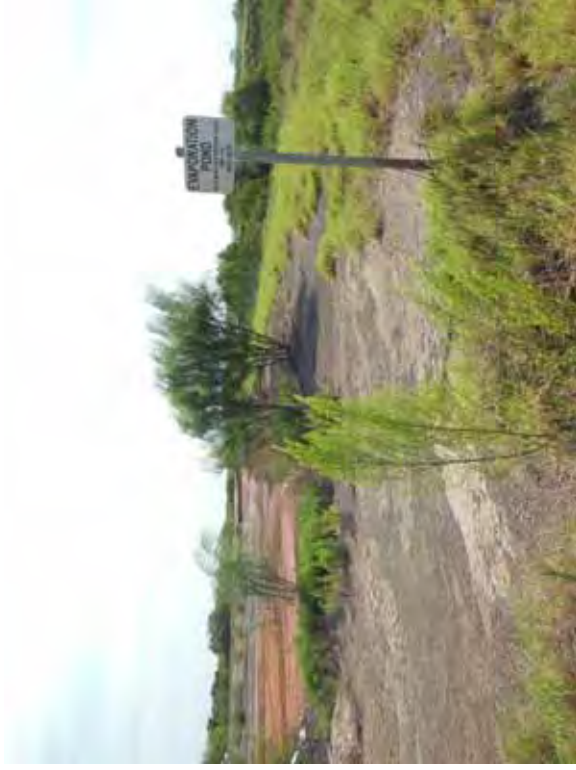
Photo 113: Pond signage near southwest corner.

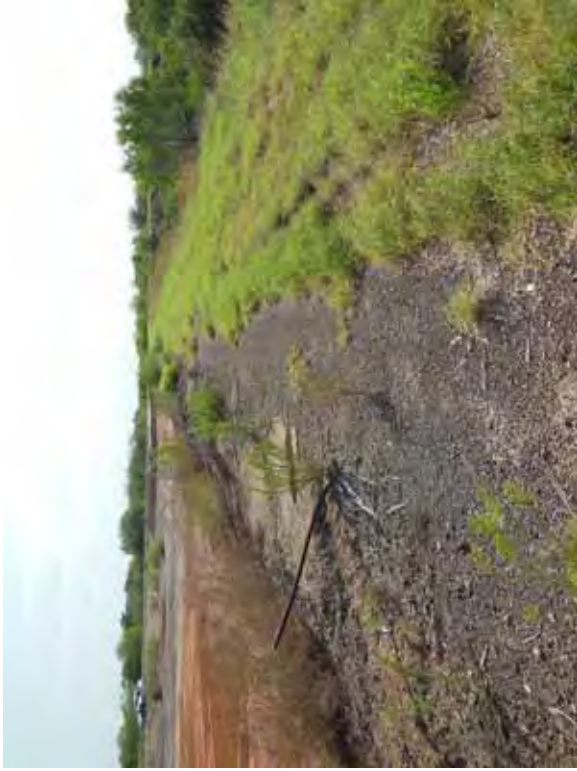
Photo 114: South embankment crest, looking east.

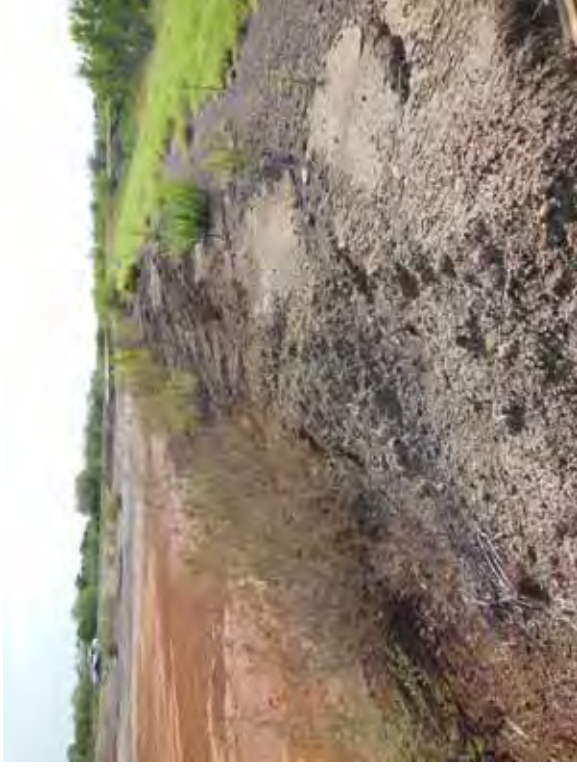
Photo 115: South embankment interior slope, looking east.

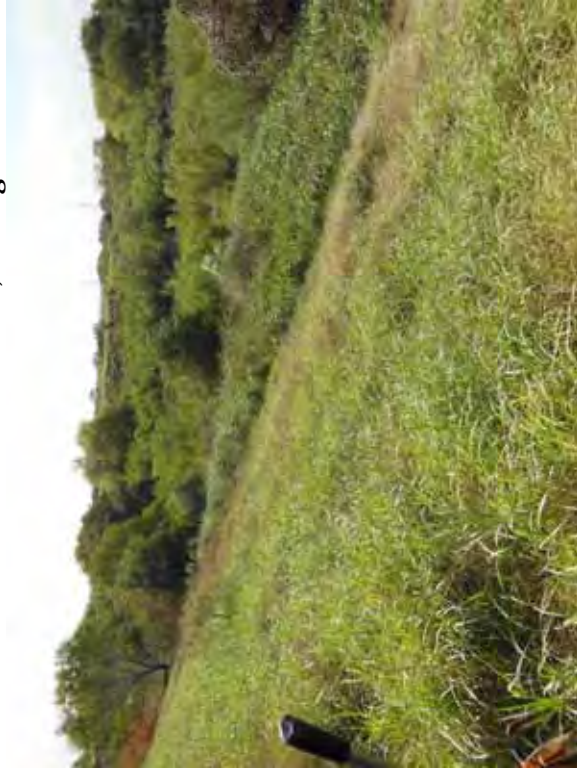
Photo 116: South embankment exterior slope, looking southeast.

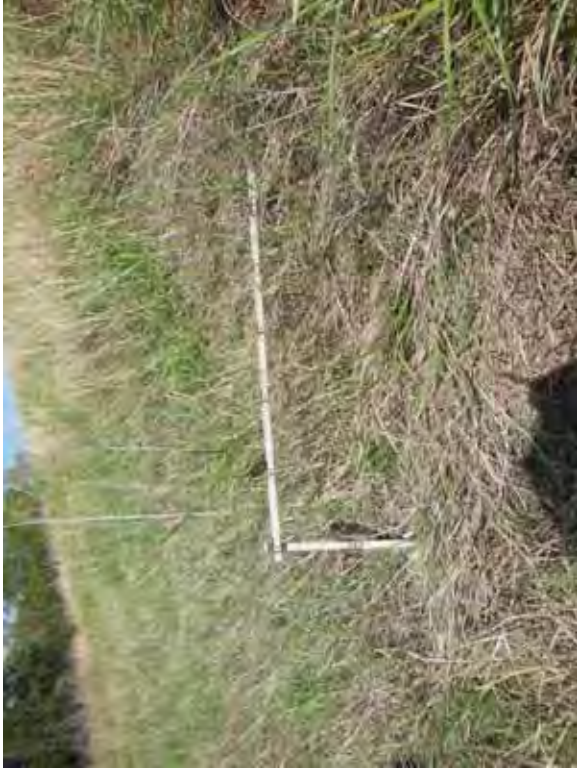
Photo 118: South embankment exterior slope measured approximately 3H:1V.

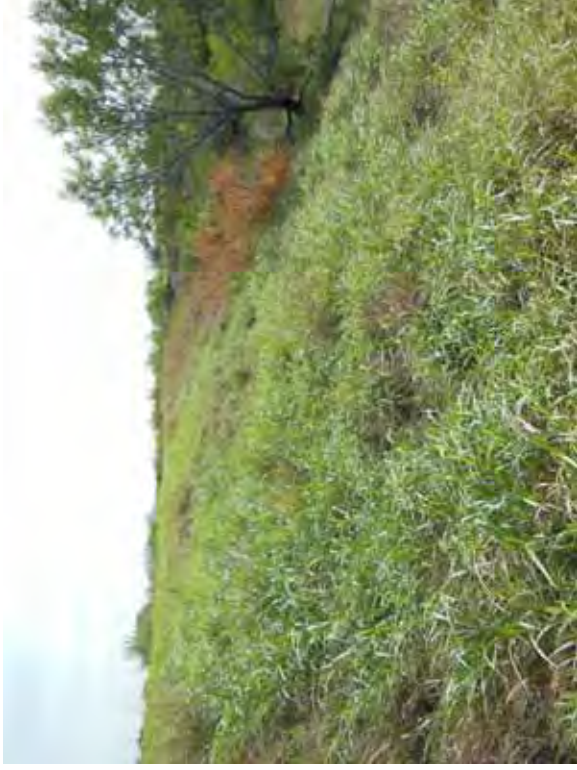
Photo 119: South embankment exterior slope, looking east.

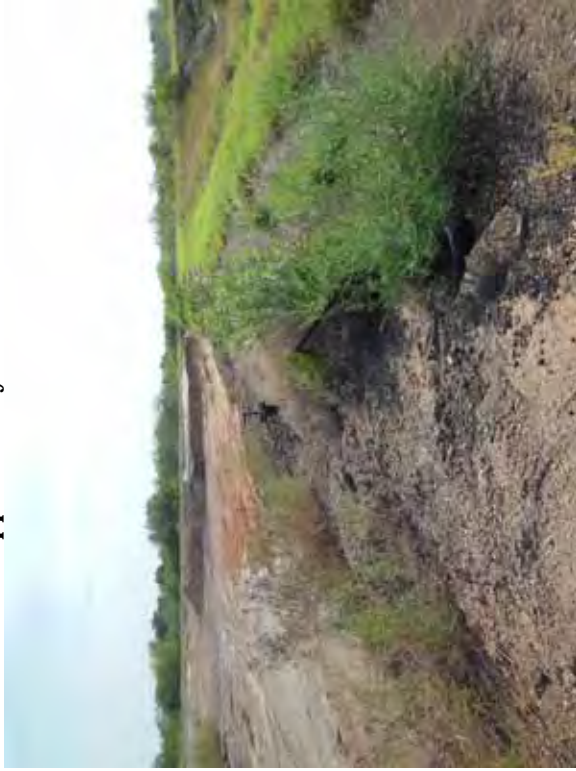
Photo 120: South embankment interior slope, looking east.

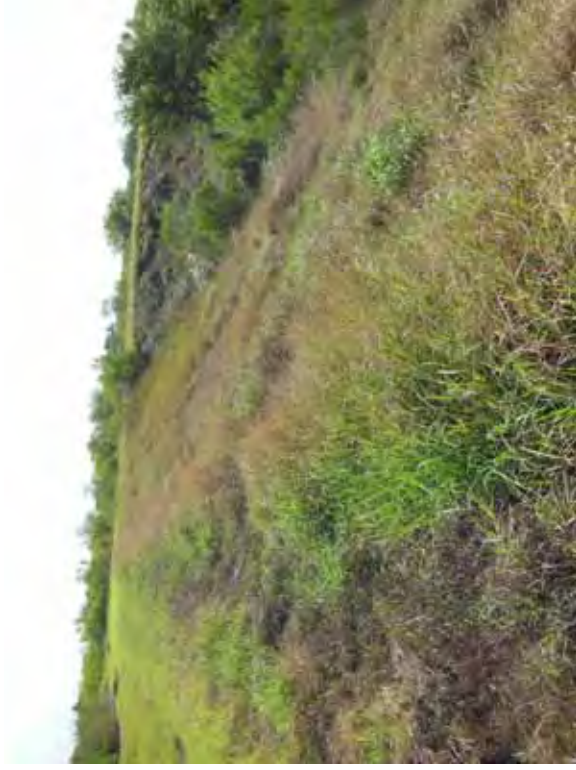
Photo 121: South embankment exterior slope, looking east.

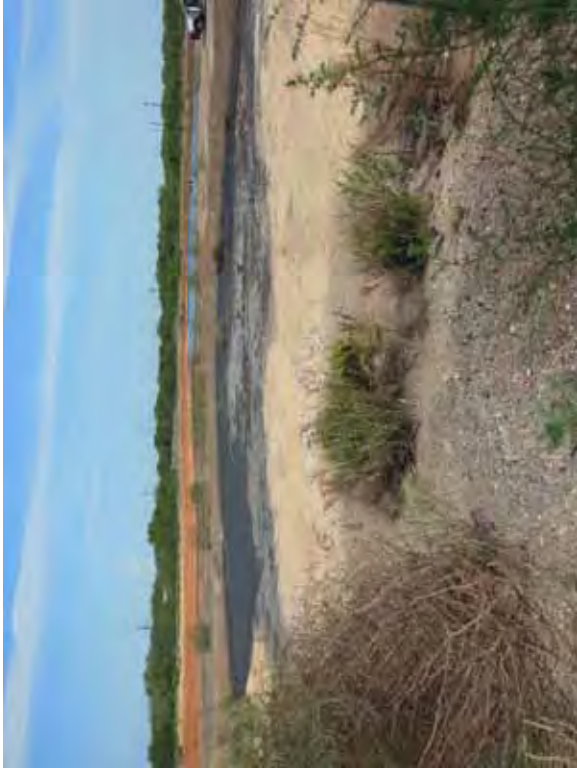
Photo 122: Interior slope at southeast corner, looking northwest.
