ASSESSMENT OF DAM SAFETY OF COAL COMBUSTION SURFACE IMPOUNDMENTS FINAL REPORT

**CPS Energy
J.K. Spruce Power Plant
San Antonio, Texas**

Prepared for
*U.S. Environmental
Protection Agency
Washington, D.C.*

February 2014
Revised May 2014
Revised June 2014

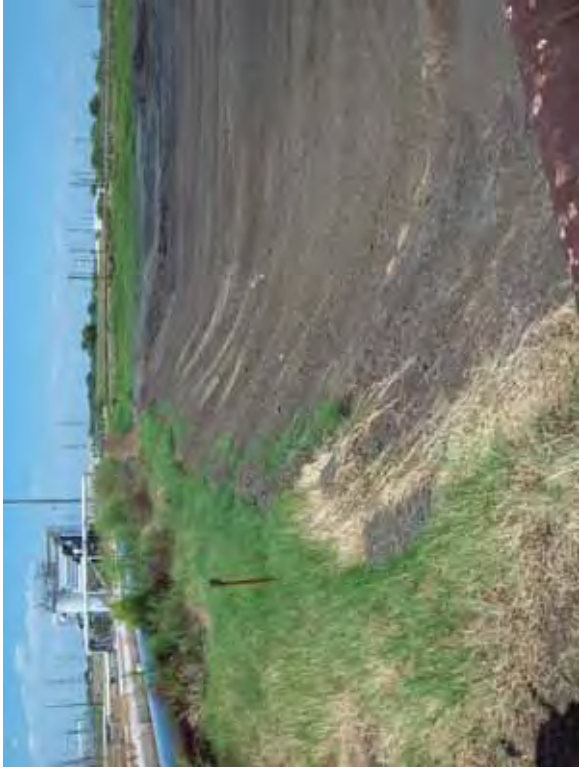
Photo 1: East embankment interior slope, looking north.

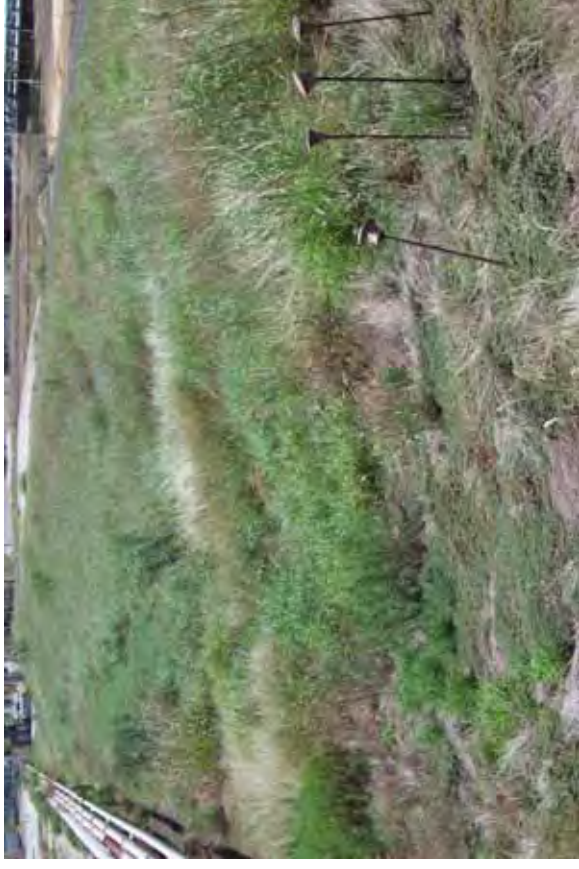
Photo 2: South embankment exterior slope, looking west.

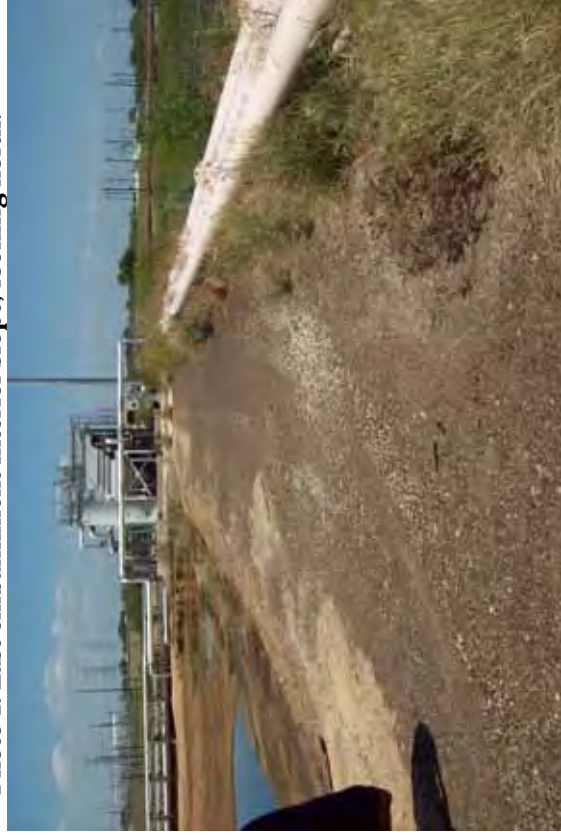
The crest of the SRH Pond appeared to be in satisfactory condition (Photographs 3, 13, 20, and 50). The crest was approximately 15 feet wide at all embankments except at the east embankment where it widened to approximately 50 feet to accommodate the clarifier pad (Photograph 8). Two spillways that connect the SRH and South Bottom Ash Ponds were located on the east embankment crest (Photographs 5 and 9). Supports for overhead piping were located at the west embankment crest (Photograph 22). The crest of the embankments consists of compacted granular soils and gravel and is exposed to minimal vehicle traffic. No depressions or evidence of settlement were observed on the crest.

Photo 3: East embankment crest, looking north.

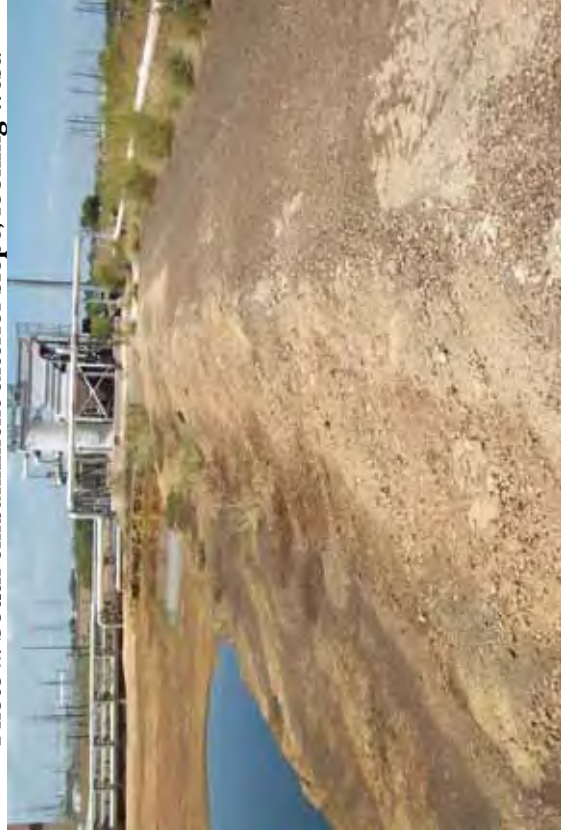
Interior slopes of the SRH Pond appear to be in fair condition (Photographs 4, 12, 14, 19, 45, and 51). Interior slopes were at 3H:1V and covered in a layer of granular material and other solids. Some sparse vegetation was observed in limited areas on the east and north embankment interior slopes (Photographs 4, 8, 9, and 17). Concrete roadway ramps into the pond for equipment access were located at the north and south embankment interior slopes (Photographs 17 and 53). Two spillway inlets were located on the east embankment interior slope (Photograph 7 and 11). Piping and sump pumps were located on a concrete pad built into the west embankment interior slope (Photograph 19 and 25). Visible portions of interior slopes did not include riprap or other armoring.

Photo 4: East embankment interior slope, looking north.

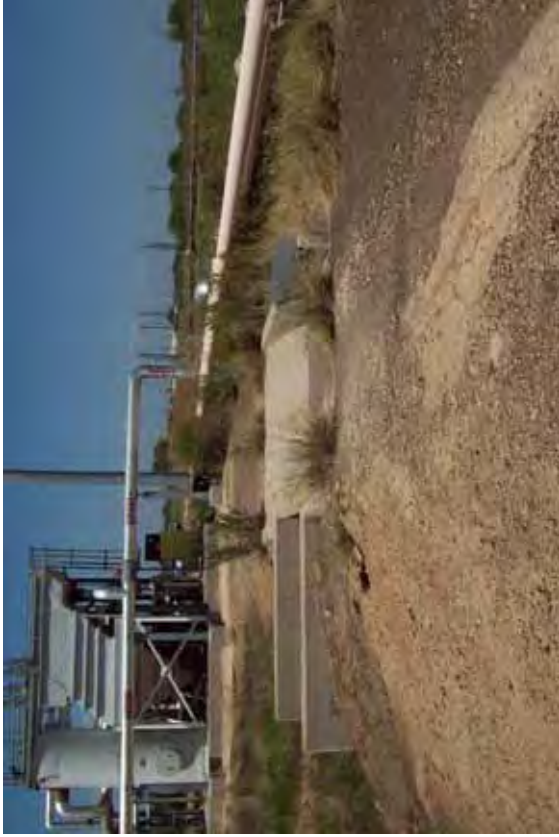
Photo 5: Spillway between SRH Pond and South Bottom Ash Pond at east embankment crest, looking north.

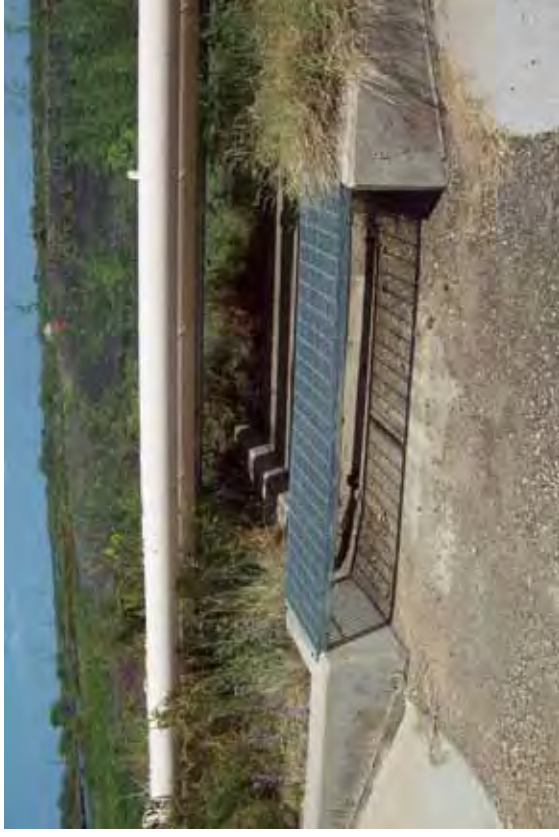
Exterior slopes of the SRH Pond appear to be in fair condition (Photographs 1, 15, 21, 46, and 52). The exterior slopes of the north, west, and south embankments are approximately 3H:1V and covered in grassy vegetation approximately 3 inches tall. The north embankment is shared with the #1 Stormwater Runoff Pond (Photograph 15). The east embankment is shared with the South Bottom Ash Pond and is covered in ash material and vegetation (Photographs 1, 6, and 10). Two spillway outlets were located on the east embankment exterior slope (Photograph 6 and 10). No areas of erosion or indications of seepage were observed at the spillways.

Photo 6: Spillway between SRH Pond and South Bottom Ash Pond at east embankment exterior slope, looking east.

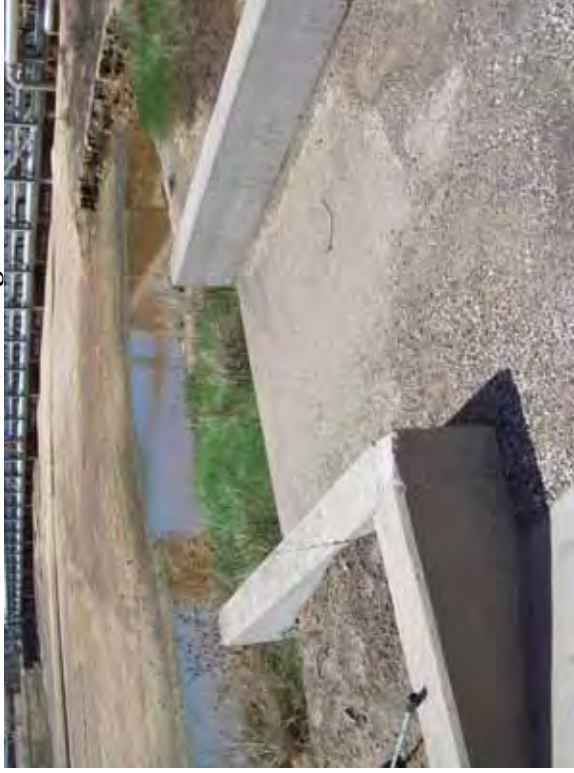
Photo 7: Spillway between SRH Pond and South Bottom Ash Pond at east embankment interior slope, looking west.

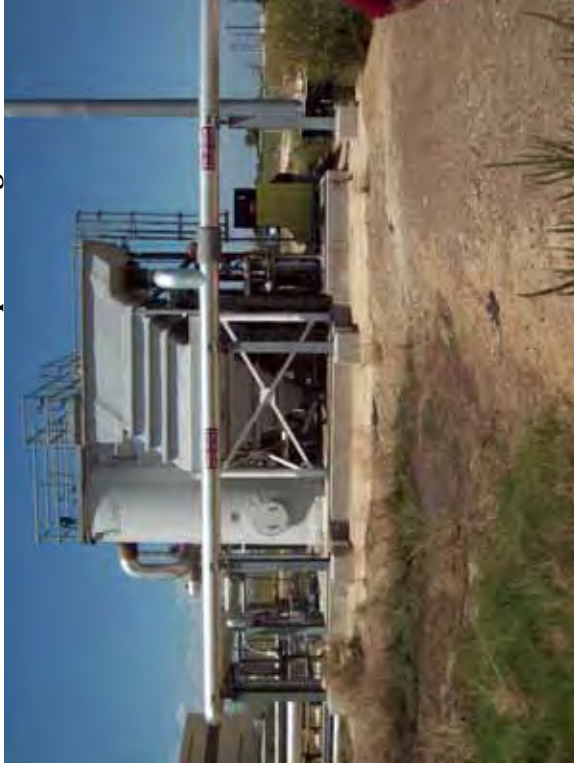
Photo 8: SRH Pond clarifier structure at east embankment crest, looking north.

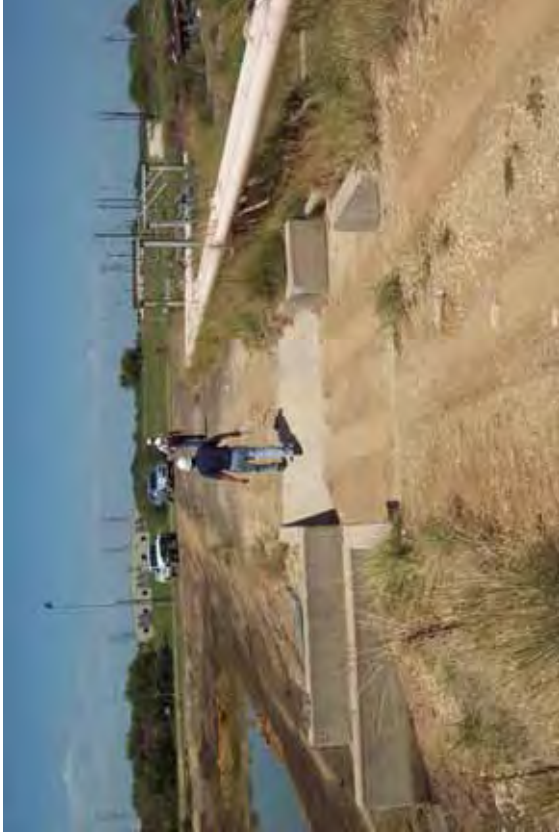
Photo 9: Spillway between SRH Pond and South Bottom Ash Pond at east embankment crest, looking north.

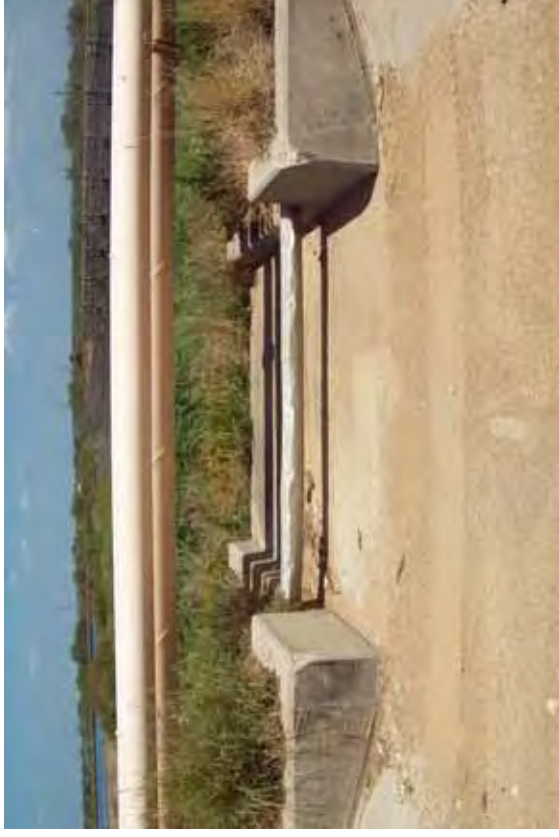
Photo 10: Spillway between SRH Pond and South Bottom Ash Pond at west embankment exterior slope, looking east.

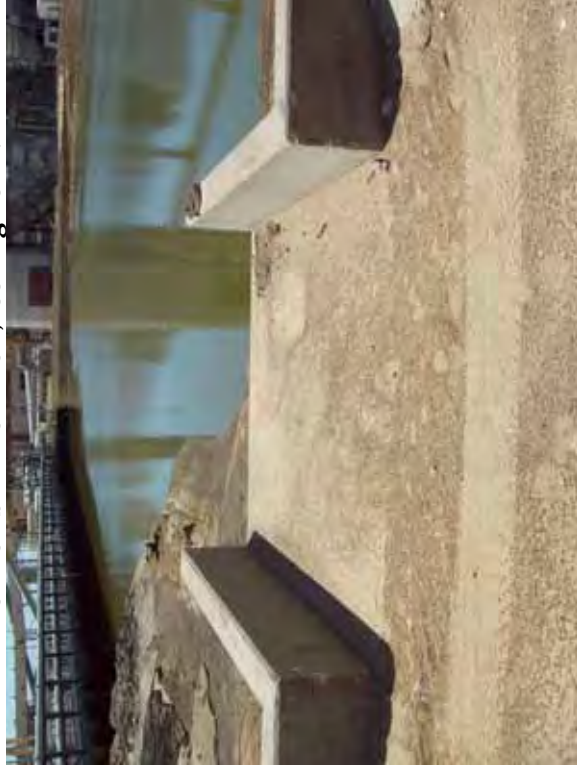
Photo 11: Spillway between SRH Pond and South Bottom Ash Pond at east embankment interior slope, looking west.

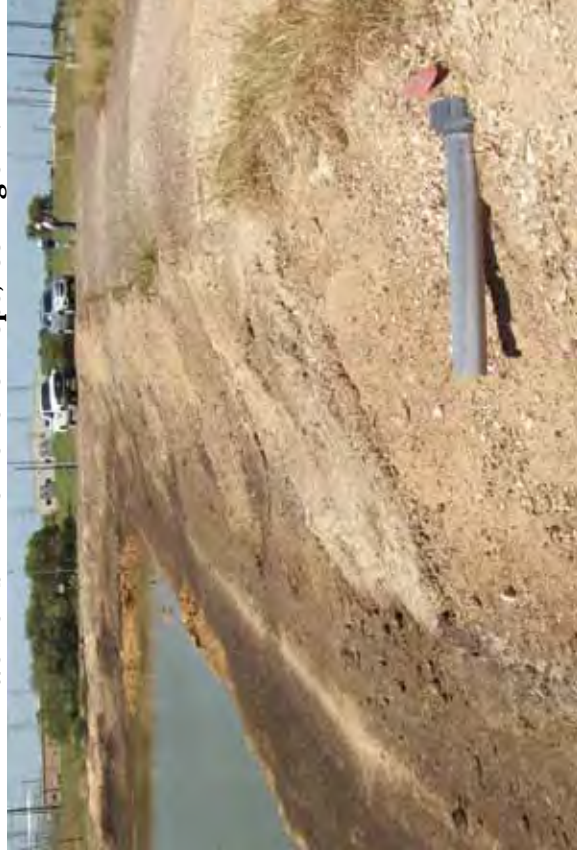
Photo 12: East embankment interior slope, looking north.

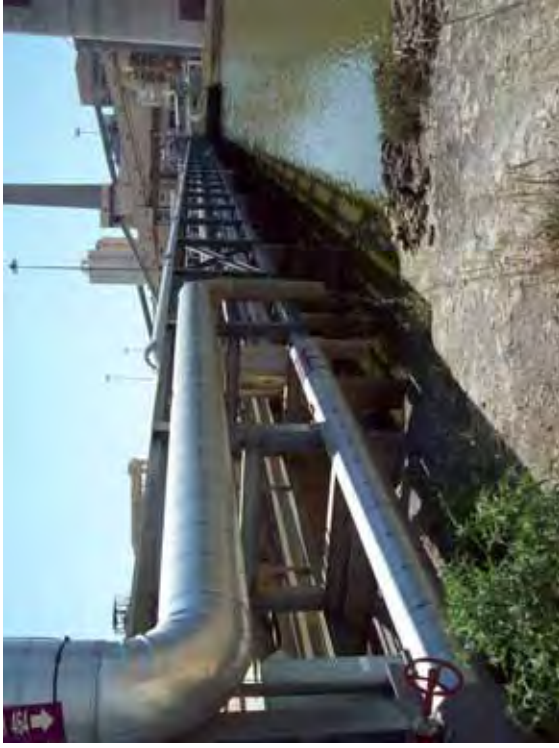
Several inlet pipes discharge liquids near into the north section of the SRH Pond; four 4-inch-diameter, eight 6-inch-diameter and two 8-inch-diameter metal pipe (Photographs 33, 38, 39, 40, 41, 42, 43, and 44). Inlet pipes discharging liquids into the south section of the SRH Pond include; four 4-inch-diameter, eight 6-inch-diameter and two 8-inch-diameter metal pipe (Photographs 26, 28, 30, 31, 32, 34, 35, 36, and 37).

Photo 33: 6-inch and 8-inch-diameter SRH-north inlet pipe labeled "SRH Pond & Clarifier Syst 464", looking west.

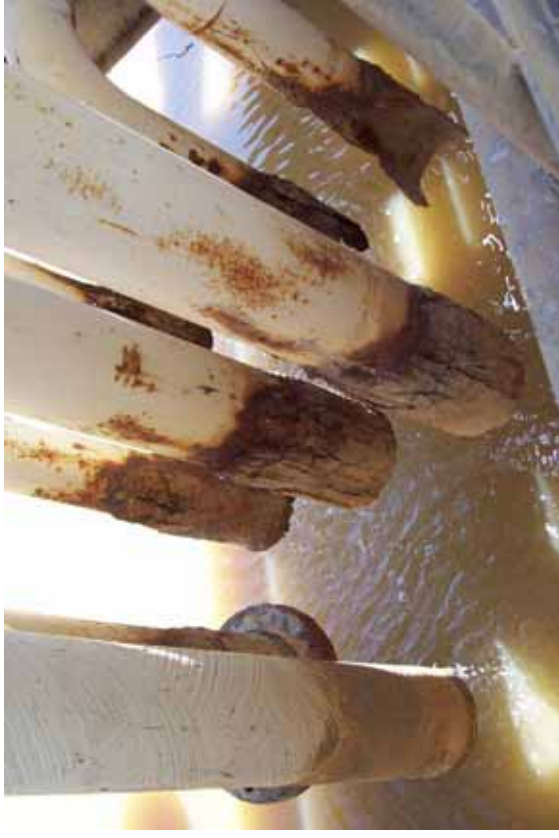
Photo 34: Nine outlet pipes into SRH-south, looking south.

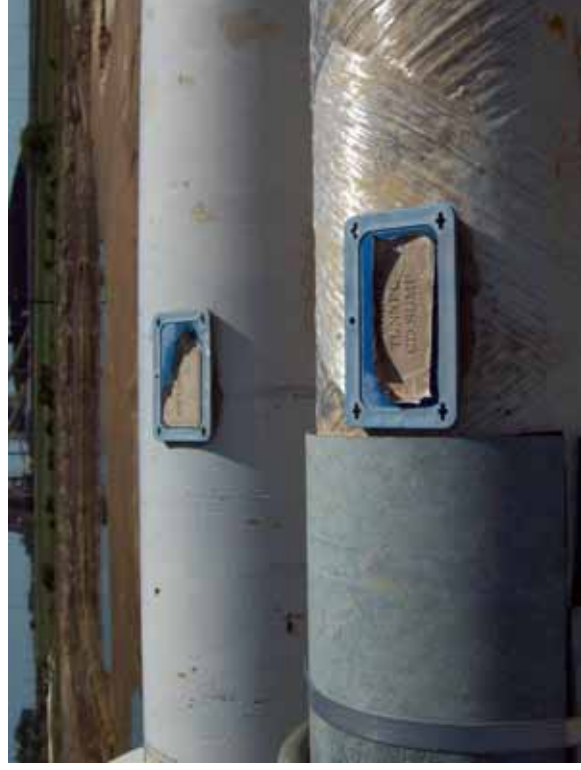
Photo 36: Labels for left two 6-inch-diameter inlets shown in Photo 34.

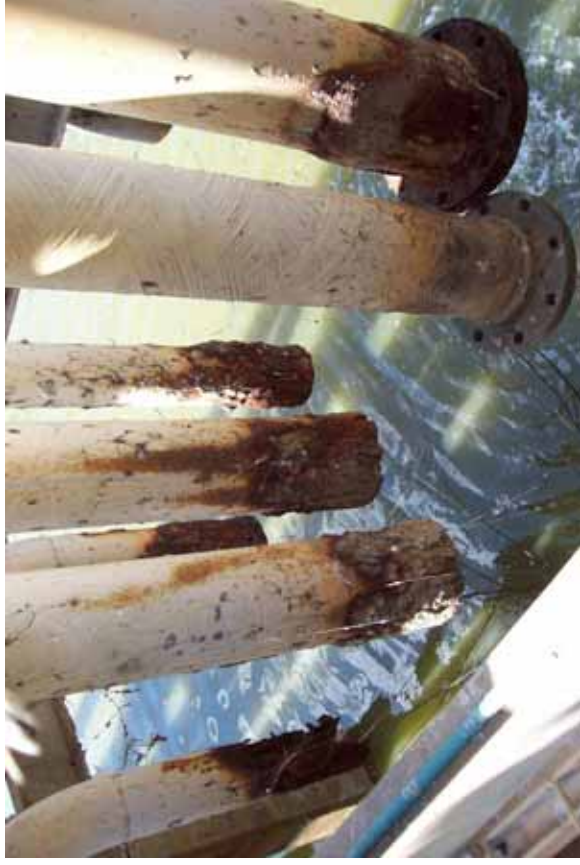
Photo 38: Nine outlet pipes into SRH-north, looking north.

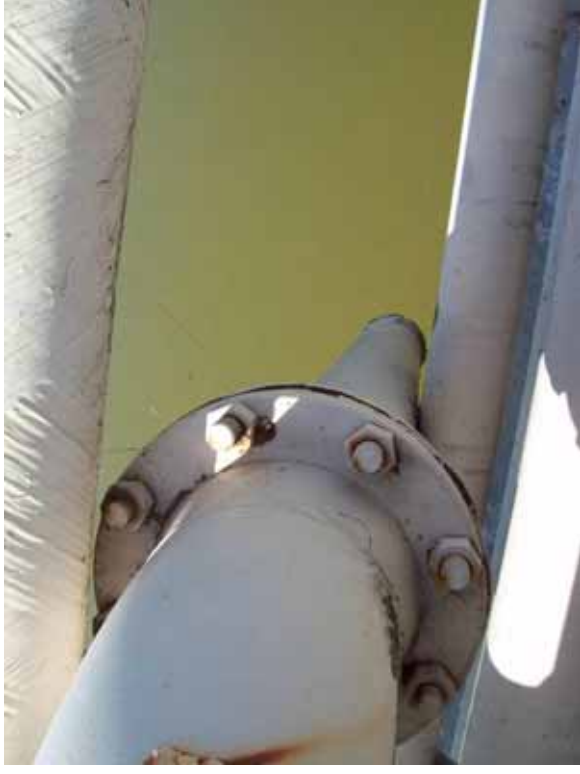
Photo 42: 6-inch-diameter metal SRH-north inlet pipe labeled "Waste Slurry Sump", looking north.

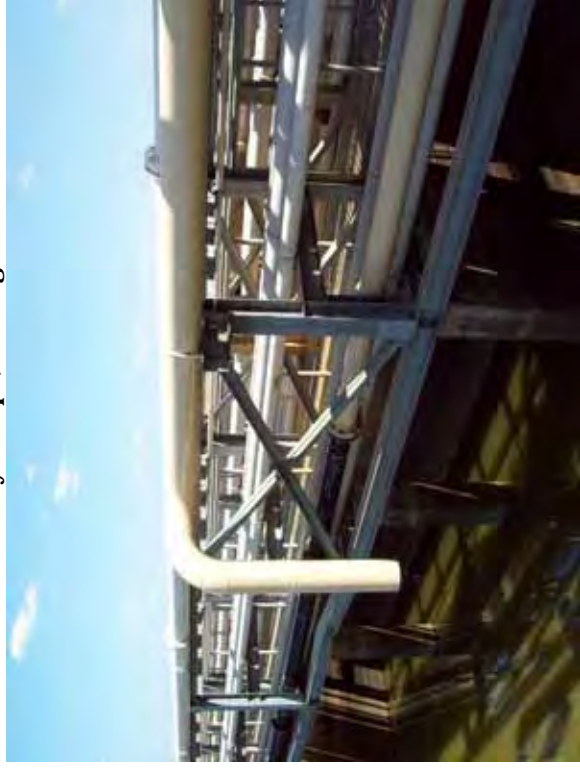
Photo 44: 8-inch-diameter metal SRH-north inlet pipe labeled "Plant Drain System III", looking southeast.

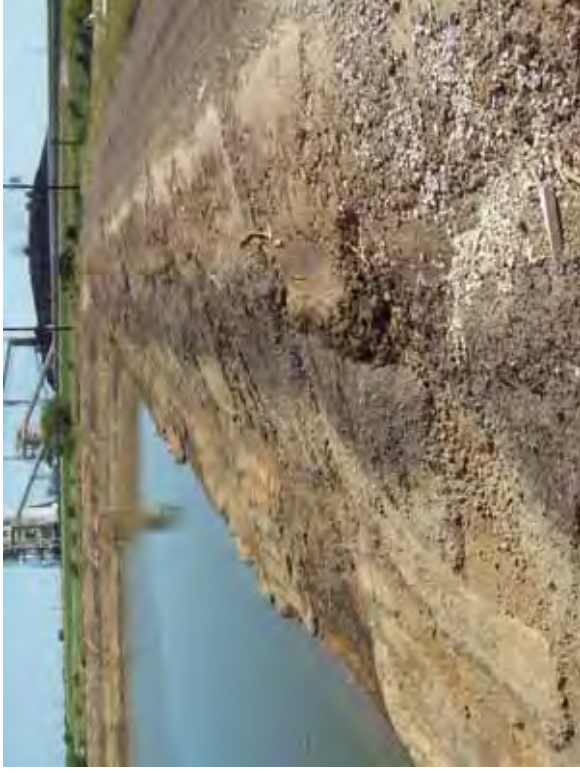
Photo 45: West embankment interior slope, looking south.

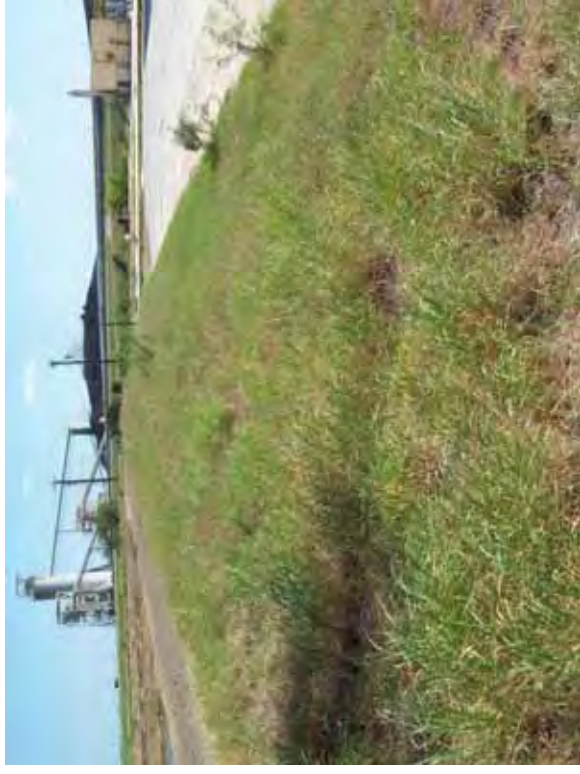
Photo 46: West embankment exterior slope, looking south.

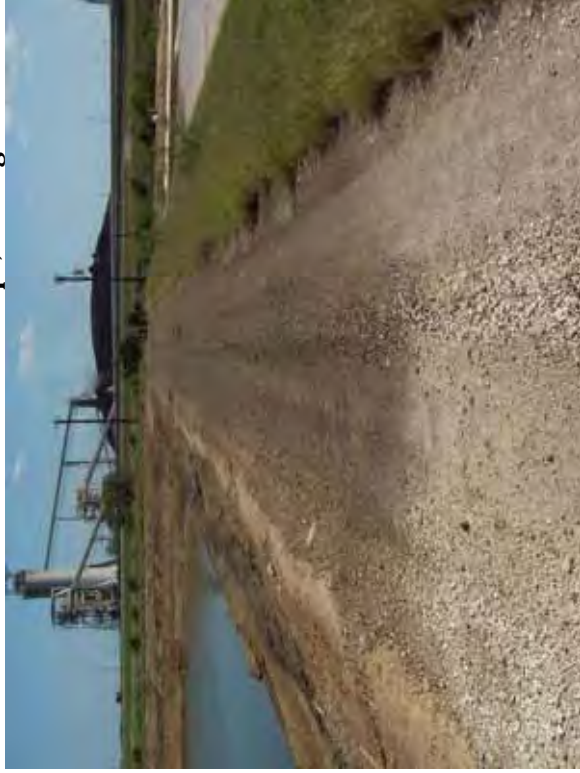
Photo 47: West embankment crest, looking south.

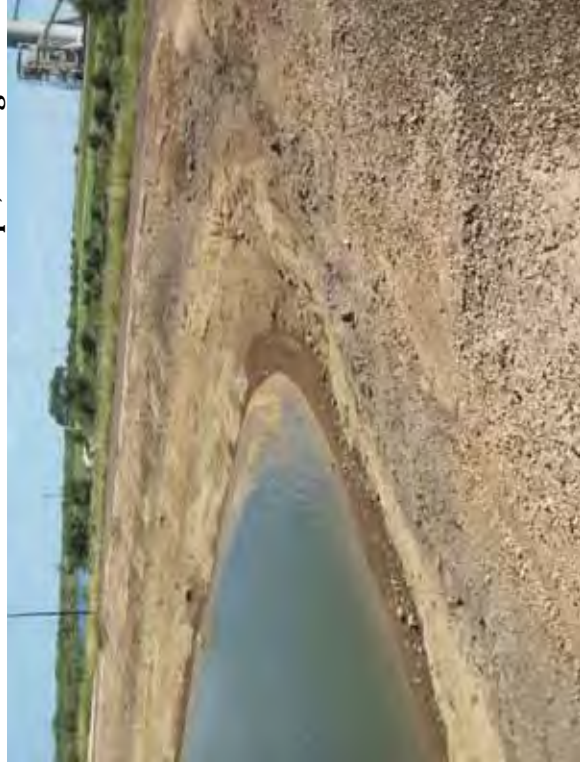
Photo 48: Interior slope at southwest corner interior slope, looking southeast.

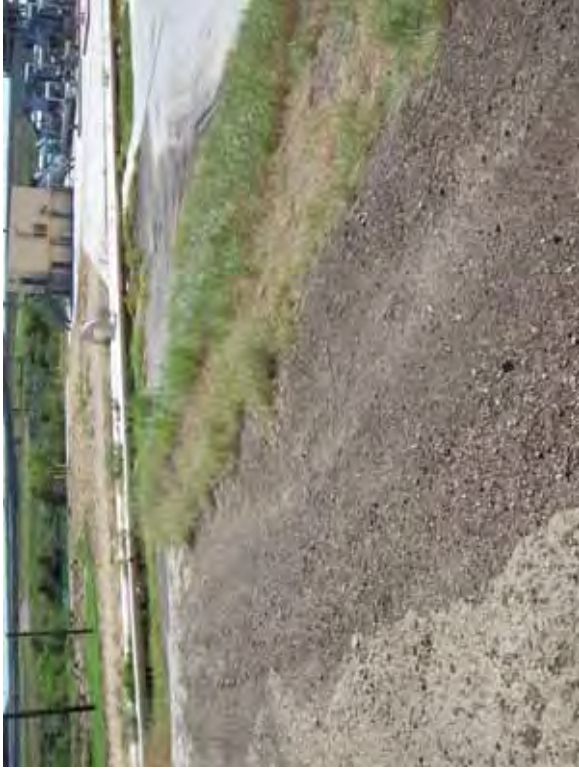
Photo 49: Exterior slope at southwest corner, looking southwest.

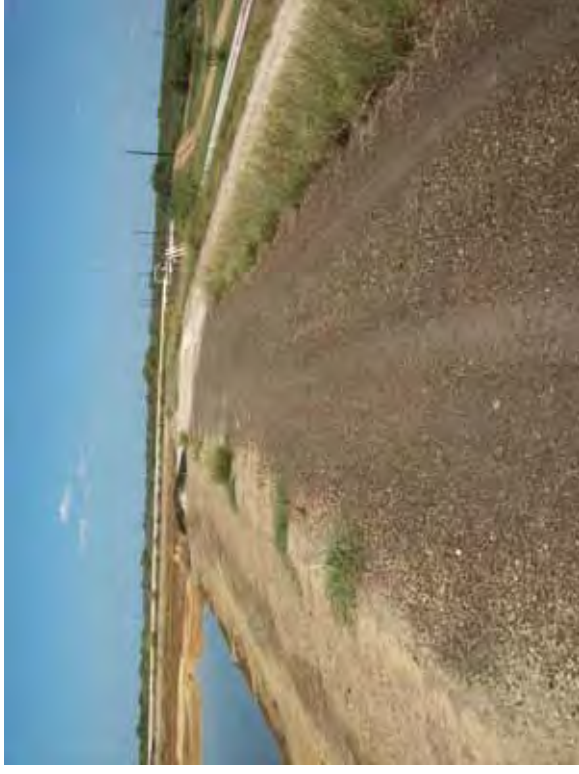
Photo 50: South embankment crest, looking east.

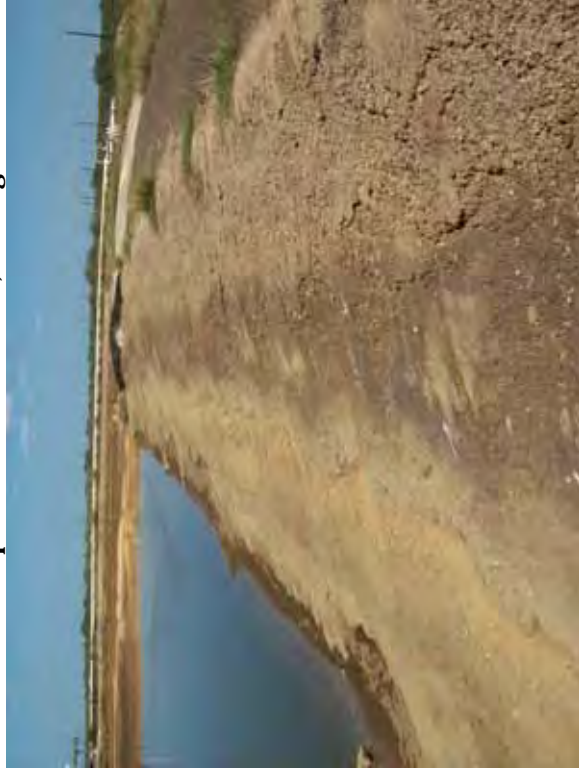
Photo 51: South embankment interior slope, looking east.

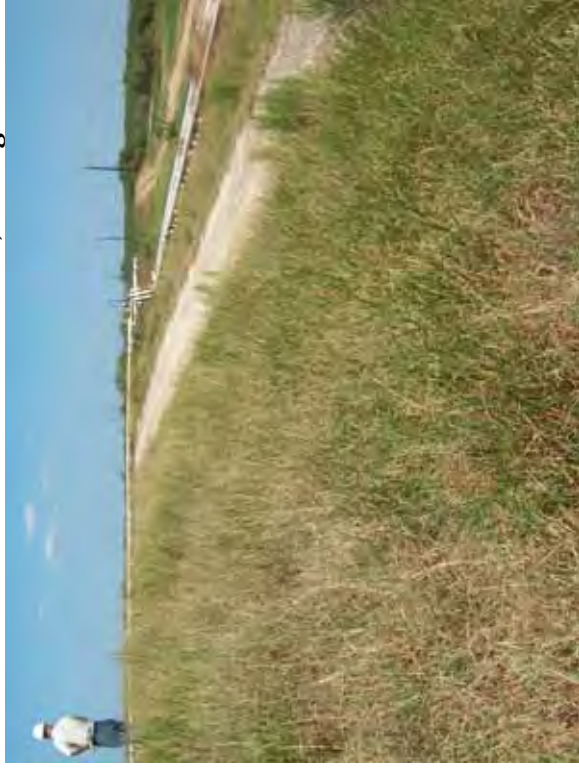
Photo 52: South embankment exterior slope, looking east.

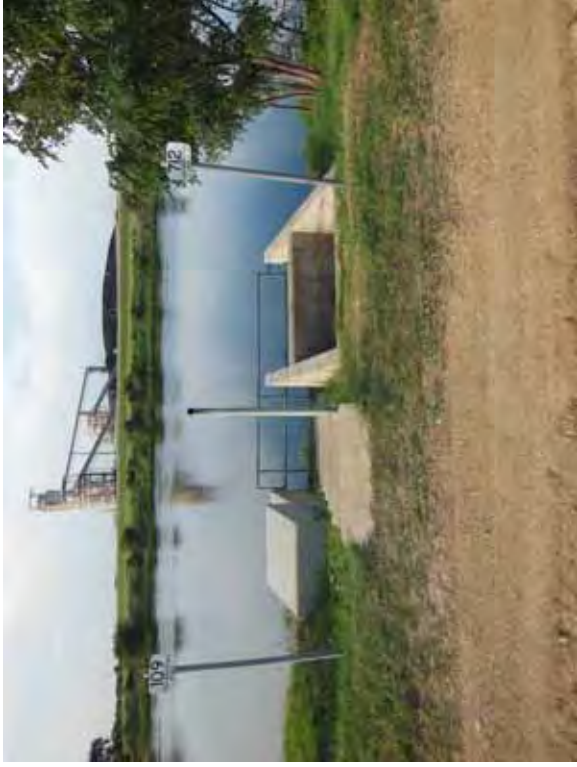
The outlet structure near the west embankment interior slope consists of two 18-inch-diameter steel outlet pipes, one is located in the north section of the pond and one is in the south section. The outlet pipes were submerged during the site assessment (Photographs 24 and 27). CCW is pumped through the outlet pipes to the clarifier located at the east embankment crest (Photograph 8). Liquids from the clarifiers are discharged to outfall 109 at the Plant intake canal (Photographs 55, 56, and 57).

Photo 57: SRH outfall 109, looking south.

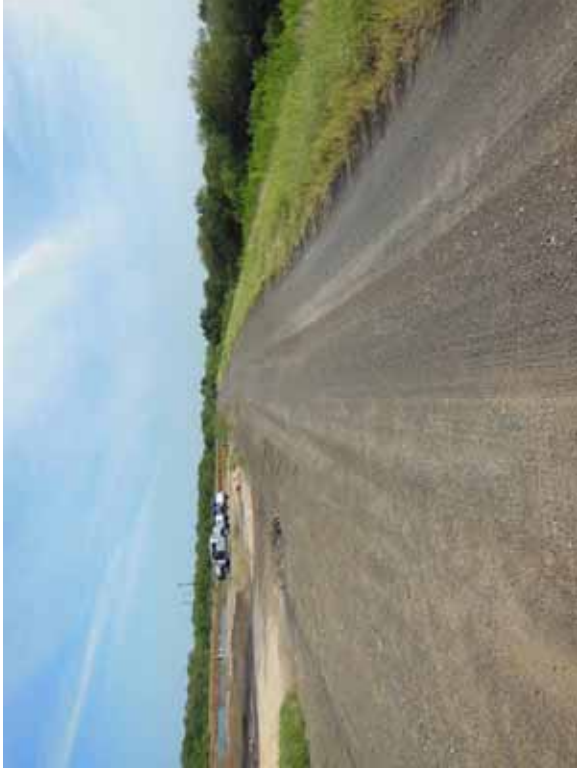
The embankment crest of the Evaporation Pond appeared to be in satisfactory condition (Photographs 58, 68, 76, and 82). The crest was approximately 15 feet wide at all embankments except the north embankment which measured approximately 50 feet wide. The crest of the embankment consists of a compacted gravel drive and grass. The surface is exposed to minimal vehicle traffic. No depressions or evidence of settlement were observed on the crest.

Photo 58: East Embankment crest, looking north.

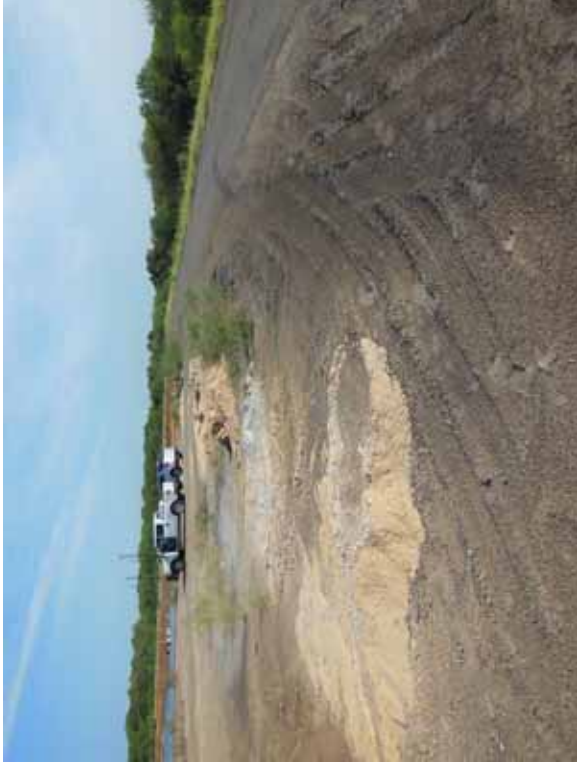
Due to the level of solids and water in the Evaporation Pond during the assessment, only the upper 0.5 to 2 ft of the interior slopes were visible (Photographs 59, 69, 70, 74, and 83). Vegetation covered some portions of the west and south embankment interior slopes (Photographs 79, 83, and 88). Ash and other solid material extend up to the crest near the southeast corner interior slope and on the east embankment interior slope (Photographs 59 and 90). Visible portions of interior slopes did not include riprap or other armoring.

Photo 59: East embankment interior slope, looking north.

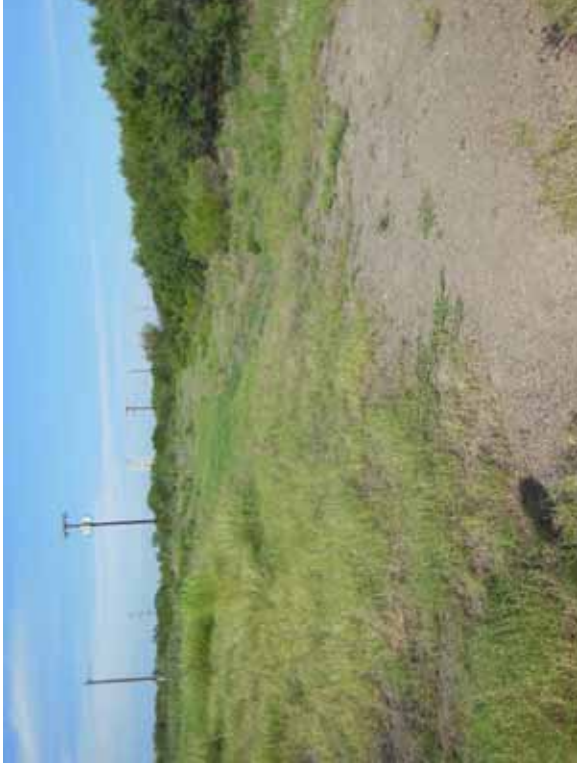
Photo 67: North embankment exterior slope, looking west.

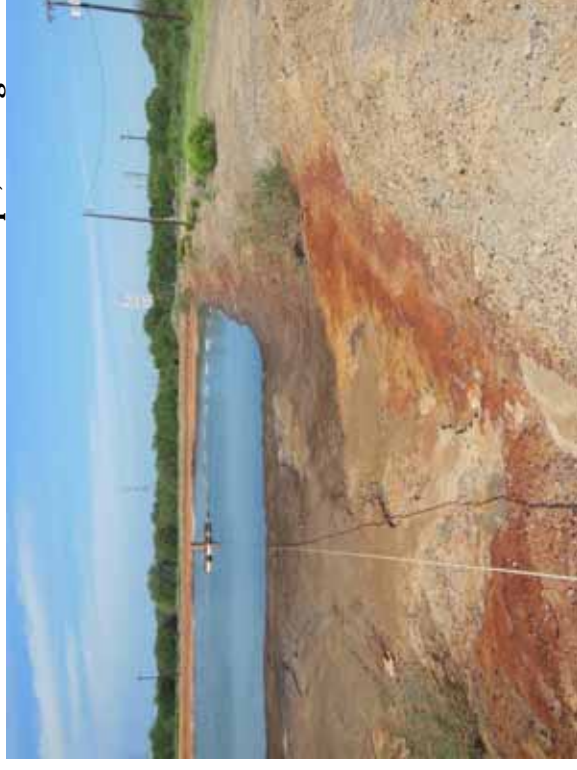
Photo 69: North embankment interior slope, looking west.

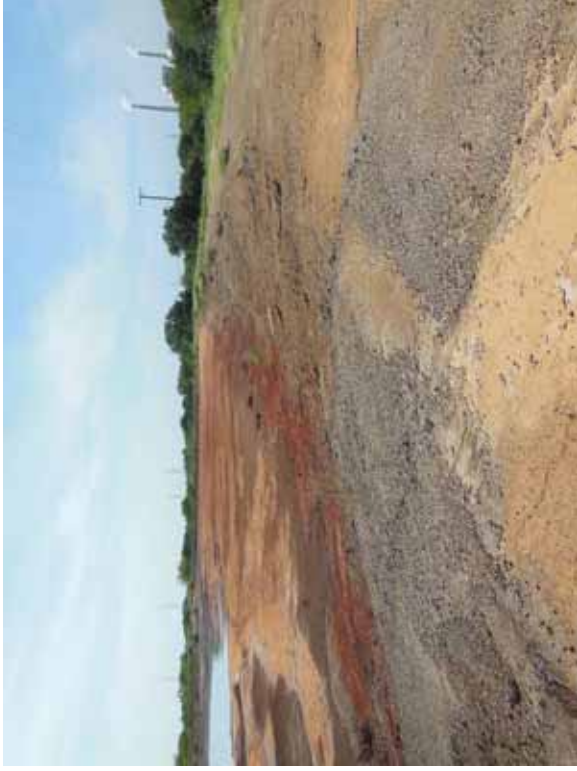
Photo 74: West embankment interior slope, looking south.

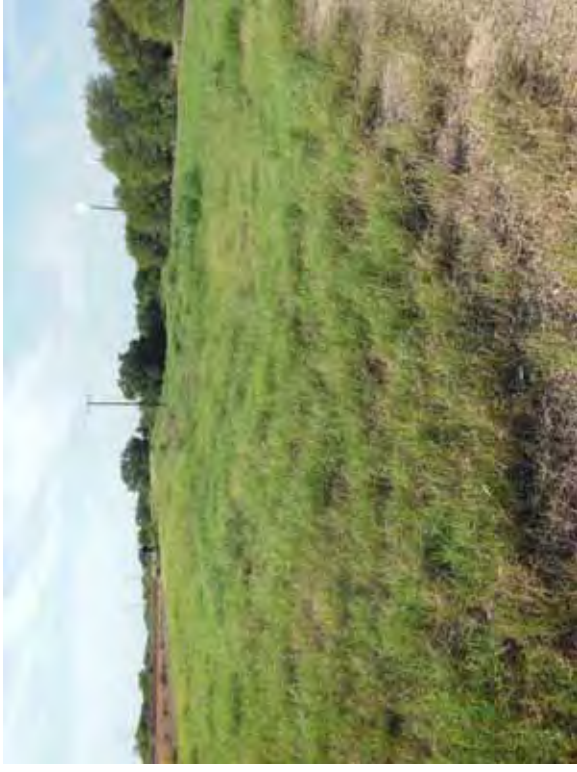
Photo 75: West embankment exterior slope, looking south.

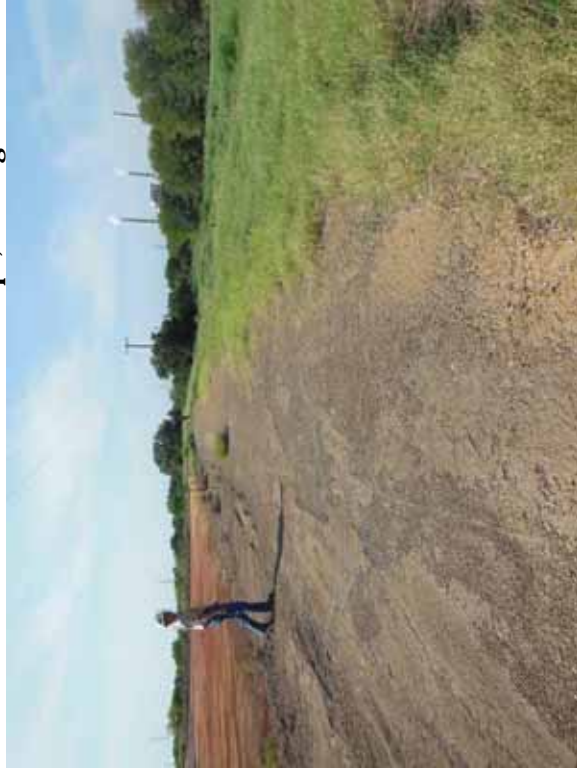
Photo 76: West embankment crest, looking south.

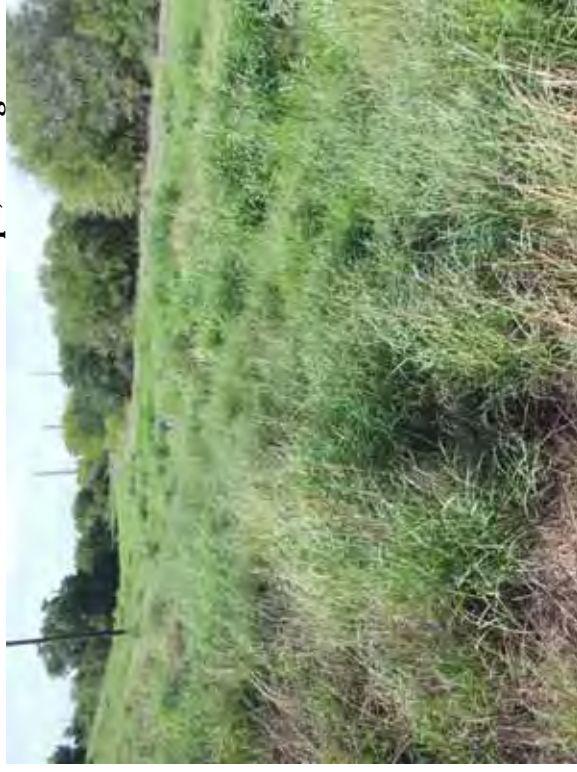
The exterior slopes appear to be in satisfactory condition and are covered in grassy vegetation approximately 2 feet high and a few small trees and bushes with diameters less than 6 inches in diameter (Photographs 61, 66, 77, and 87). Areas of loose soil were observed at the east embankment exterior slope (Photographs 60, 62, and 64) and an animal burrow was observed at the west embankment exterior slope (Photograph 78). An area of exposed soil was observed at the south embankment exterior slope (Photograph 85). Based on construction drawings, the exterior slopes are 3H:1V at all embankments, though slopes measured in the field ranged from 3H:1V to 4H:1V (Photographs 65 and 86). Trees up to 12 inches in diameter were located at the toe of all embankments (Photographs 63, 73, 80, and 87).

Photo 77: West embankment exterior slope, looking southwest.

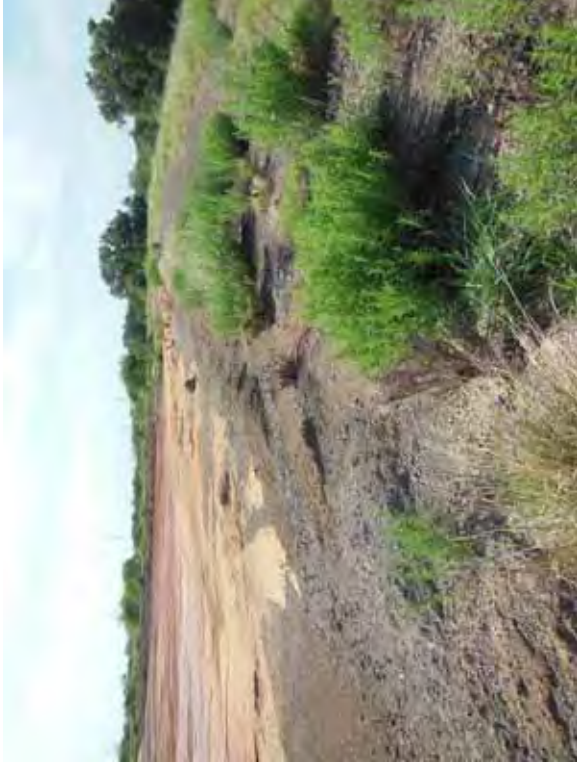
Photo 79: West embankment interior slope, looking south.

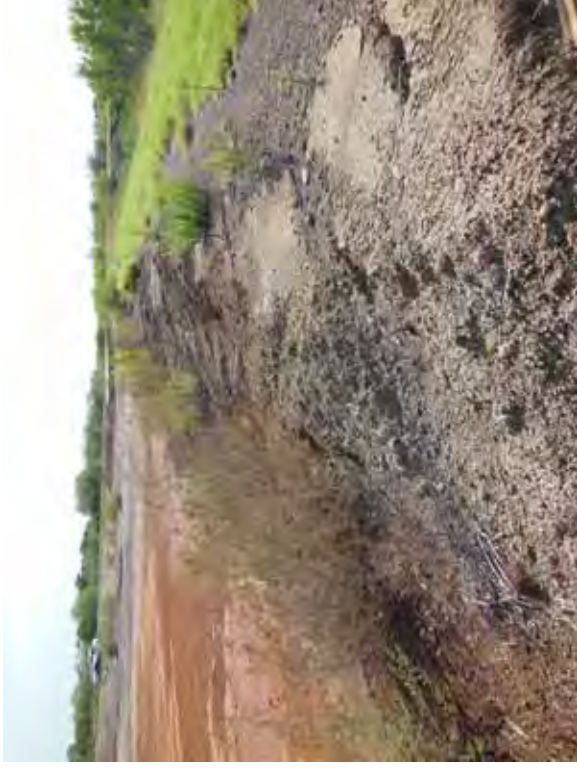
Photo 83: South embankment interior slope, looking east.

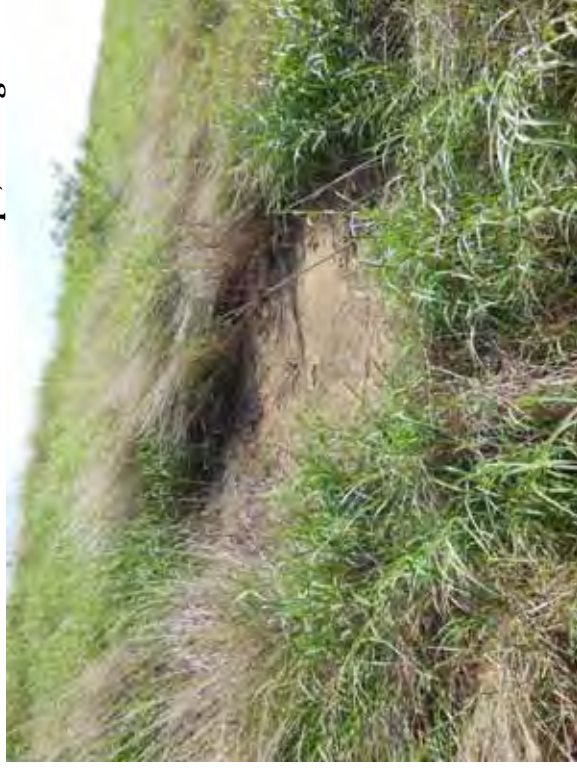
Photo 85: Exposed soil at south embankment exterior slope, looking north.

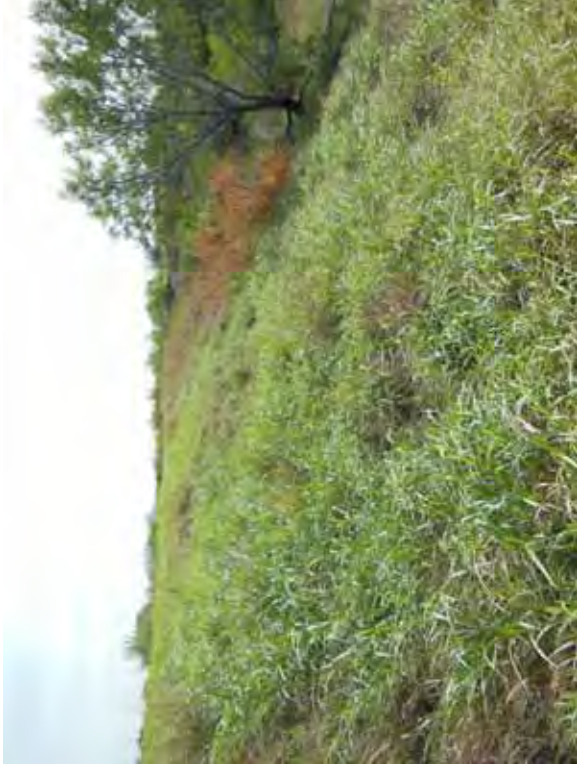
Photo 87: South embankment exterior slope, looking east.

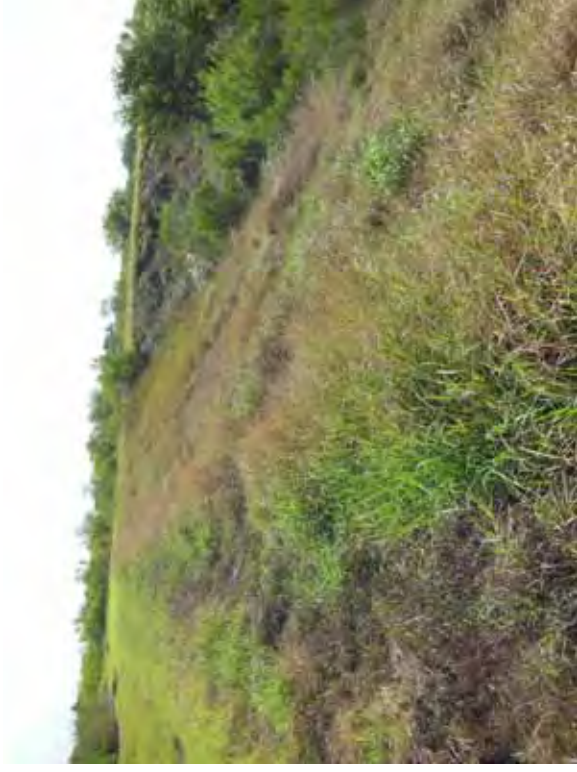
Photo 89: South embankment exterior slope, looking east.

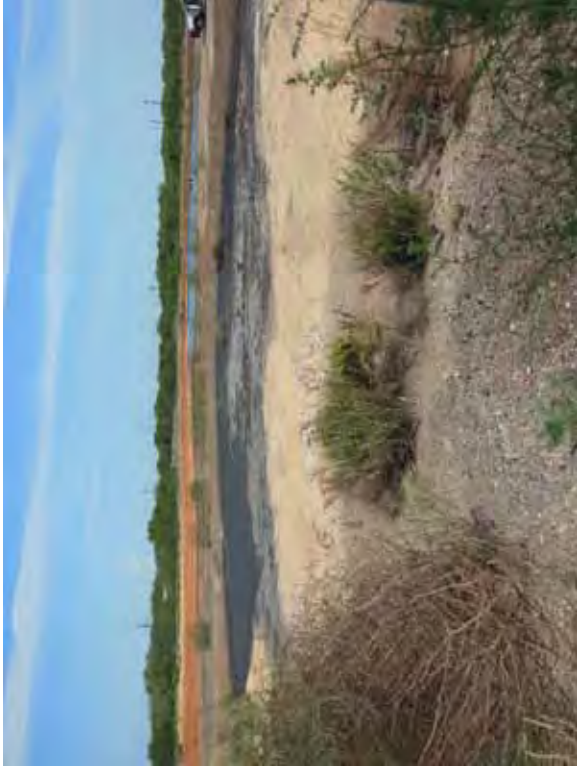
Photo 90: Interior slope at southeast corner, looking northwest.
