ASSESSMENT OF DAM SAFETY OF COAL COMBUSTION SURFACE IMPOUNDMENTS FINAL REPORT

**CPS Energy
J.T. Deely Power Plant
San Antonio, Texas**

Prepared for
*U.S. Environmental
Protection Agency
Washington, D.C.*

February 2014
Revised May 2014
Revised June 2014

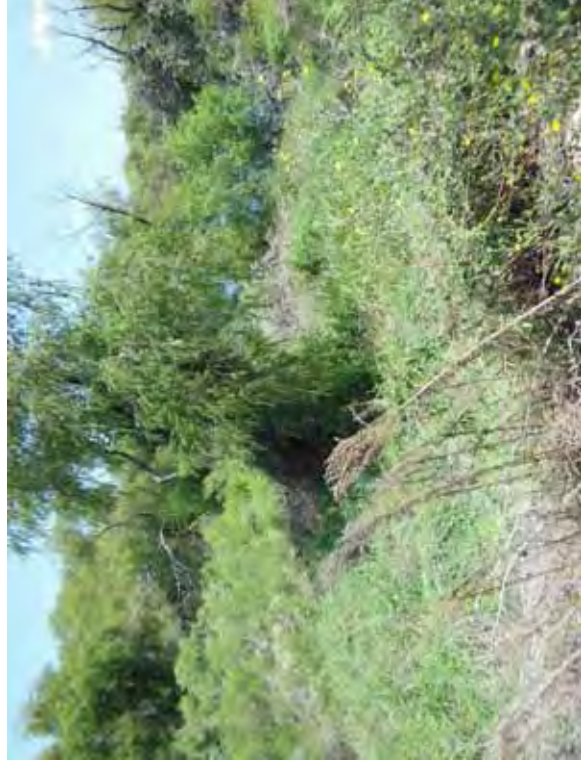
**Photo 8: NP - North embankment exterior slope, looking north. Calaveras
Lake in distance.**

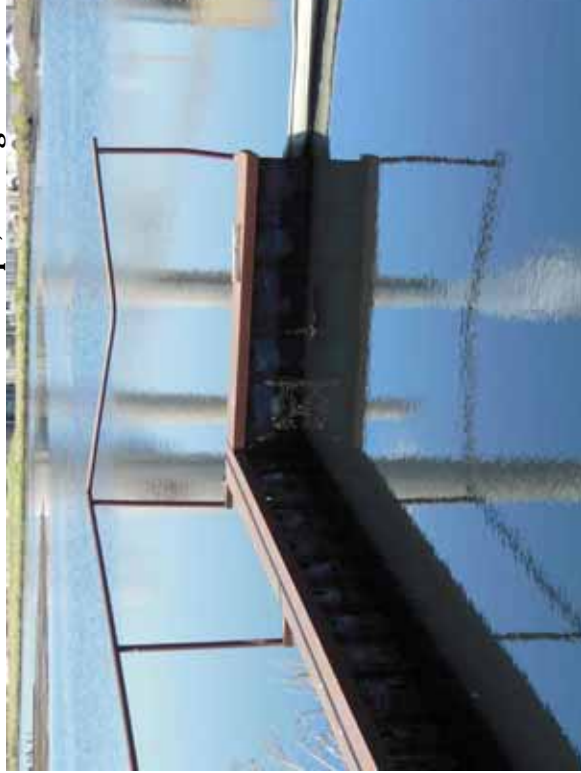
**Photo 11: NP - Outlet structure at northeast corner, looking west.
Outlet riser pipe.**

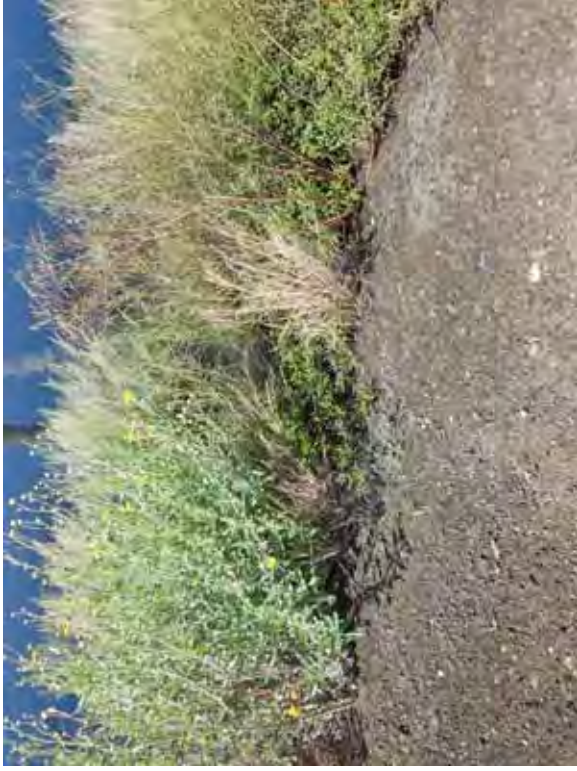
Photo 13: NP - East embankment interior slope, looking west. Note vegetation on slope.

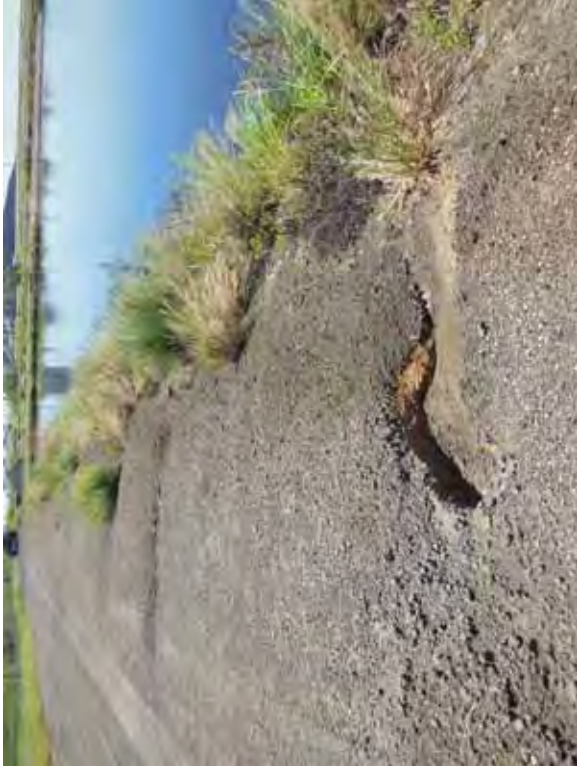
Photo 17: NP - East embankment interior slope, looking south. Note erosion rills in ash material.

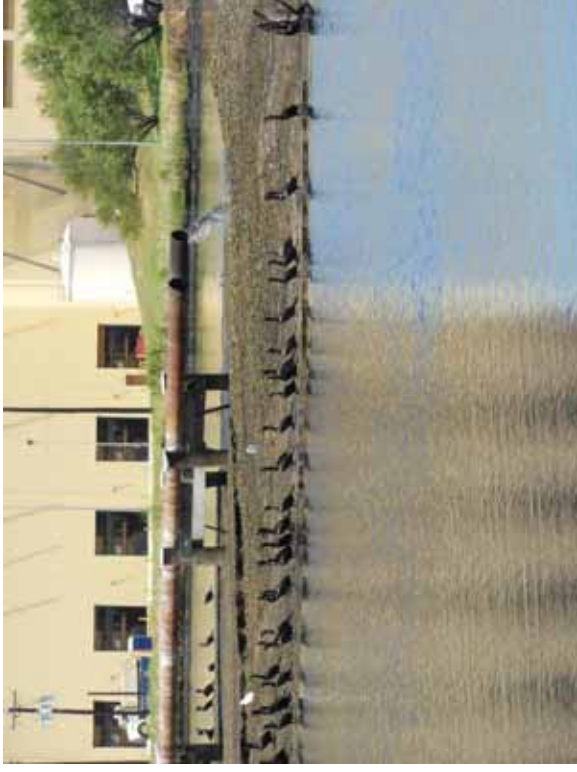
Three inlet pipes discharge liquids near the center of the North Bottom Ash Pond; two 12-inch-diameter welded steel and one 8-inch-diameter welded steel pipe (Photographs 18 and 33).

Photo 18: NP - Inlet piping, looking northwest. Piping includes one 8-inch diameter and two 12-inch-diameter pipes.

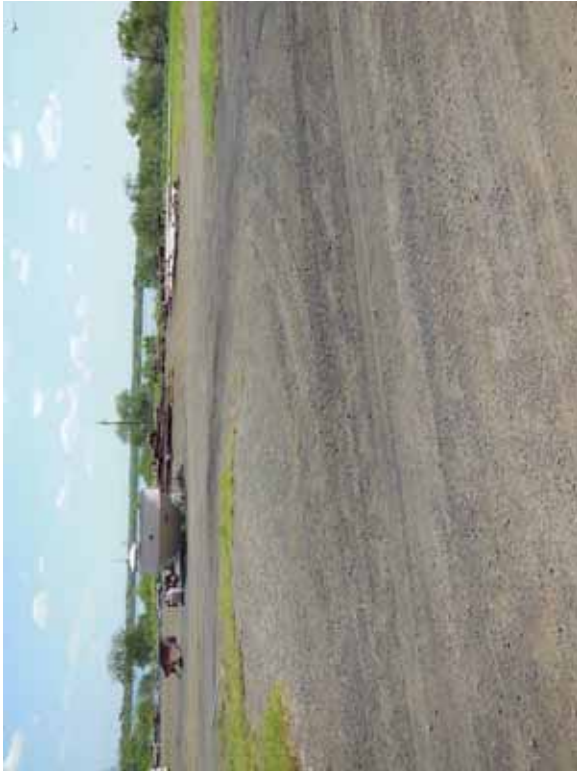
Photo 19: NP - Exterior slope at southeast corner, looking east.

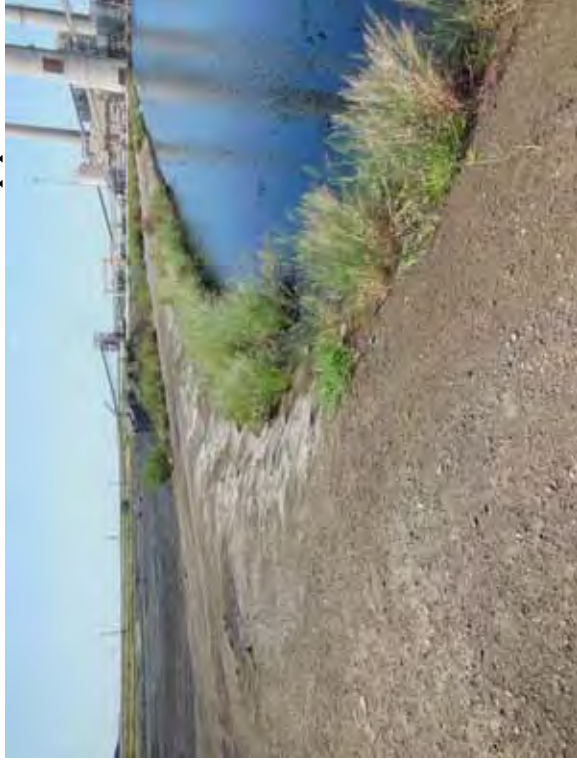
Photo 20: NP - Interior slope at southeast corner, looking west.

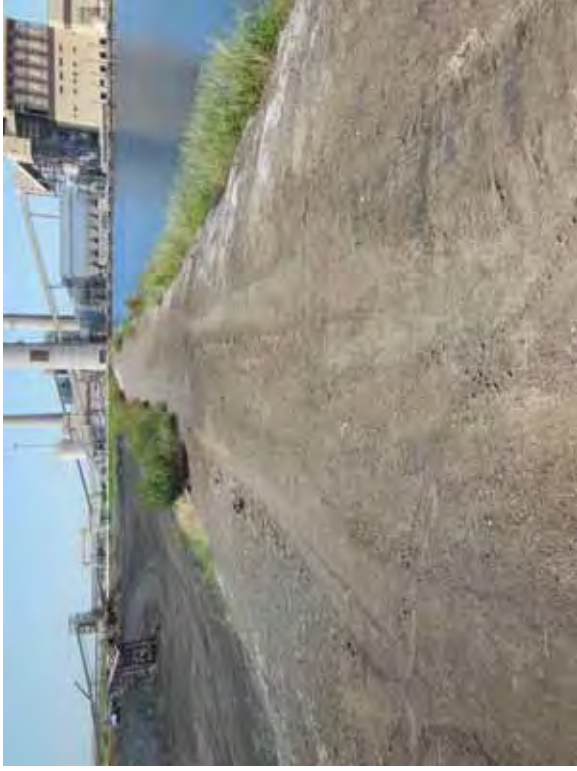
Photo 21: NP/SP - Common embankment crest, looking west.

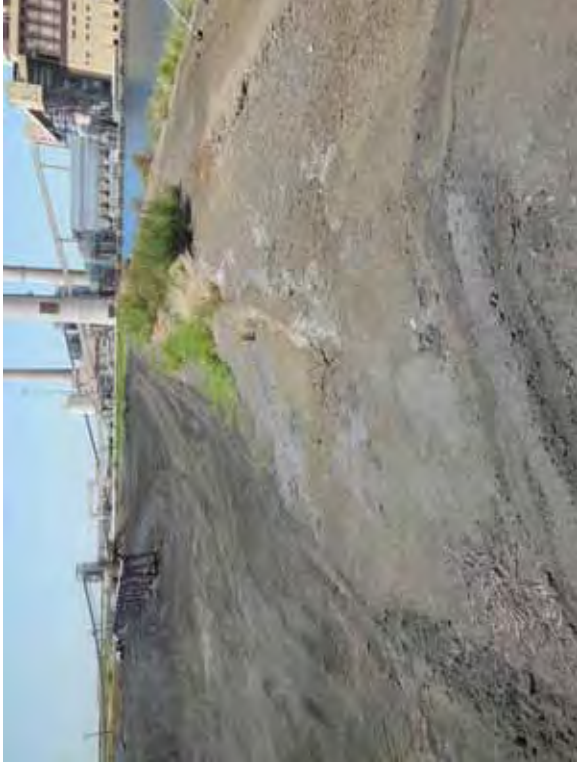
Interior slopes appeared to be in fair condition (Photographs 30, 59, 66, and 70). Based on construction drawings, the interior slopes were constructed at 2H:1V. The north embankment is shared with the North Bottom Ash Pond and is covered in ash material (Photograph 22). Vegetation is sparse, consisting primarily of grass and brush, approximately 2 feet high (Photographs 24, 25, 26, 59, 64, 70, and 84). Some areas of minor erosion into the ash material (Photographs 24, 25, and 26) were observed. A stockpile of CCW was observed on the east embankment interior slope (Photograph 57). Visible portions of interior slopes were not protected by riprap or other armoring.

Photo 22: NP/SP - Common embankment south slope, looking west.

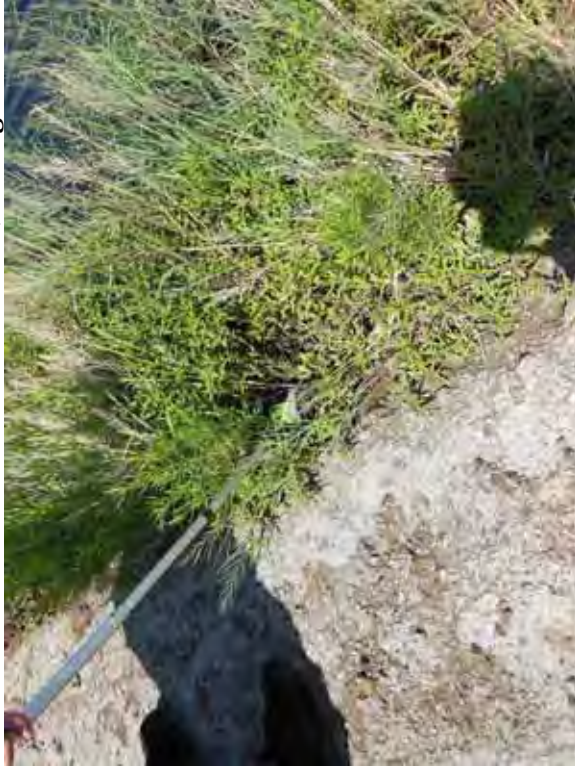
Photo 23: NP/SP - Erosion of ash material on common embankment north slope.

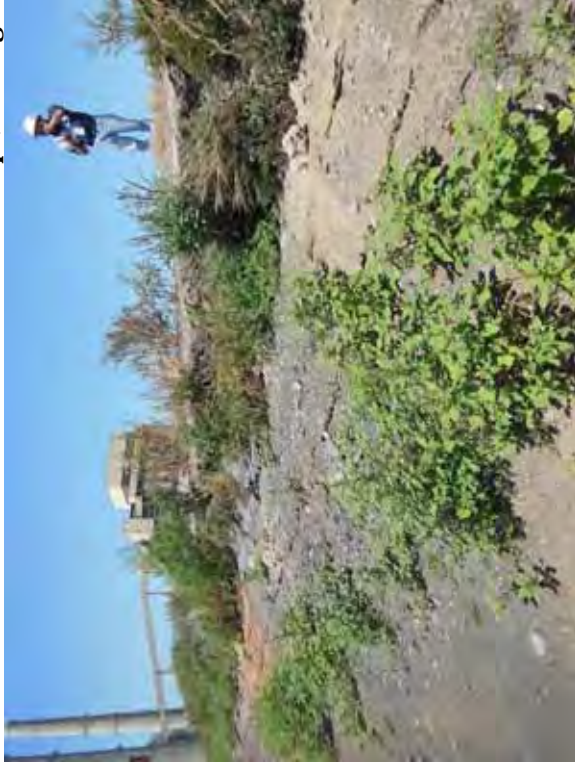
Photo 24: NP/SP - Erosion of ash material on common embankment south slope, looking northwest.

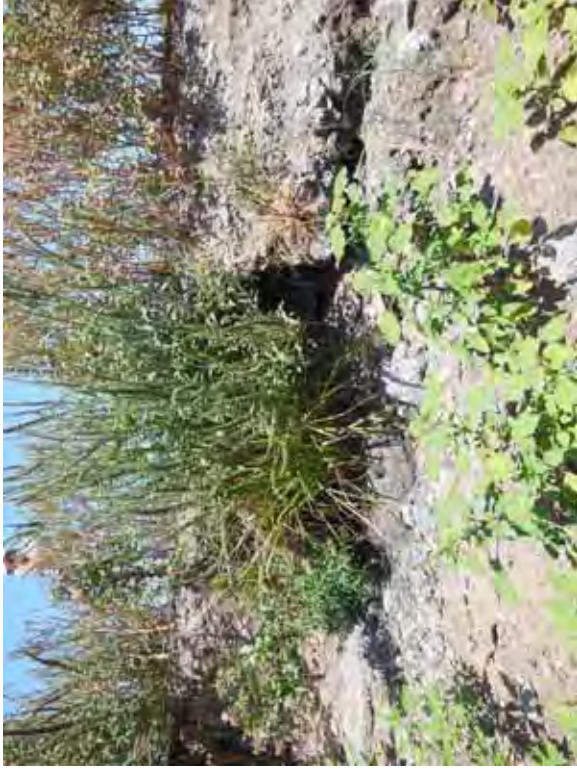
Photo 25: NP/SP - Vegetation and ash material on common embankment south slope.

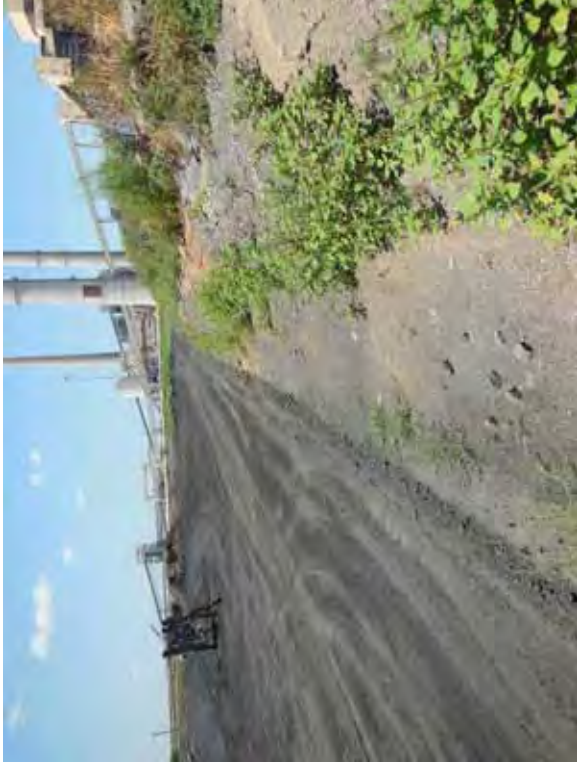
Photo 26: NP/SP - Erosion of ash material on common embankment south slope, looking west.

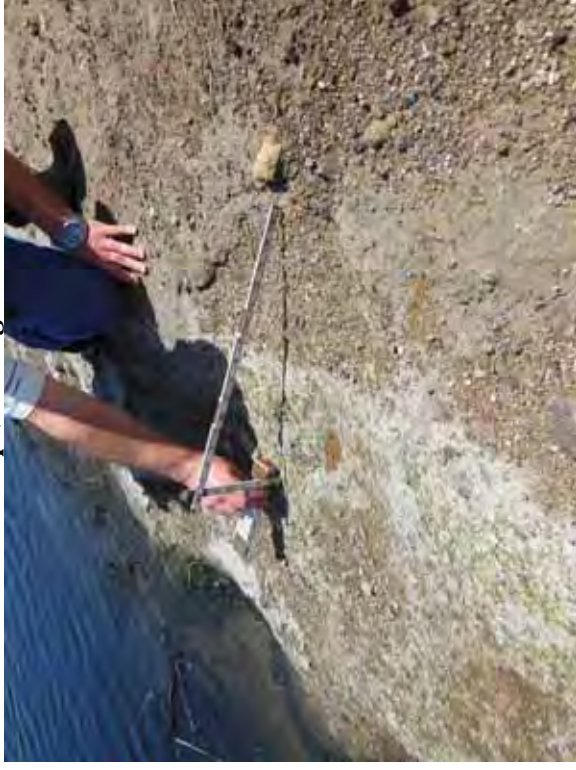
Photo 28: NP/SP - Common embankment north slope, looking east. Slope measured approximately 3H:1V.

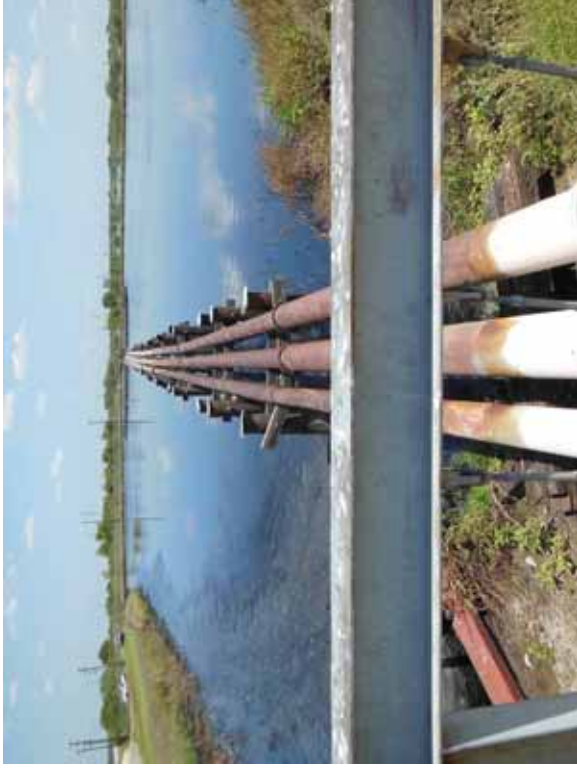
Photo 33: NP - Inlet pipes at southwest corner. Piping includes one 8-inch diameter and two 12-inch-diameter pipes.

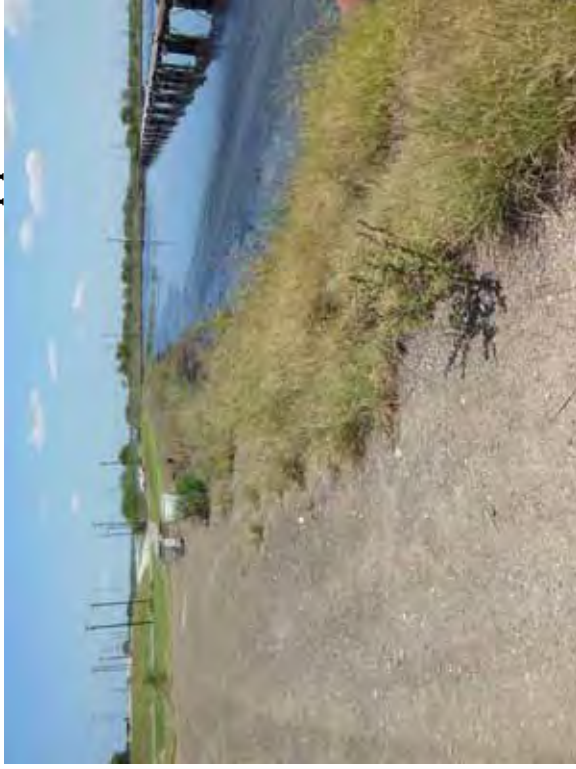
Due to the water level in the North Bottom Ash Pond during the assessment, only the upper 2 feet of the interior slopes were visible (Photographs 3, 12, 27, and 40). Based on construction drawings, the interior slopes were constructed at 2H:1V. The interior slopes were measured at approximately 3H:1V near the top of the embankment and included a layer of ash material (Photograph 28). Small areas of erosion into ash were observed on the interior slope at the east, south, and west embankments (Photographs 17, 23, 38, and 43) and an area of loose ash was observed on the east embankment interior slope (Photograph 14). Vegetation covered some portions of the interior slopes that were visible (Photographs 6, 12, 32, and 35). Visible portions of interior slopes did not include riprap or other armoring.

Photo 35: NP - West embankment interior slope, looking northeast.

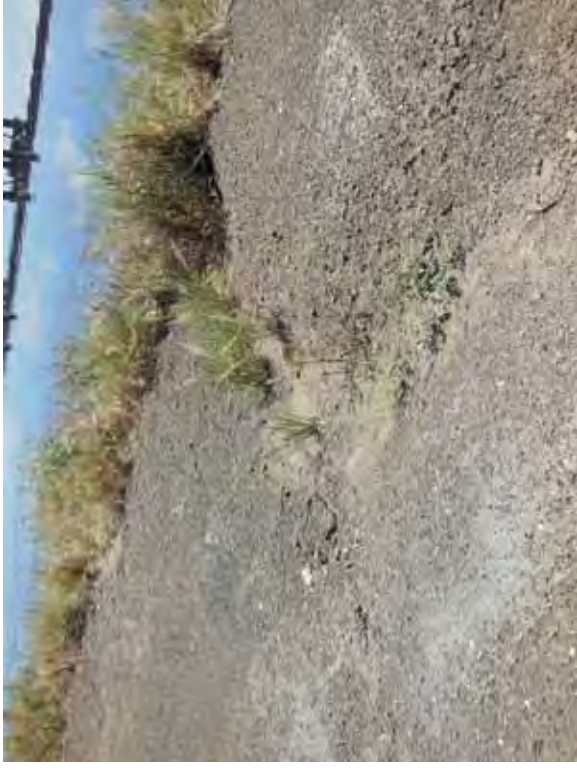
Photo 38: NP - Erosion rill in ash material at west embankment interior slope.

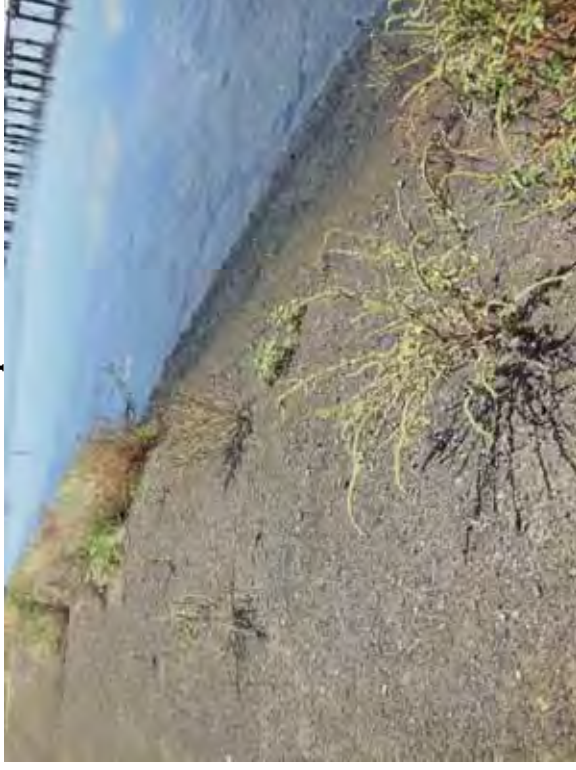
Photo 40: NP - West embankment interior slope, looking northeast.

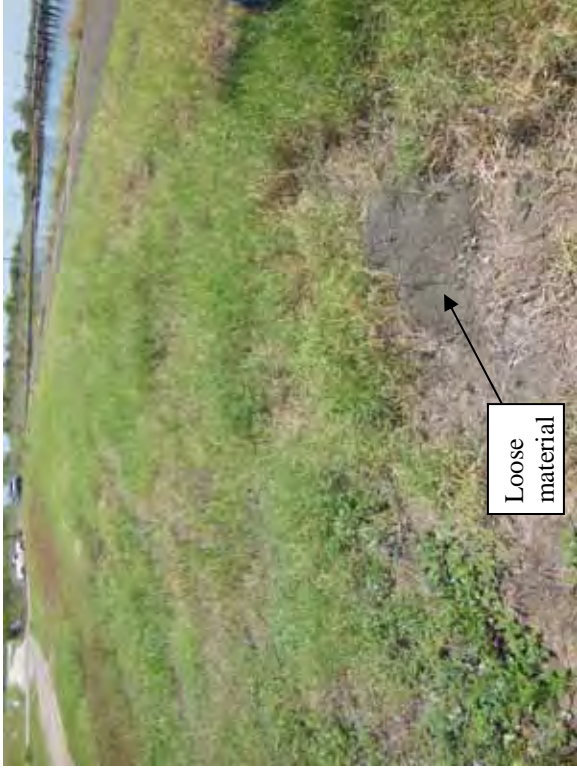
Photo 41: NP - West embankment exterior slope, looking north. Note area of loose soil/ash material.

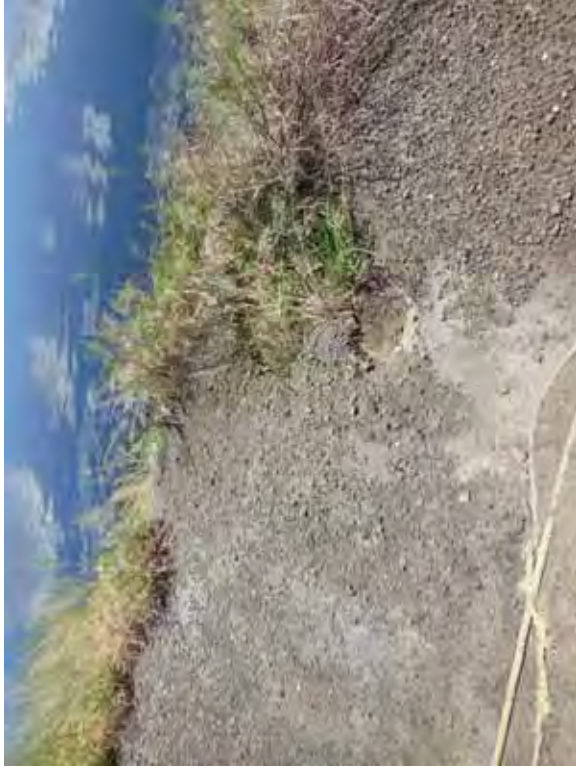
Photo 43: NP - Erosion of ash material at west embankment interior slope.

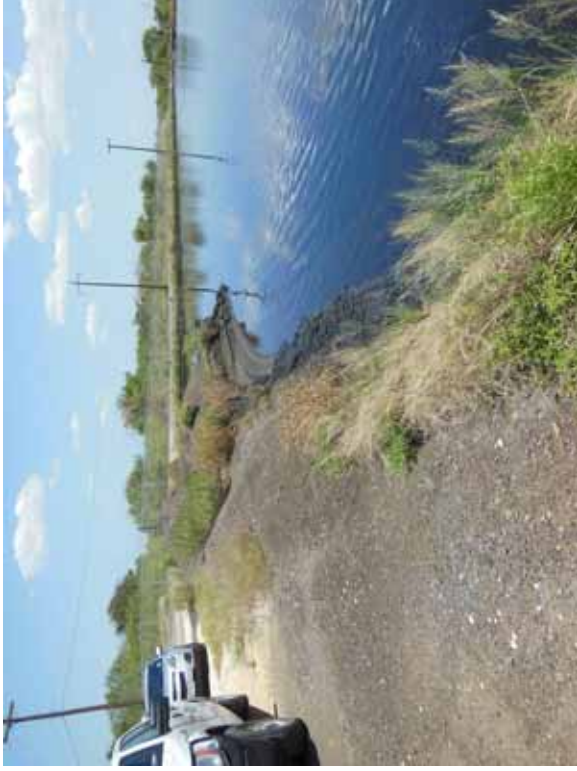
**Photo 45: NP - West embankment interior slope, looking northeast.
Note area of ash material on slope near northwest corner.**

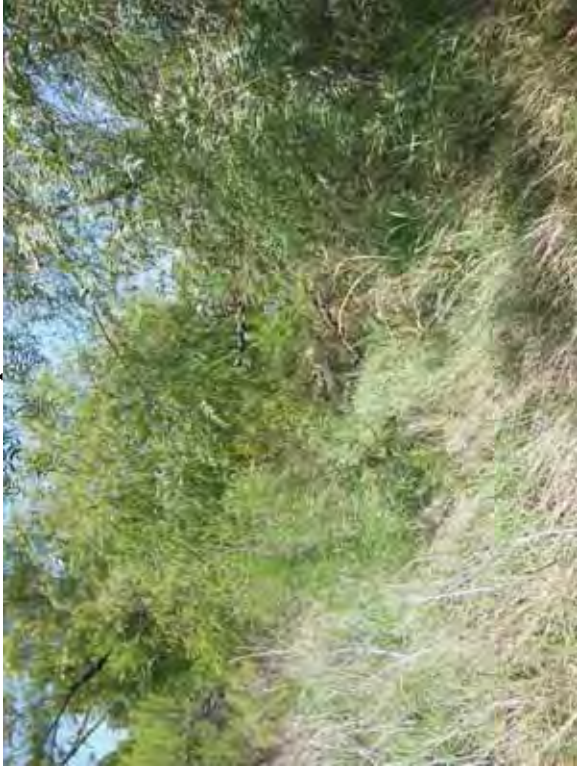
**Photo 47: NP - Vegetation on north embankment exterior slope,
looking north.**

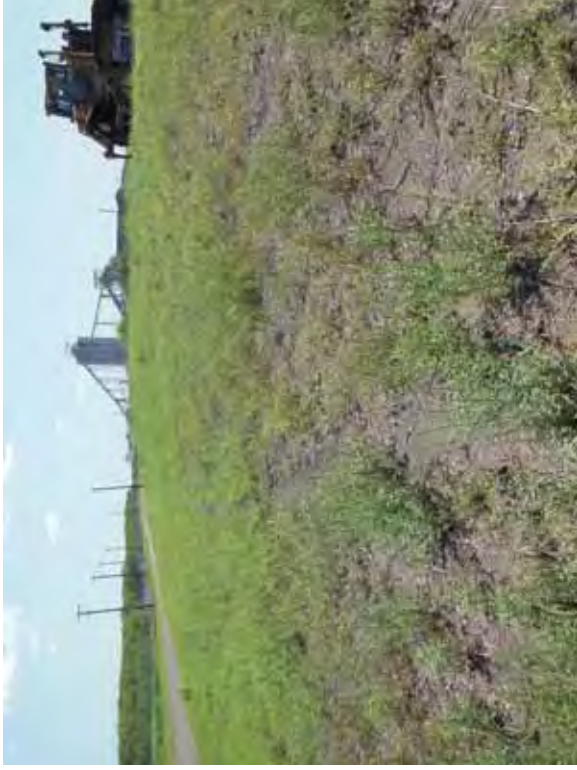
Photo 53: SP - East embankment exterior slope, looking south.

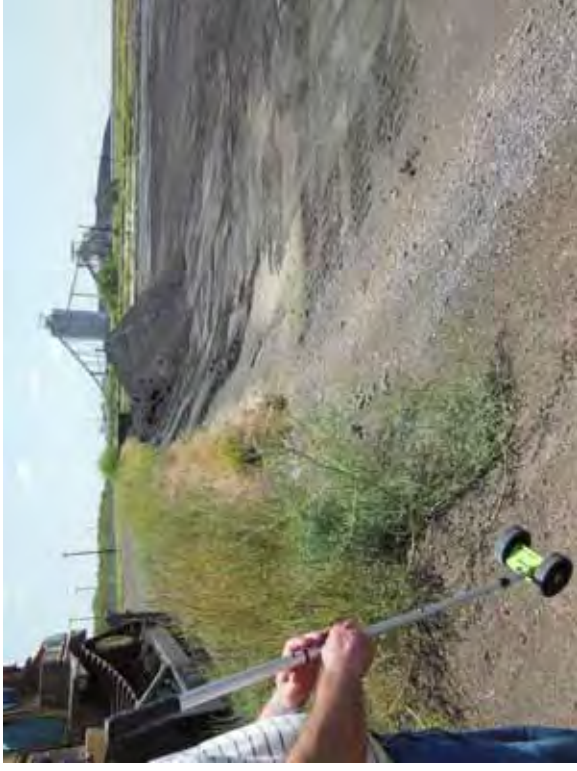
Photo 54: SP - East embankment interior slope, looking south.

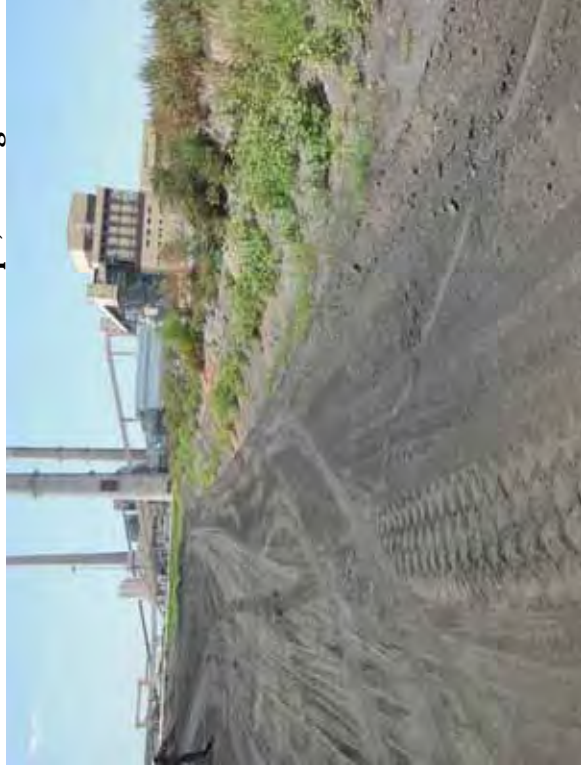
Photo 55: NP/SP - Common embankment south slope, looking west.

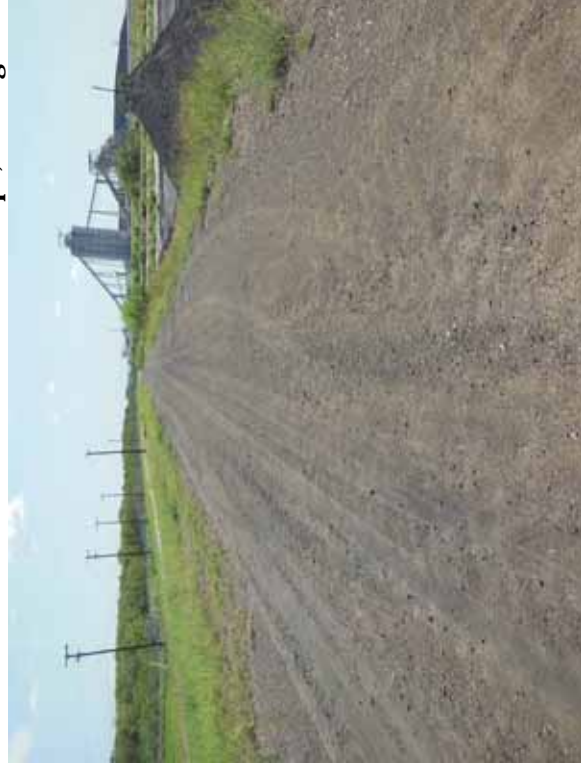
The crest of the South Bottom Ash Pond appeared to be in satisfactory condition (Photographs 29, 56, 65, and 73). All embankment crests were approximately 15 feet wide and consists of compacted granular soils and gravel and is exposed to minimal vehicle traffic. A clarifier structure associated with the adjacent SRH Pond was located on the west embankment crest (Photograph 78). The west embankment crest included two spillways connecting the SRH and South Bottom Ash Ponds (Photographs 75, 76, 77, 79, 80, and 81). No depressions or evidence of settlement were observed on the crest.

Photo 56: SP - East embankment crest, looking south.

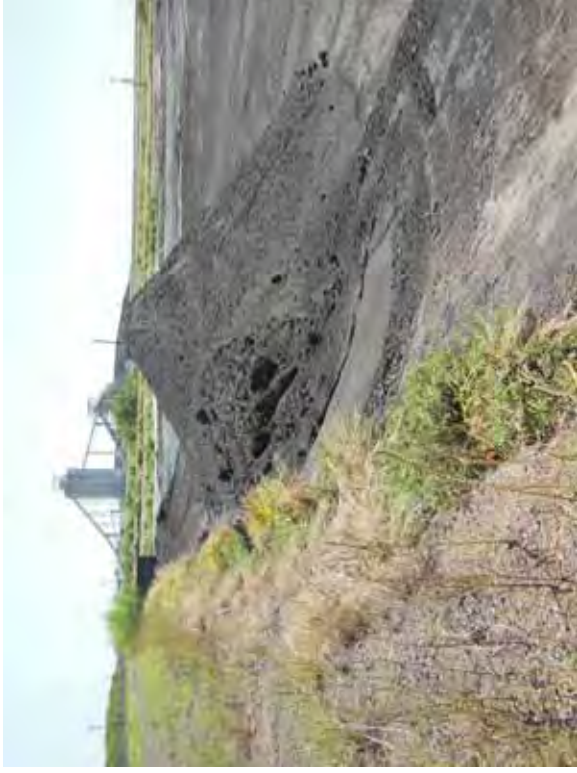
Photo 57: SP - Ash/soil pile on east embankment interior slope, looking south.

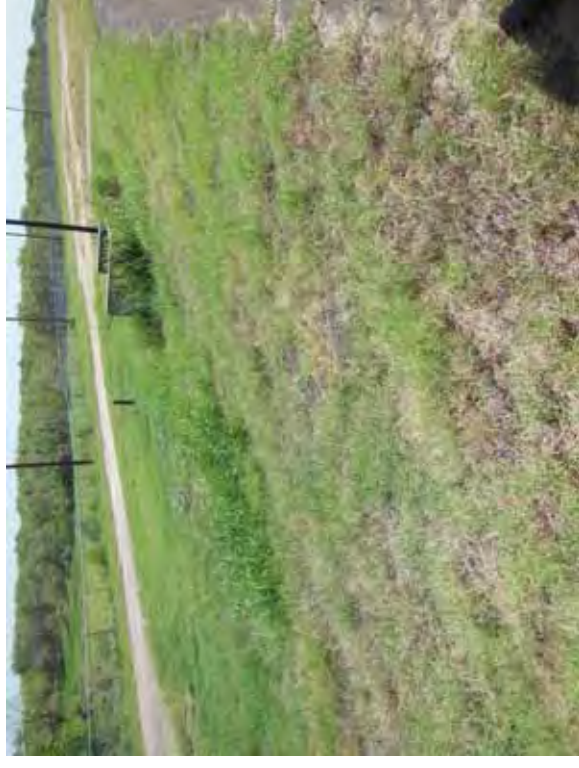
Photo 60: SP - Exterior slope at southeast corner, looking south.

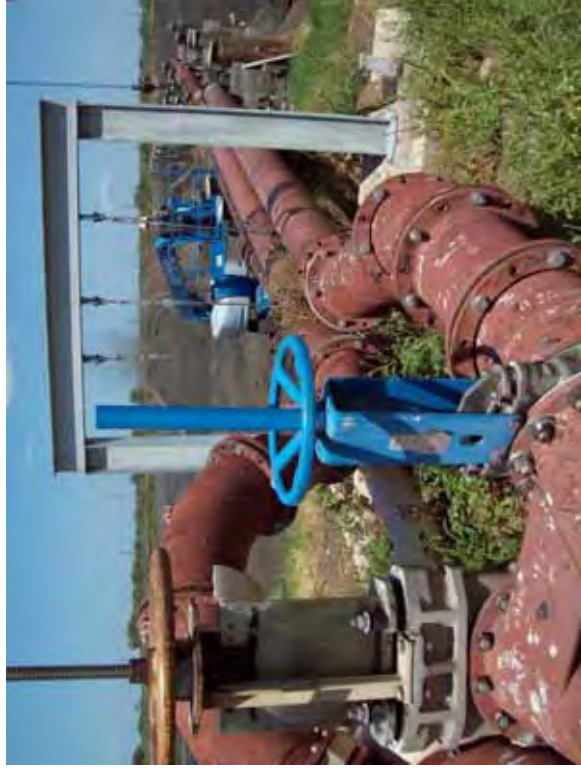
Three inlet pipes discharge liquids near the center of the South Bottom Ash Pond; two 12-inch-diameter welded steel and one 8-inch-diameter welded steel pipe (Photograph 71). The piping was being replaced during the site assessment (Photograph 68).

Photo 71: SP - Inlet piping at southwest corner interior slope, looking northeast.

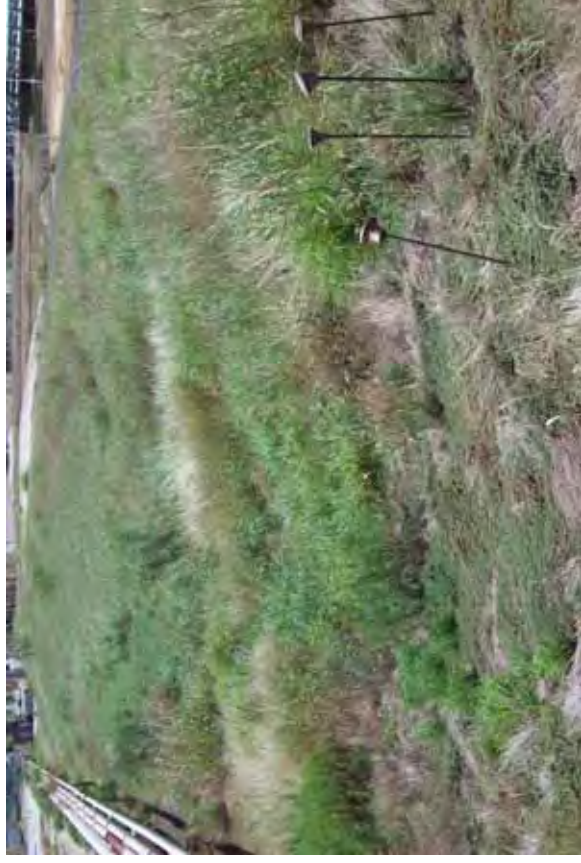
Photo 72: SP - Exterior slope at southwest corner, looking west.

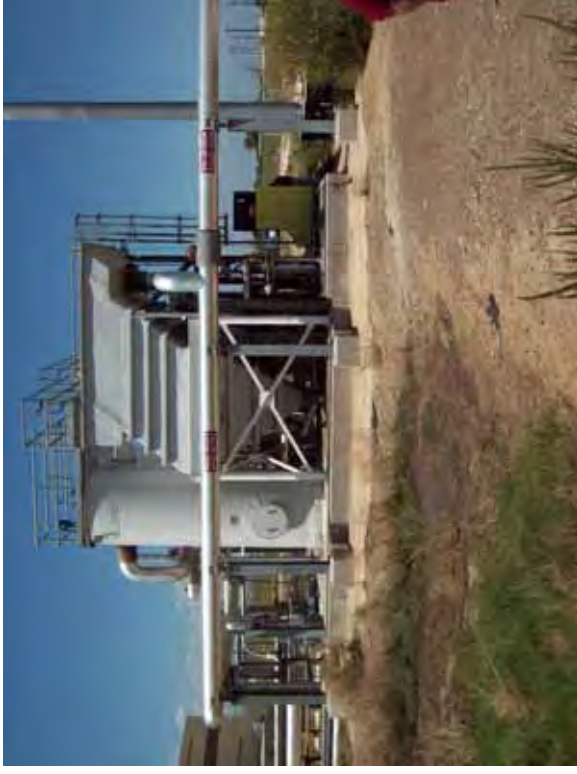
Photo 78: SP - SRH Pond clarifier structure at west embankment crest, looking north.

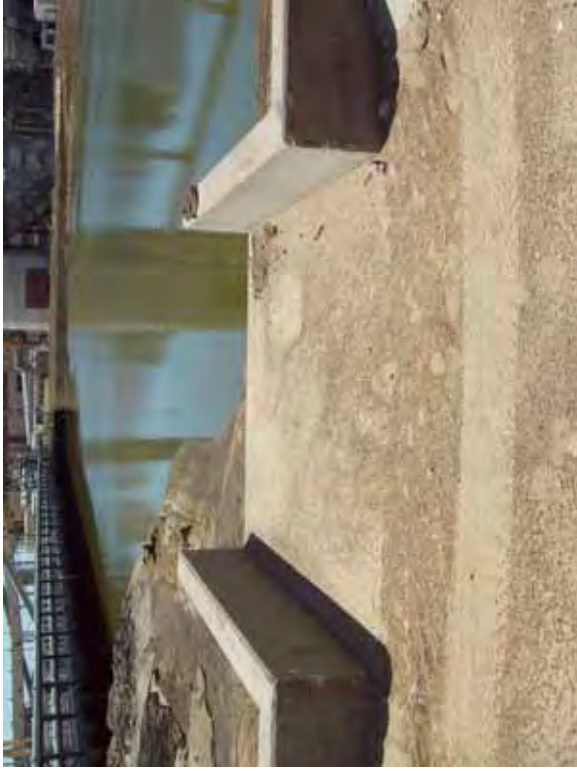
Photo 81: SP - Spillway between SRH Pond and South Bottom Ash Pond at west embankment exterior slope, looking west.

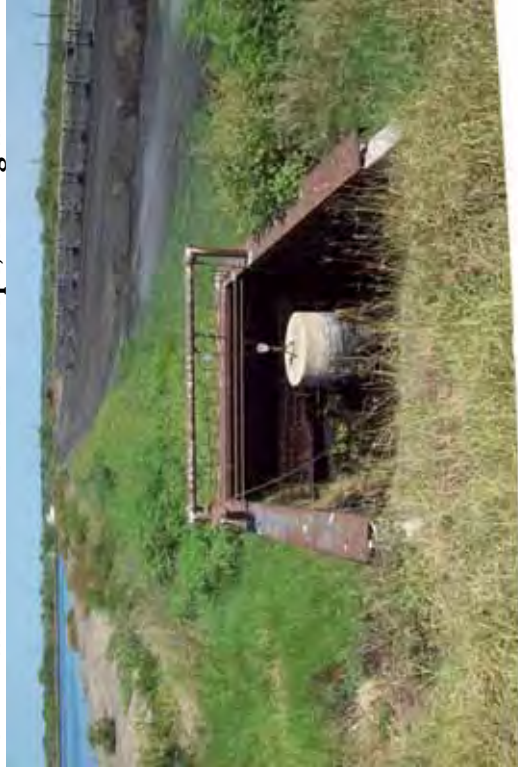
The outlet structure near the interior slope of at the southeast corner consists of a 12-inch-diameter welded steel vertical outlet pipe and a 12-inch-diameter steel drain pipe. The outlet pipes are partially surrounded by a steel sheet pile wall containing an opening, with a floating sorbent boom, for flow to the outlet pipes (Photograph 61). The outlet pipes discharge liquids from the South Bottom Ash Pond to outfalls at the Plant intake canal (Photographs 85, 86, 87, and 89). A 24-inch-diameter welded steel outlet pipe at the interior slope near the northwest corner returns liquids from the pond to the Plant (Photograph 83).

Photo 83: SP - 24-inch-diameter Plant return outlet, looking east.

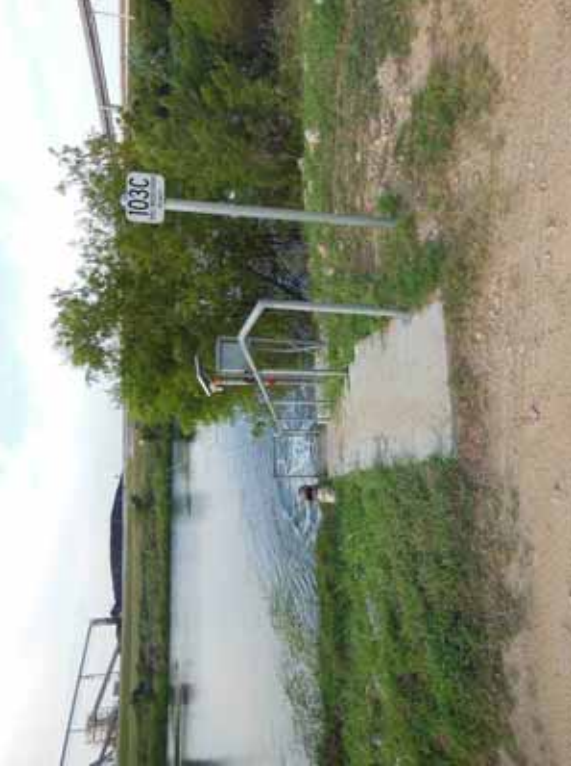
Photo 85: NP/SP - Discharge outfall 103C into Plant intake canal.

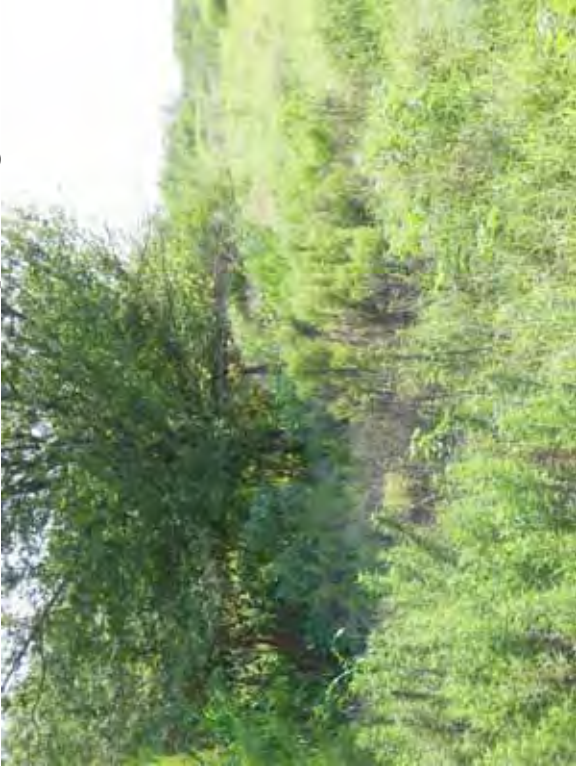
Photo 104: North embankment exterior slope, looking east. Note trees near exterior toe.

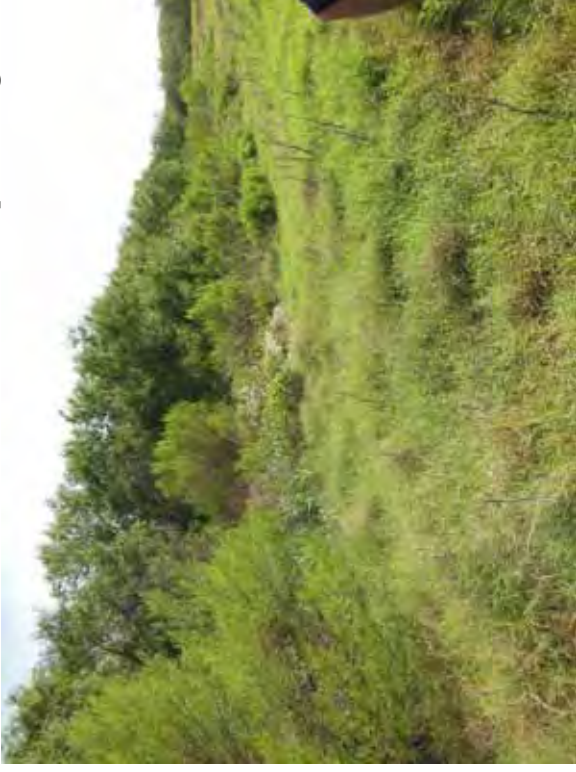
The exterior slopes appear to be in satisfactory condition and are covered in grassy vegetation approximately 2 feet high and a few small trees and bushes with diameters less than 6 inches in diameter (Photographs 93, 98, 109, and 119). Areas of loose soil were observed at the east embankment exterior slope (Photographs 92, 94, and 96) and an animal burrow was observed in the west embankment exterior slope (Photograph 110). An area of exposed soil was observed at the south embankment exterior slope (Photograph 117). Based on construction drawings, the exterior slopes are 3H:1V at all embankments, though slopes measured in the field ranged from 3H:1V to 4H:1V (Photographs 97 and 118). Trees up to 12 inches in diameter were located at the toe of all embankments (Photographs 95, 105, 112, and 119).

Photo 105: Trees at north embankment exterior toe, looking east.

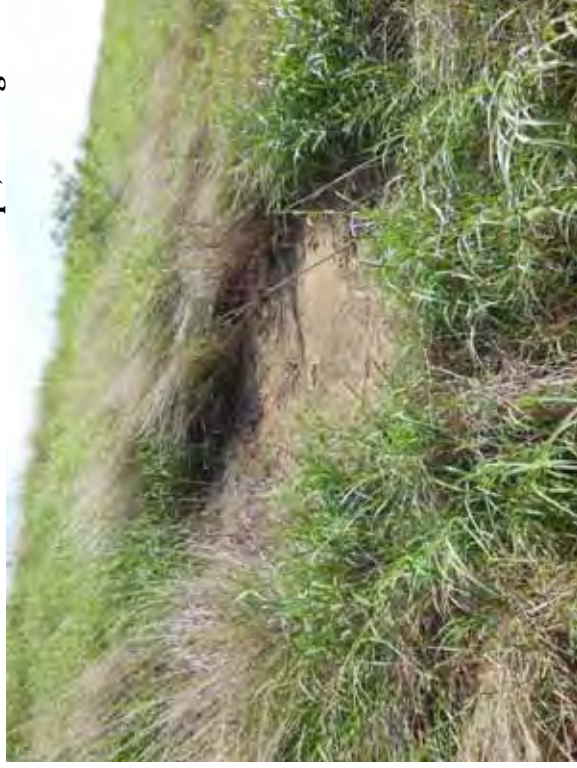
Photo 117: Exposed soil at south embankment exterior slope, looking north.
