ASSESSMENT OF DAM SAFETY OF COAL COMBUSTION SURFACE IMPOUNDMENTS FINAL REPORT

**CPS Energy
J.K. Spruce Power Plant
San Antonio, Texas**

Prepared for
*U.S. Environmental
Protection Agency
Washington, D.C.*

February 2014
Revised May 2014
Revised June 2014

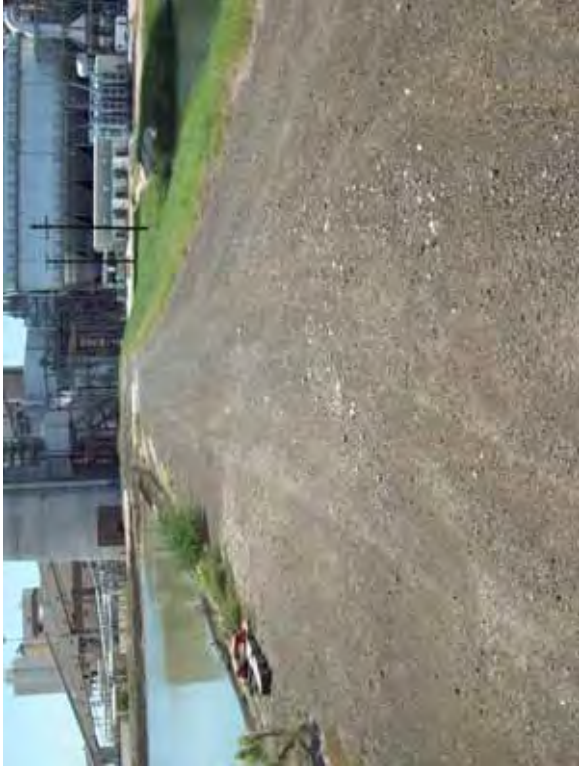
The crest of the SRH Pond appeared to be in satisfactory condition (Photographs 3, 13, 20, and 50). The crest was approximately 15 feet wide at all embankments except at the east embankment where it widened to approximately 50 feet to accommodate the clarifier pad (Photograph 8). Two spillways that connect the SRH and South Bottom Ash Ponds were located on the east embankment crest (Photographs 5 and 9). Supports for overhead piping were located at the west embankment crest (Photograph 22). The crest of the embankments consists of compacted granular soils and gravel and is exposed to minimal vehicle traffic. No depressions or evidence of settlement were observed on the crest.

Photo 13: North embankment crest, looking west.

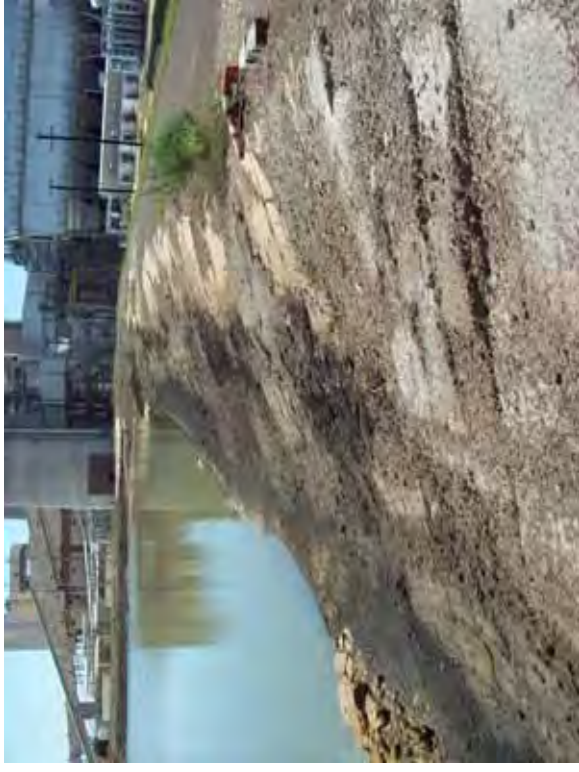
Interior slopes of the SRH Pond appear to be in fair condition (Photographs 4, 12, 14, 19, 45, and 51). Interior slopes were at 3H:1V and covered in a layer of granular material and other solids. Some sparse vegetation was observed in limited areas on the east and north embankment interior slopes (Photographs 4, 8, 9, and 17). Concrete roadway ramps into the pond for equipment access were located at the north and south embankment interior slopes (Photographs 17 and 53). Two spillway inlets were located on the east embankment interior slope (Photograph 7 and 11). Piping and sump pumps were located on a concrete pad built into the west embankment interior slope (Photograph 19 and 25). Visible portions of interior slopes did not include riprap or other armoring.

Photo 14: North embankment interior slope, looking west.

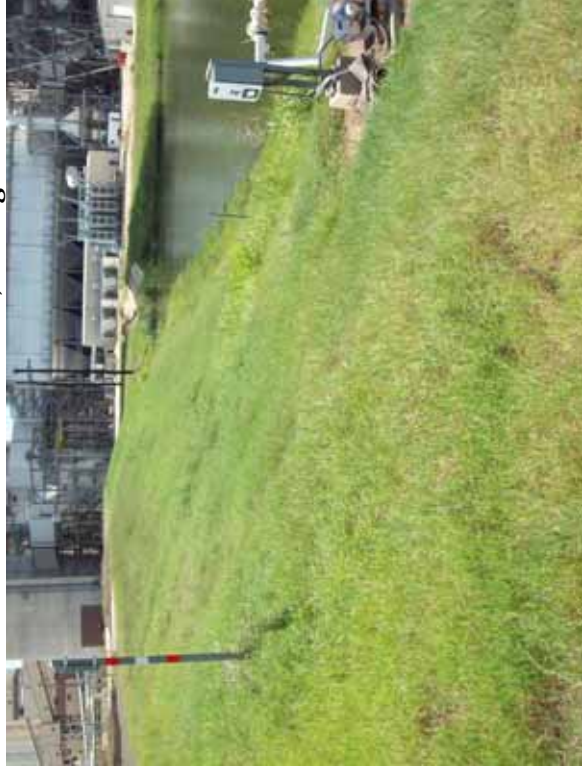
Exterior slopes of the SRH Pond appear to be in fair condition (Photographs 1, 15, 21, 46, and 52). The exterior slopes of the north, west, and south embankments are approximately 3H:1V and covered in grassy vegetation approximately 3 inches tall. The north embankment is shared with the #1 Stormwater Runoff Pond (Photograph 15). The east embankment is shared with the South Bottom Ash Pond and is covered in ash material and vegetation (Photographs 1, 6, and 10). Two spillway outlets were located on the east embankment exterior slope (Photograph 6 and 10). No areas of erosion or indications of seepage were observed at the spillways.

Photo 15: North embankment exterior slope, looking west. #1 Stormwater Runoff Pond at exterior toe.

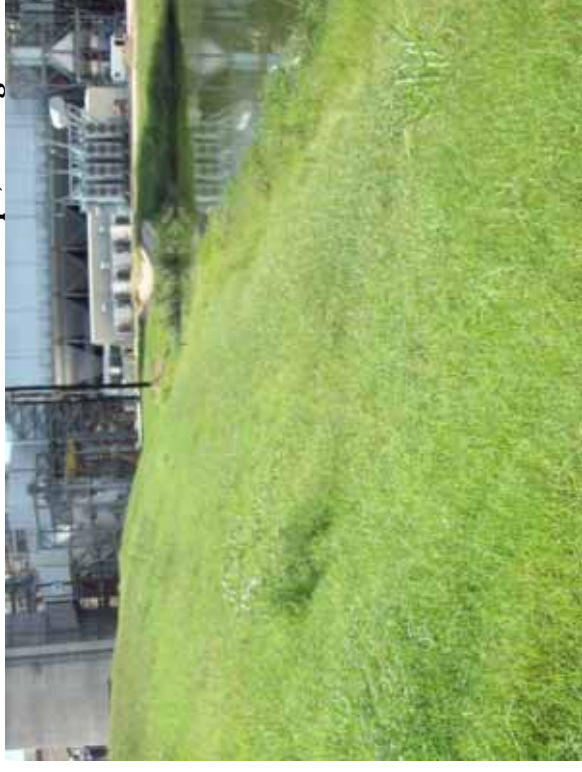
Photo 16: North embankment exterior slope, looking west.

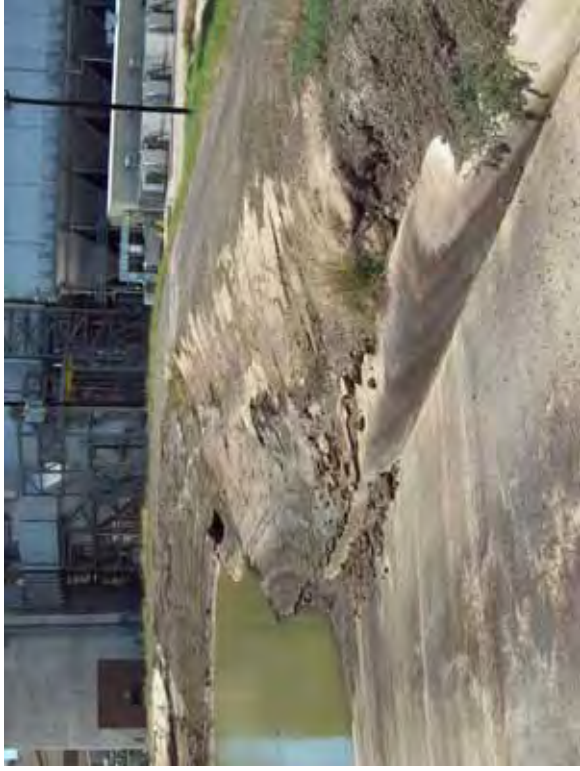
Photo 17: North embankment interior slope, looking west.

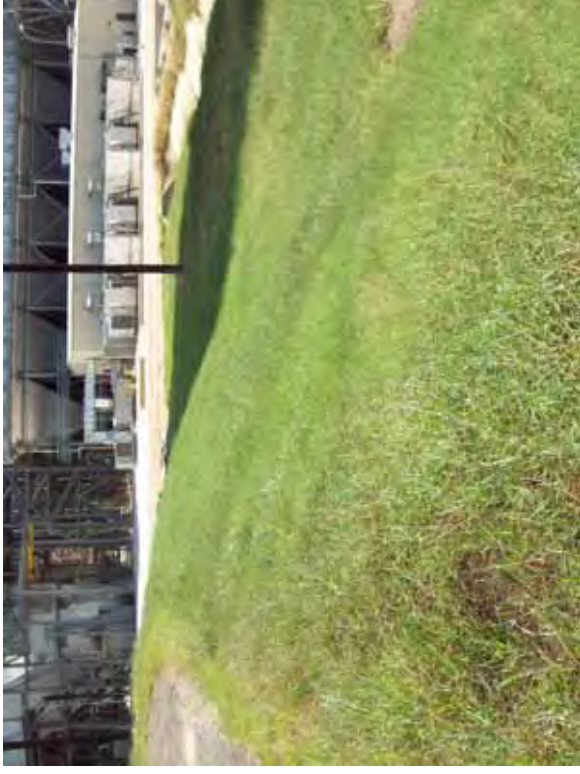
Photo 18: North embankment exterior slope, looking west.

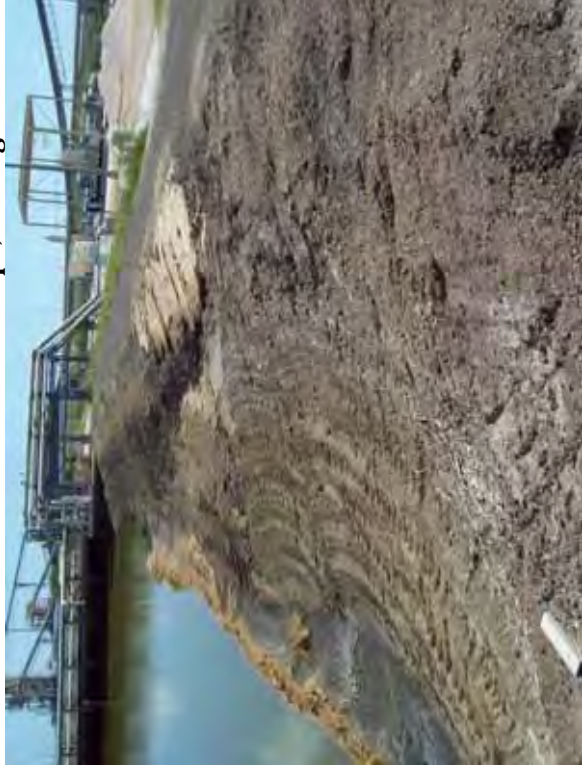
Photo 19: West embankment interior slope, looking south.

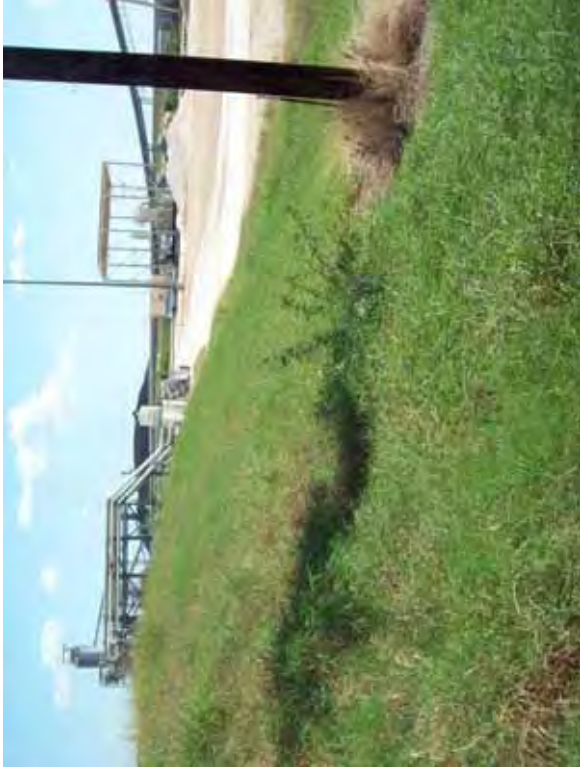
Photo 21: West embankment exterior slope, looking south.

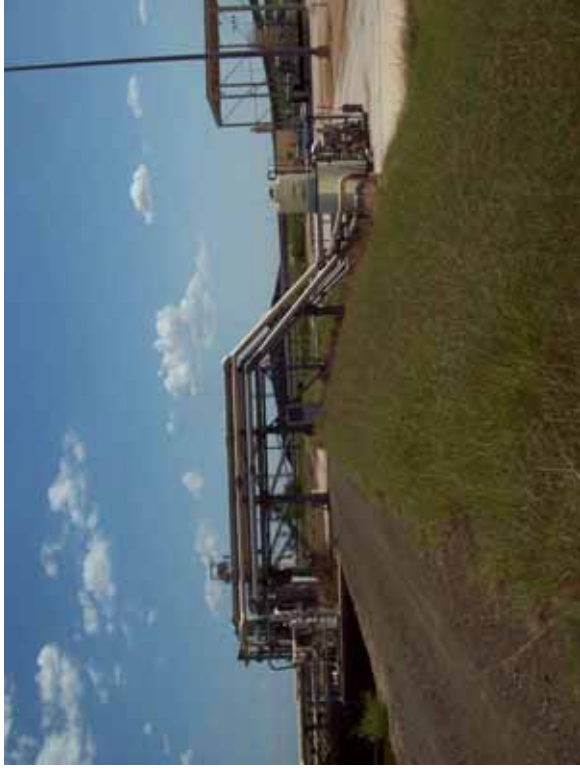
Photo 22: West embankment exterior slope, looking south.

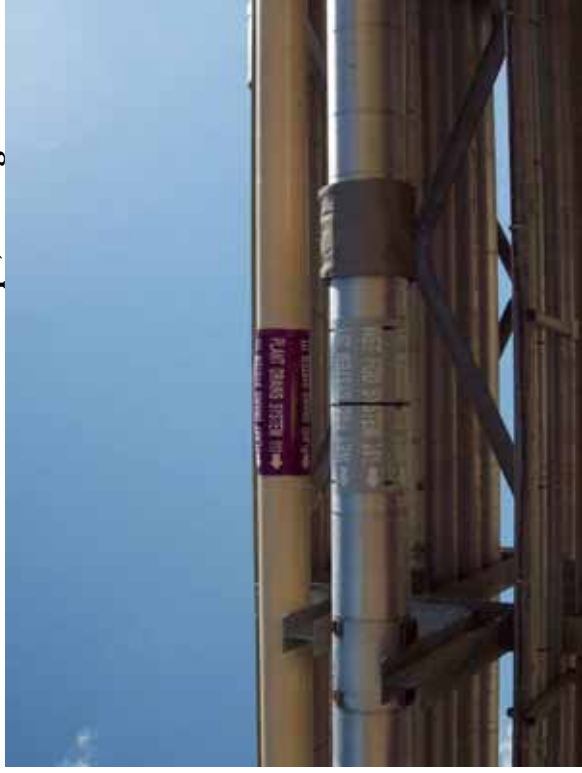
Photo 23: Overhead piping at west embankment crest, looking south.

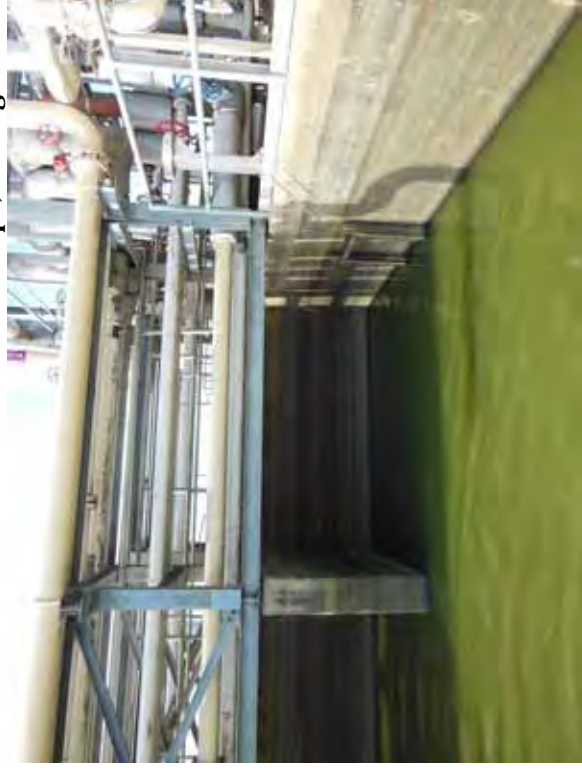
The outlet structure near the west embankment interior slope consists of two 18-inch-diameter steel outlet pipes, one is located in the north section of the pond and one is in the south section. The outlet pipes were submerged during the site assessment (Photographs 24 and 27). CCW is pumped through the outlet pipes to the clarifier located at the east embankment crest (Photograph 8). Liquids from the clarifiers are discharged to outfall 109 at the Plant intake canal (Photographs 55, 56, and 57).

Photo 24: Submerged SRH-north outlet structure at west embankment interior slope, looking south.

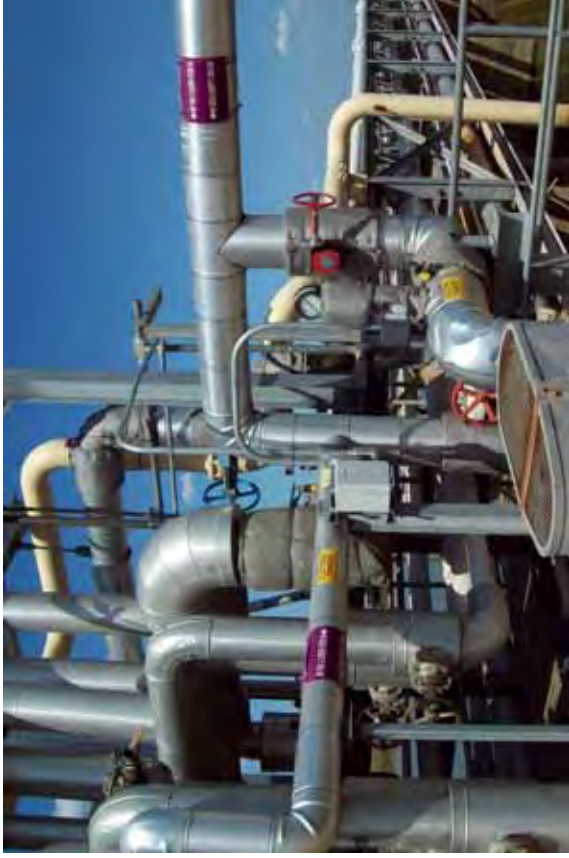
Photo 25: Piping at west embankment interior slope, looking northeast.

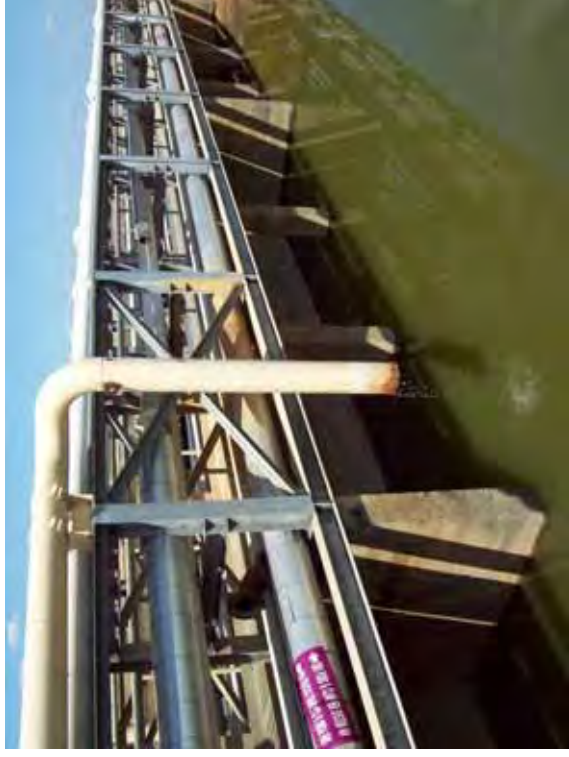
Several inlet pipes discharge liquids near into the north section of the SRH Pond; four 4-inch-diameter, eight 6-inch-diameter and two 8-inch-diameter metal pipe (Photographs 33, 38, 39, 40, 41, 42, 43, and 44). Inlet pipes discharging liquids into the south section of the SRH Pond include; four 4-inch-diameter, eight 6-inch-diameter and two 8-inch-diameter metal pipe (Photographs 26, 28, 30, 31, 32, 34, 35, 36, and 37).

Photo 26: 8-inch-diameter metal SRH-south inlet pipe labeled "Plant Drain System III", looking northeast.

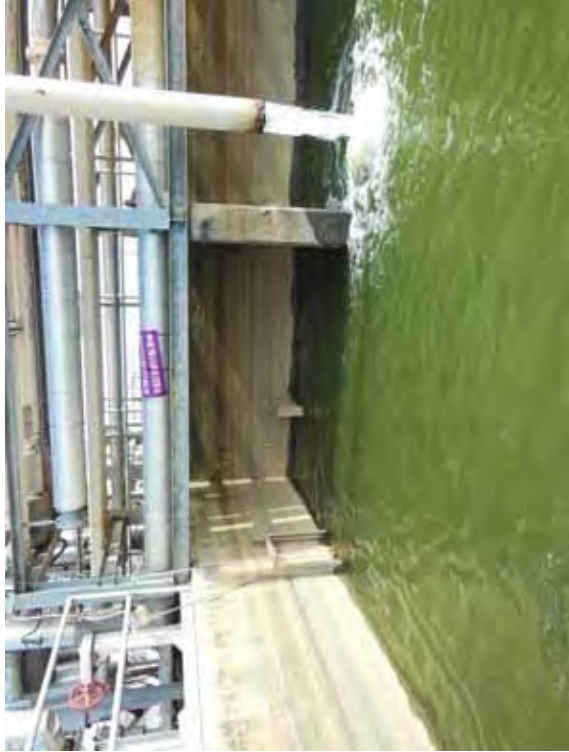
Photo 27: Submerged SRH-south outlet structure at west embankment interior slope, looking north.

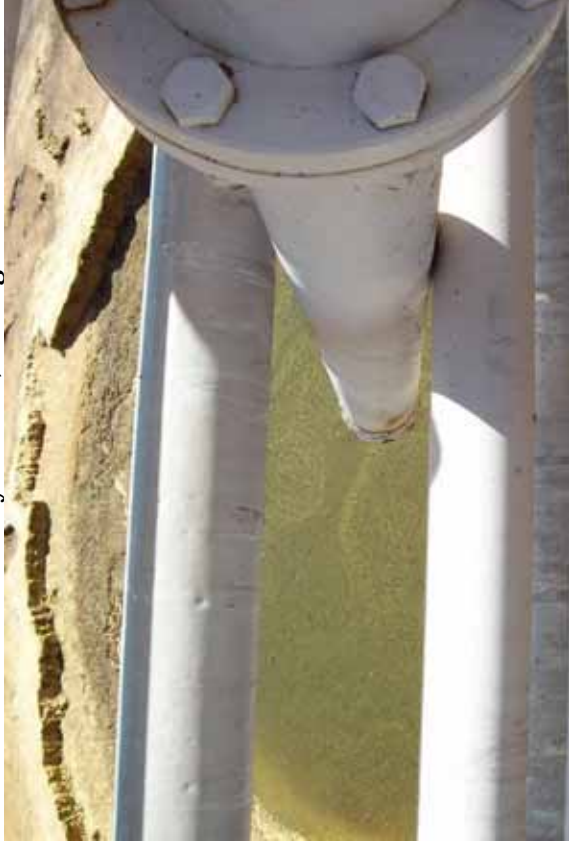
Photo 28: 6-inch-diameter metal SRH-south inlet pipe labeled "Waste Slurry Sump", looking south.

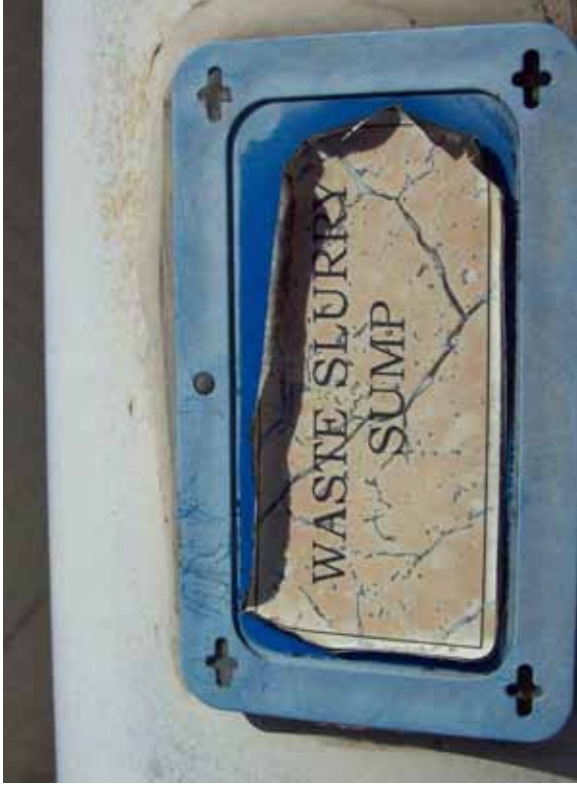
Photo 29: Label for inlet pipe in Photo 28.

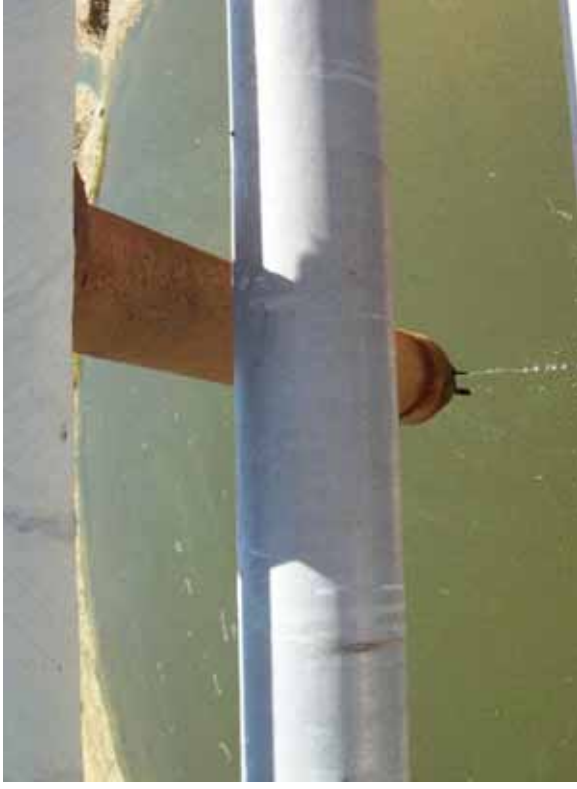
Photo 30: 6-inch-diameter metal SRH-south inlet pipe, looking south.

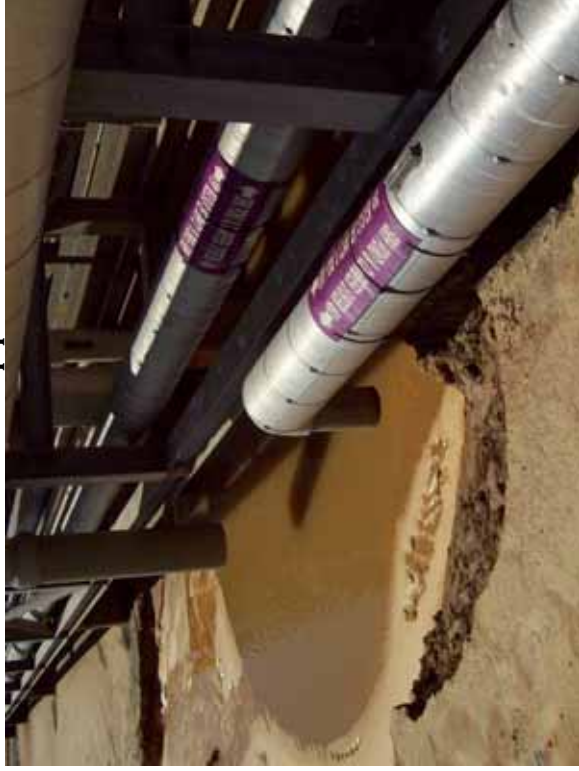
Photo 31: 6-inch-diameter SRH-south inlet pipe labeled "SRH Pond & Clarifier Syst 464", looking west.

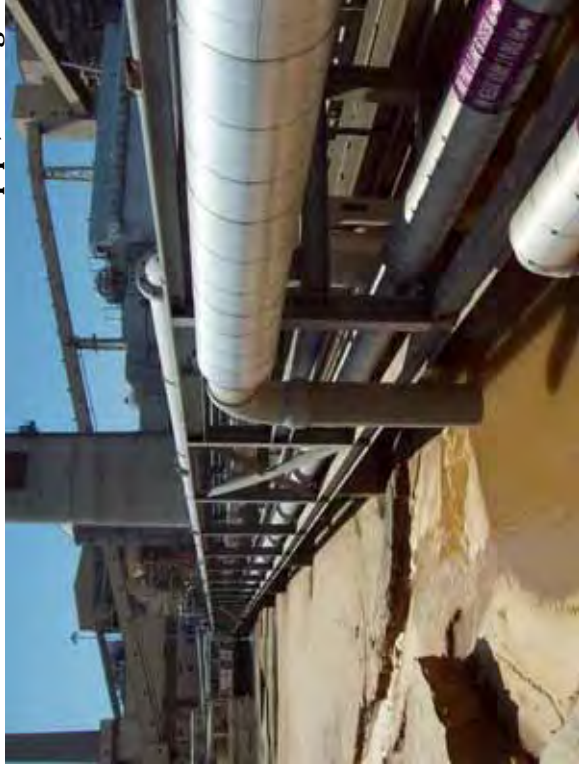
Photo 32: 8-inch-diameter SRH-south inlet pipe labeled "SRH Pond & Clarifier Syst 464", looking west.

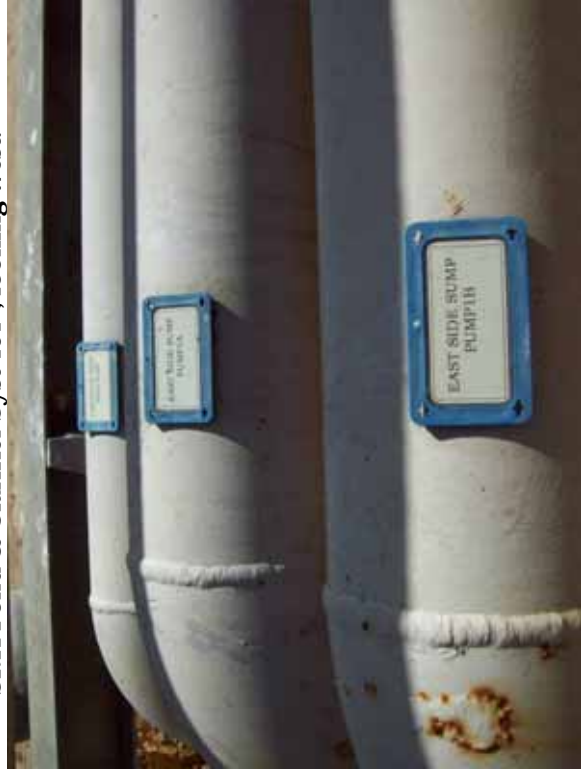
Photo 35: Labels for middle three 6-inch-diameter inlets shown in Photo 34.

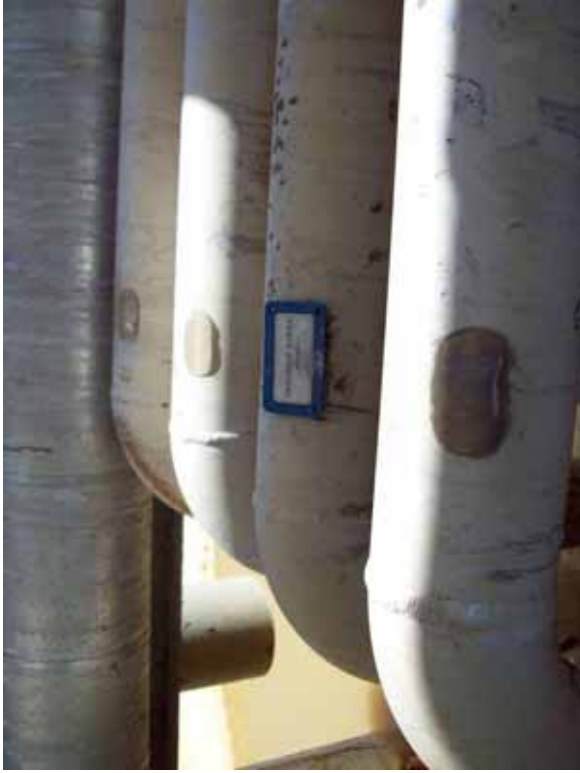
Photo 37: Labels for right four 4-inch-diameter inlets shown in Photo 34.

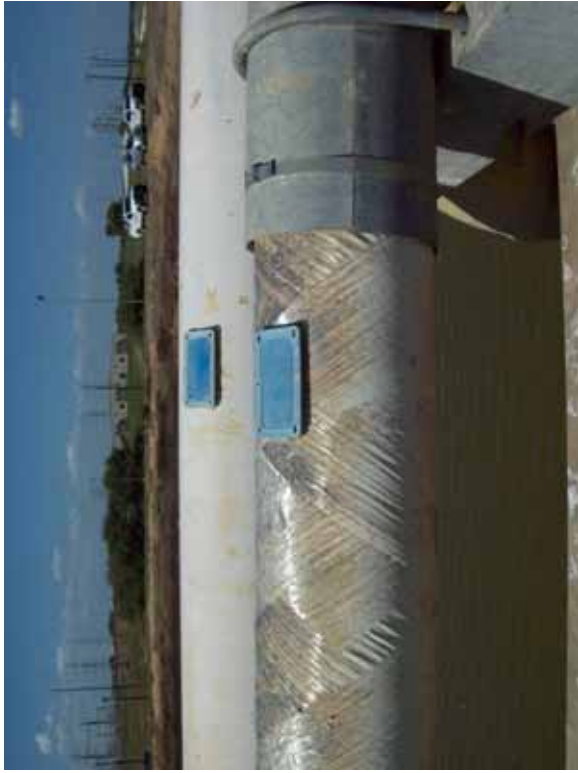
Photo 39: Labels for right two 6-inch-diameter inlets shown in Photo 38.

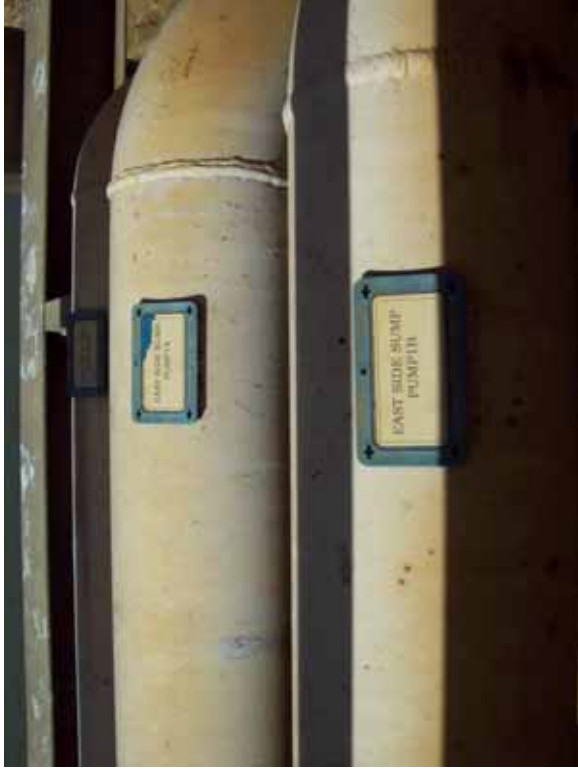
Photo 40: Labels for middle three 6-inch-diameter inlets shown in Photo 38.

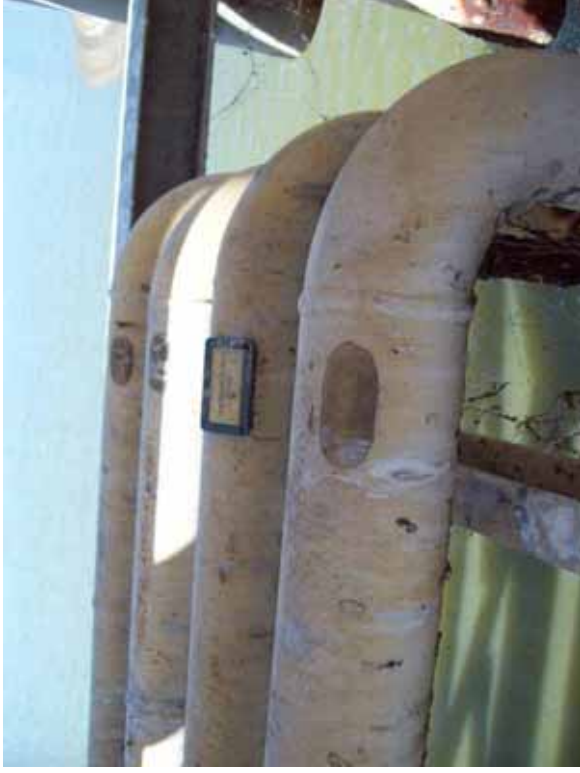
Photo 41: Labels for left four 4-inch-diameter inlets shown in Photo 38.

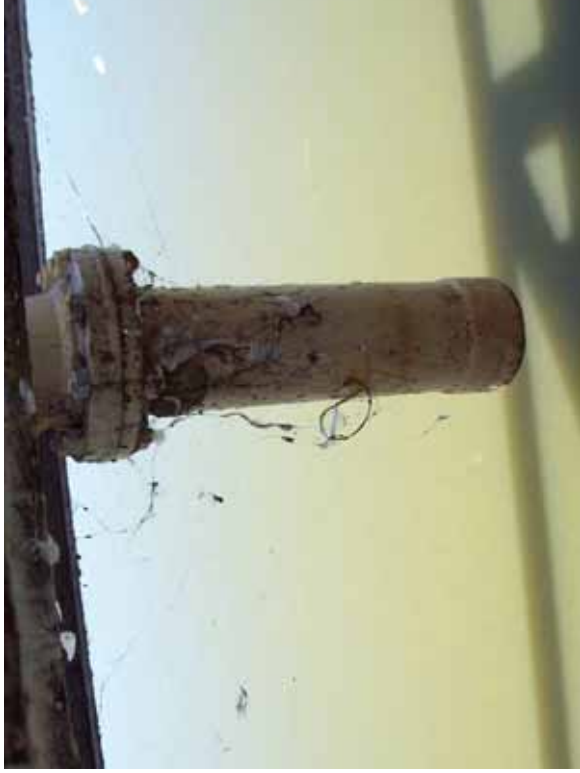
Photo 43: 6-inch-diameter metal SRH-north inlet pipe, looking north.

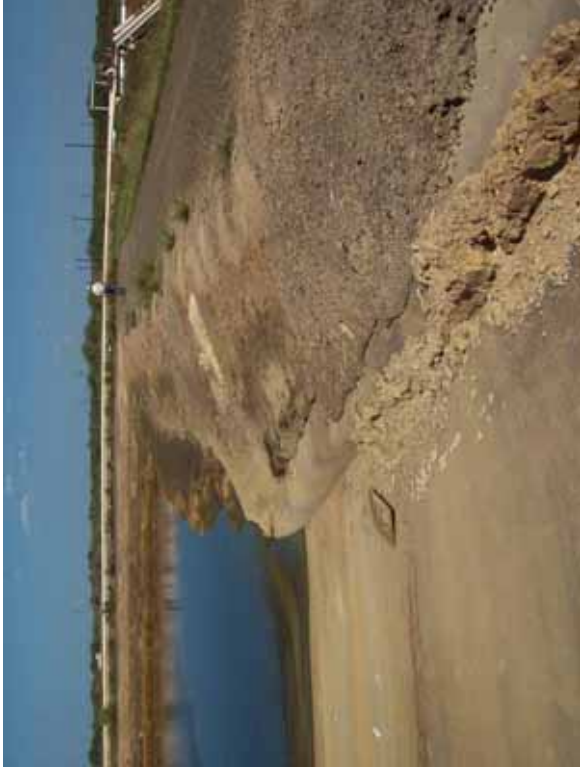
Photo 53: South embankment interior slope, looking east.

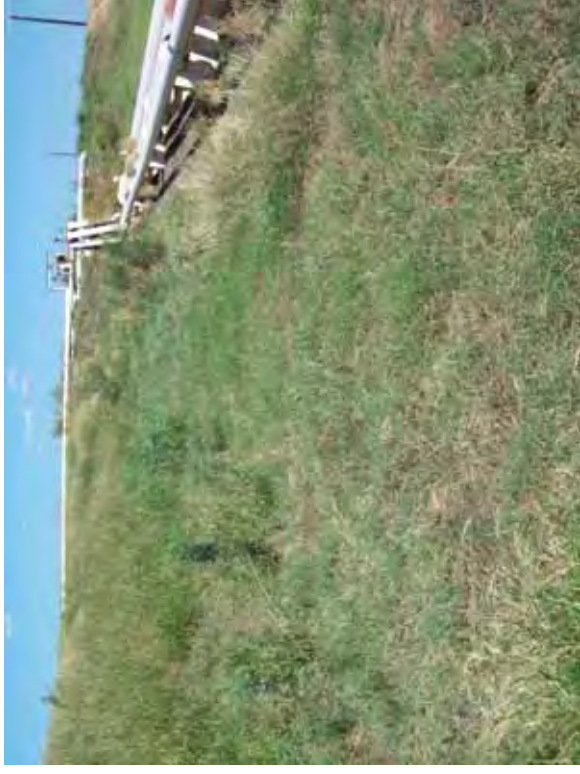
Photo 54: South embankment exterior slope, looking east.

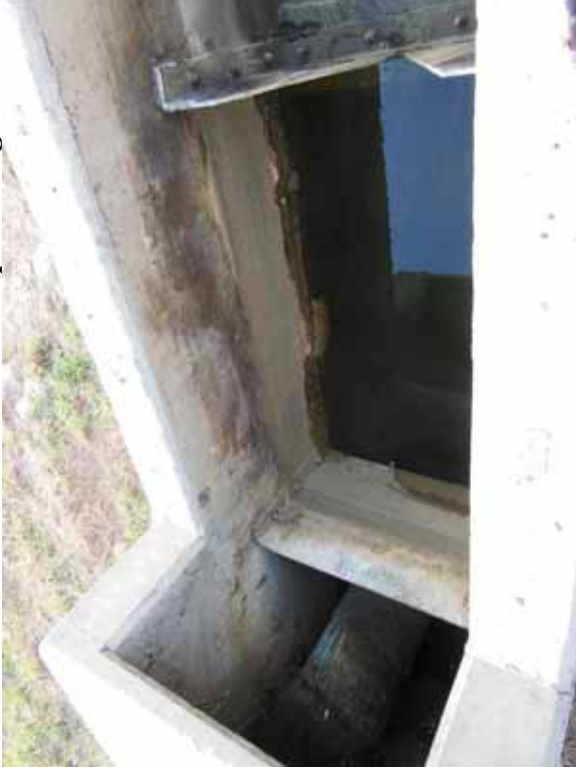
Photo 55: V-notch weir outfall for SRH Pond.

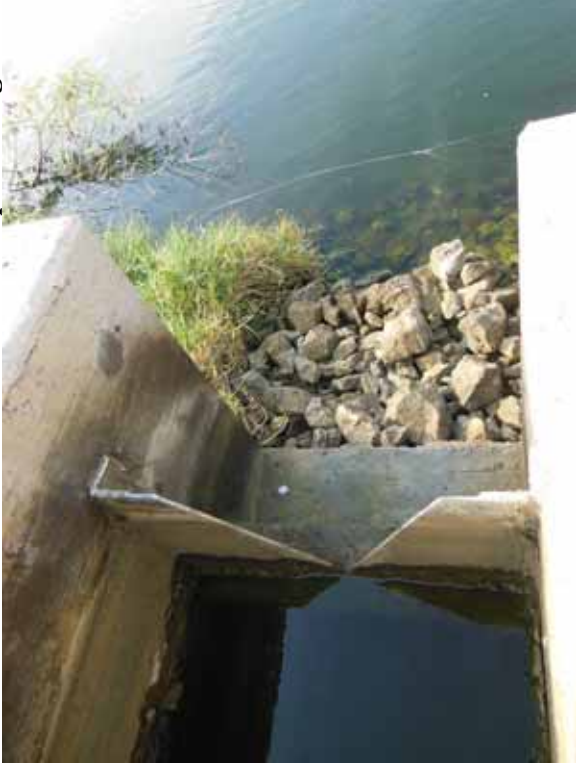
Photo 56: V-notch weir outfall for SRH Pond.

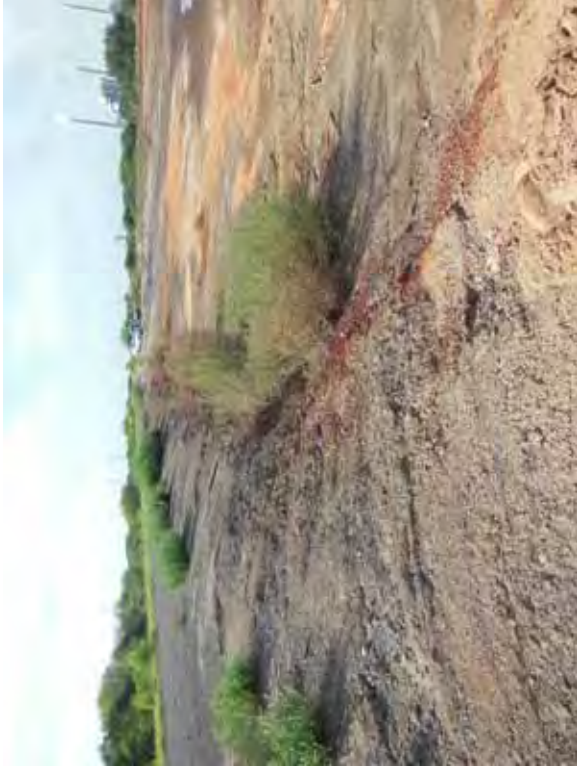
Due to the level of solids and water in the Evaporation Pond during the assessment, only the upper 0.5 to 2 ft of the interior slopes were visible (Photographs 59, 69, 70, 74, and 83). Vegetation covered some portions of the west and south embankment interior slopes (Photographs 79, 83, and 88). Ash and other solid material extend up to the crest near the southeast corner interior slope and on the east embankment interior slope (Photographs 59 and 90). Visible portions of interior slopes did not include riprap or other armoring.

Photo 70: East embankment interior slope, looking south.

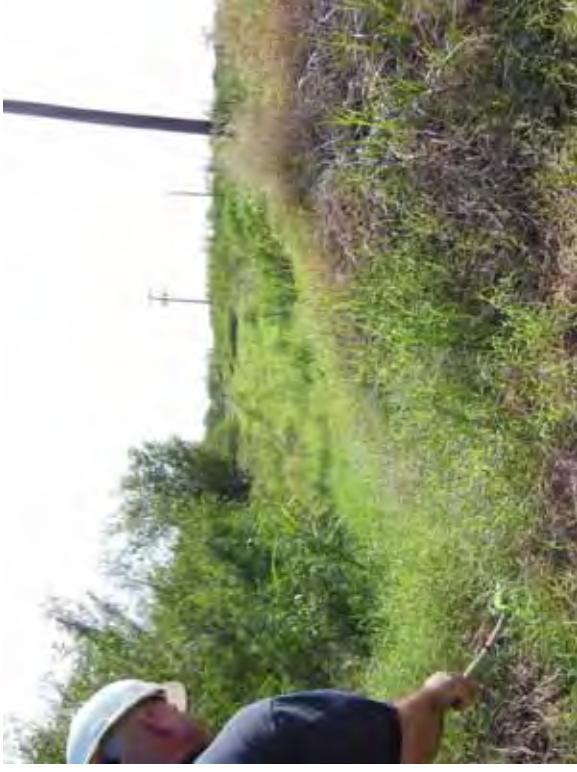
Photo 71: North embankment exterior slope, looking east.

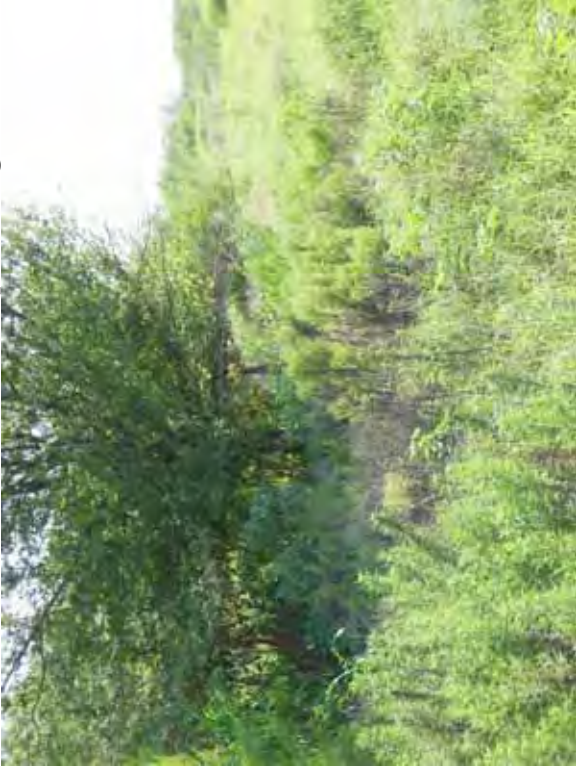
Photo 72: North embankment exterior slope, looking east. Note trees near exterior toe.

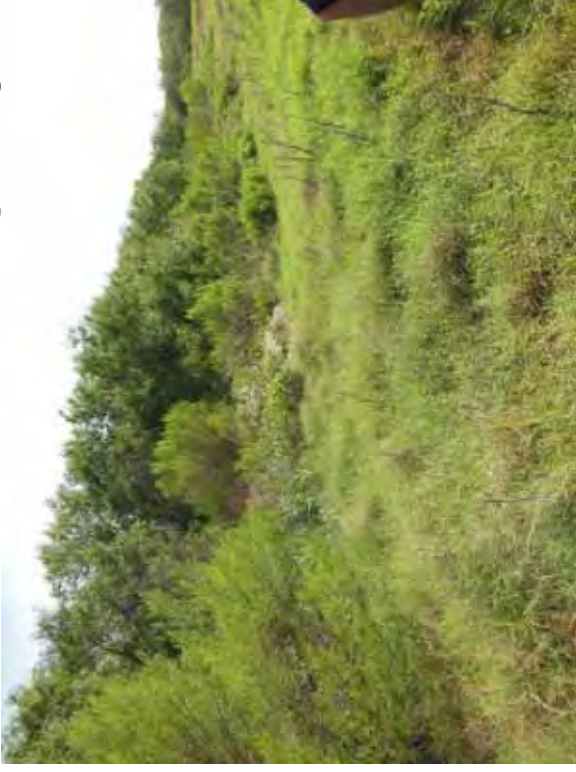
The exterior slopes appear to be in satisfactory condition and are covered in grassy vegetation approximately 2 feet high and a few small trees and bushes with diameters less than 6 inches in diameter (Photographs 61, 66, 77, and 87). Areas of loose soil were observed at the east embankment exterior slope (Photographs 60, 62, and 64) and an animal burrow was observed at the west embankment exterior slope (Photograph 78). An area of exposed soil was observed at the south embankment exterior slope (Photograph 85). Based on construction drawings, the exterior slopes are 3H:1V at all embankments, though slopes measured in the field ranged from 3H:1V to 4H:1V (Photographs 65 and 86). Trees up to 12 inches in diameter were located at the toe of all embankments (Photographs 63, 73, 80, and 87).

Photo 73: Trees at north embankment exterior toe, looking east.

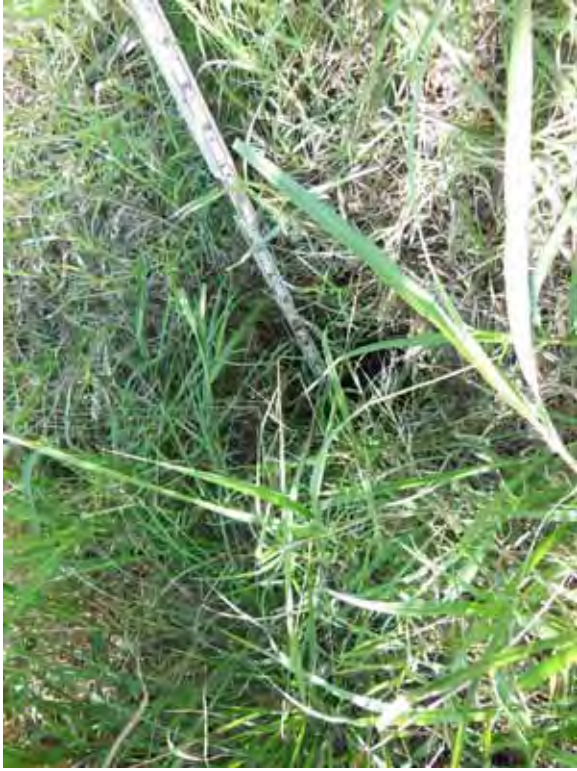
Photo 78: Approximately 18-inch-deep animal burrow at west embankment exterior slope.

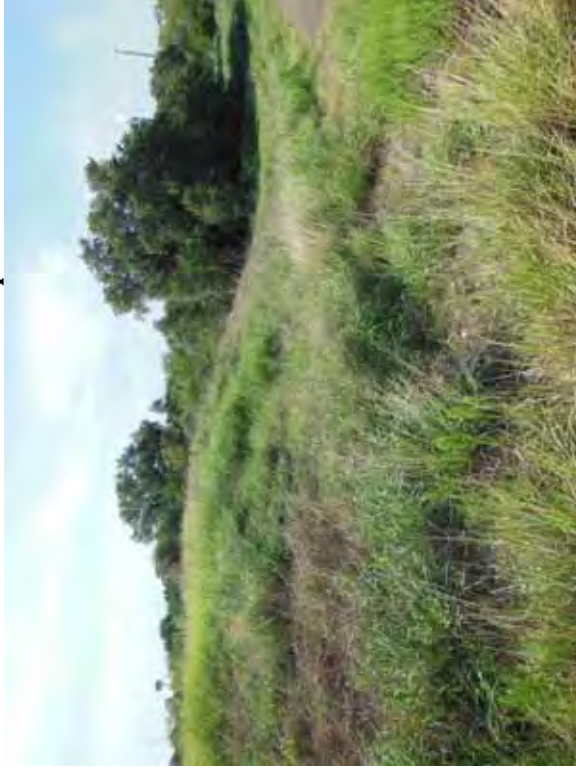
Photo 80: West embankment exterior slope, looking south.

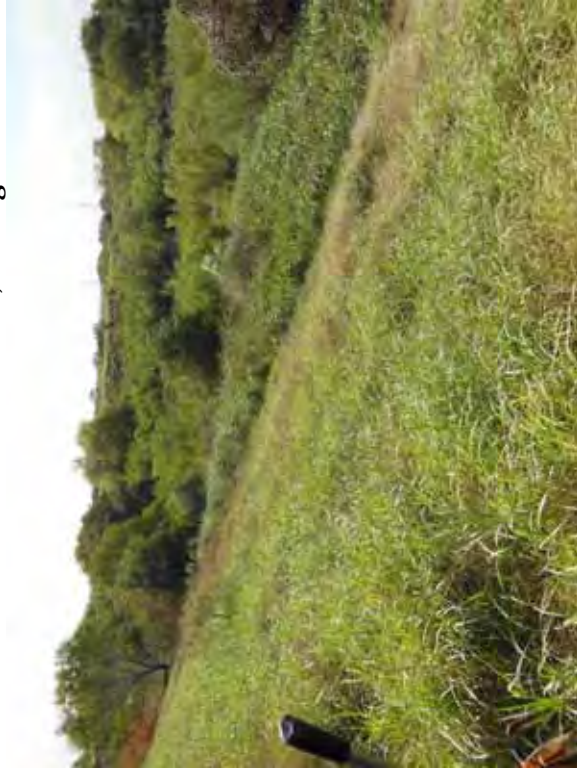
Photo 84: South embankment exterior slope, looking southeast.

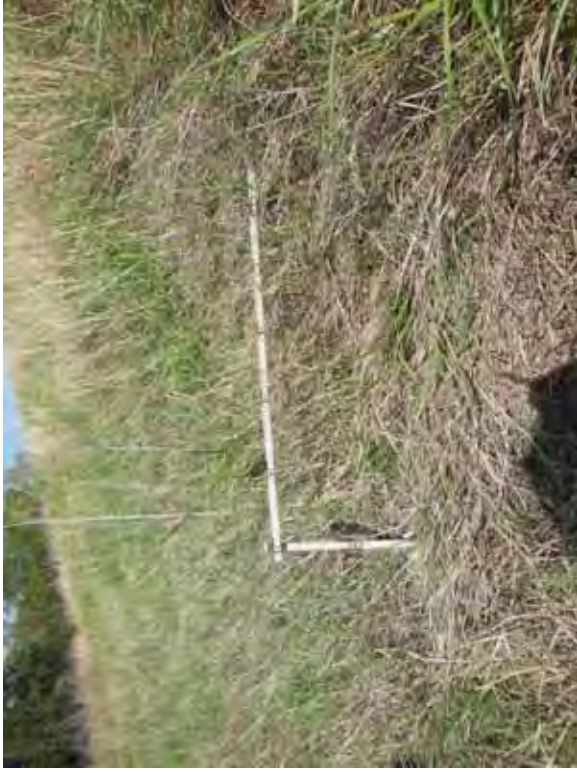
Photo 86: South embankment exterior slope measured approximately 3H:1V.

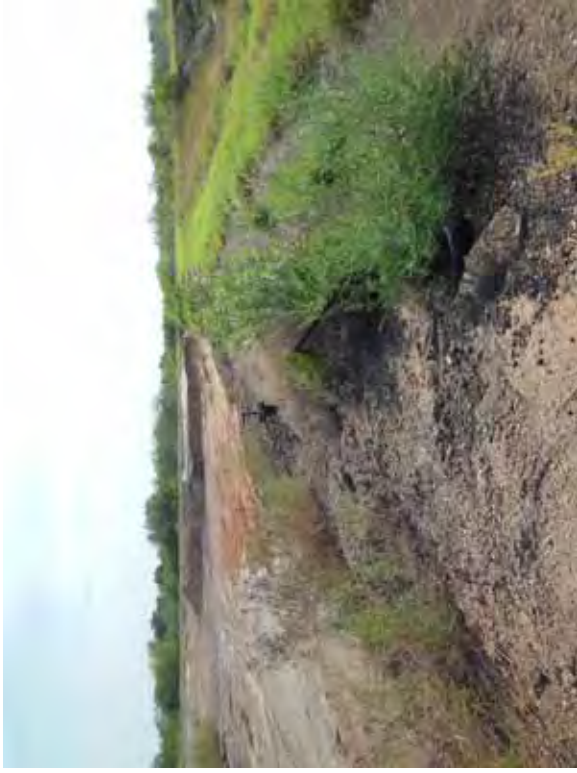
Photo 88: South embankment interior slope, looking east.
